April Report 2019

Introduction

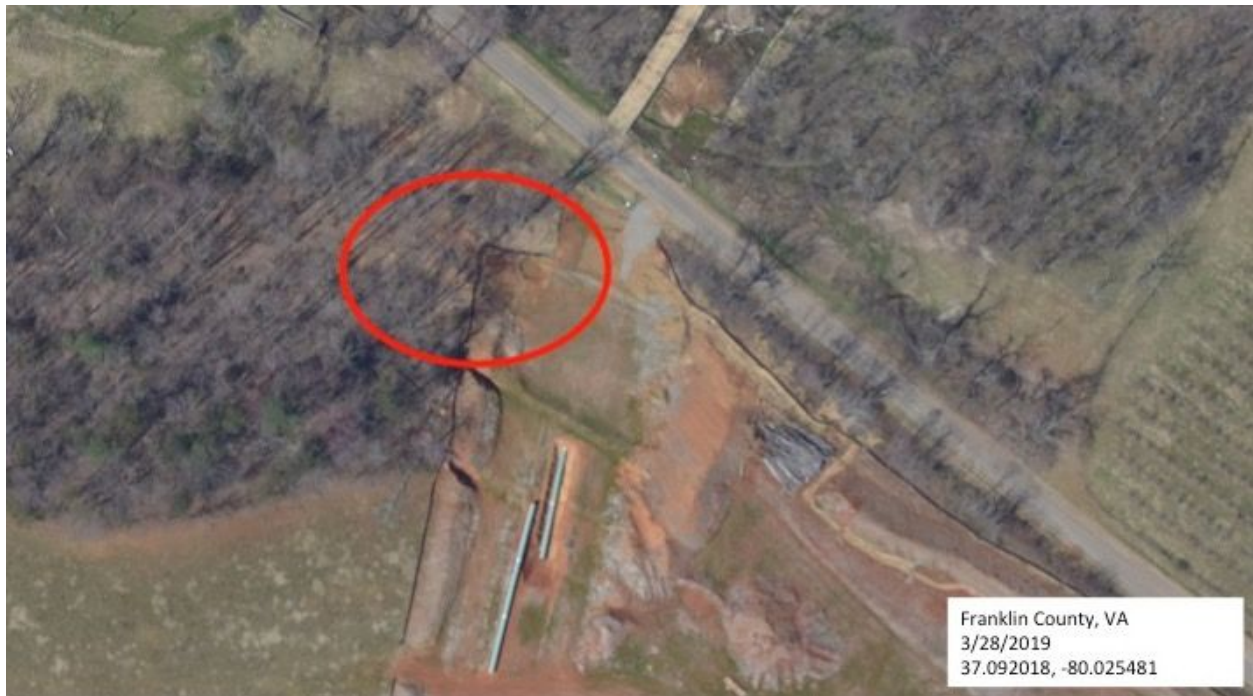
Figure 2: Aerial image of the Cahas Mountain Crossing in Franklin County, Virginia from March 28, 2019. The area shown in the subsequent figures outlined in red.

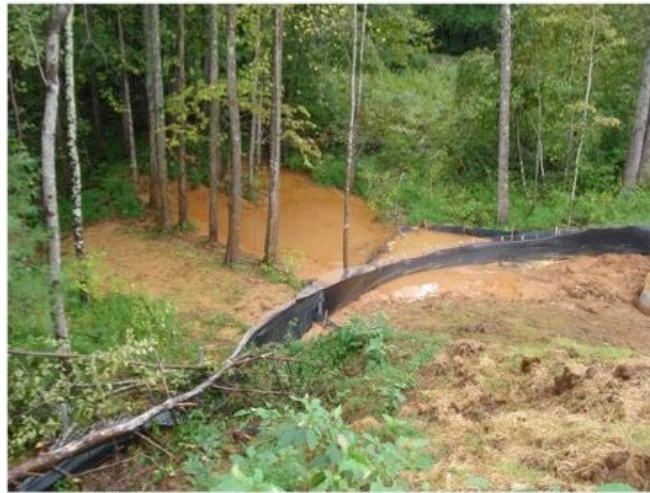
Figure 3: Large amount of mud streaming off of site at Cahas Mountain Road Crossing, despite perimeter controls in place. September 17, 2018.

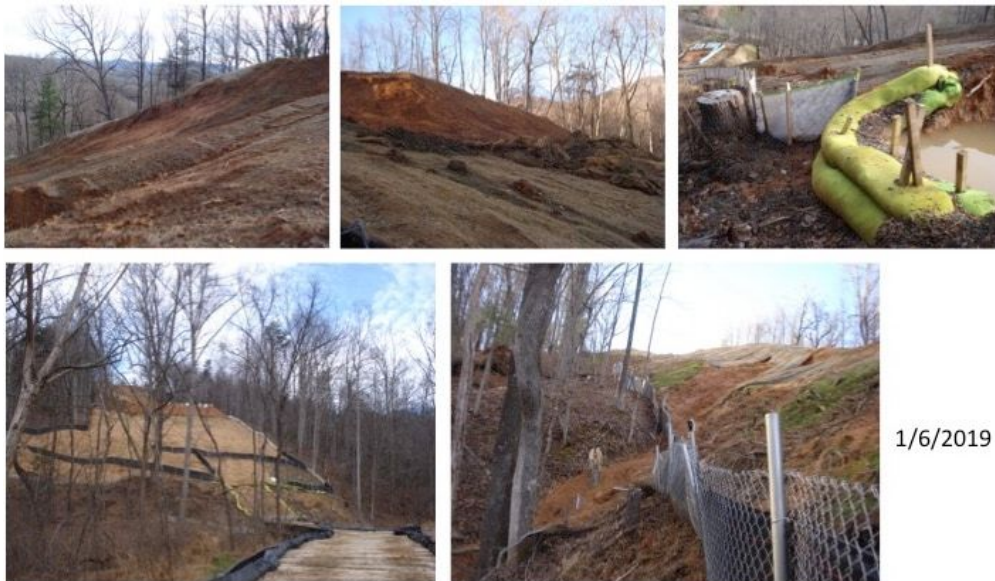
1/6/2019

Figure 4: Lack of adequate slope stabilization and ESC maintenance was reported January 6, 2019 — months after this site started seeing the problems depicted above. Note the piled jute fabric below a mound of unstabilized earth, as well as the path of sediment flowing over the

super silt fence at the perimeter and off the right-of-way. There is a stream and wetland below this site.

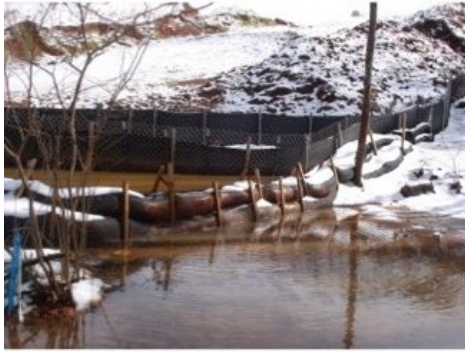
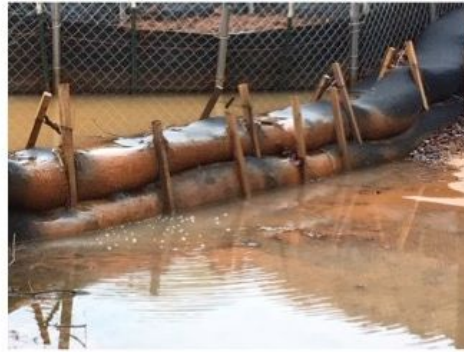
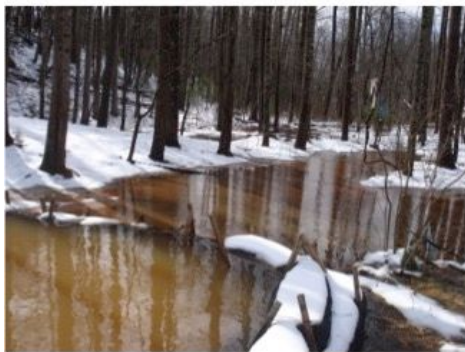
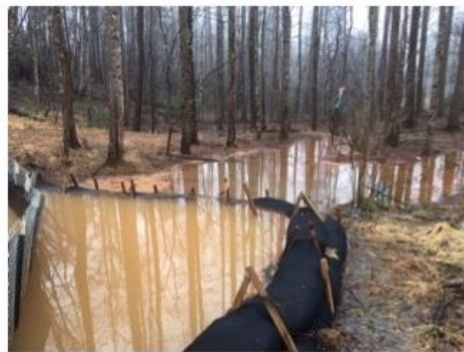
Figure 5: Images showing muddy water overrunning silt socks at the Cahas Mountain Road crossing in late February 2019.

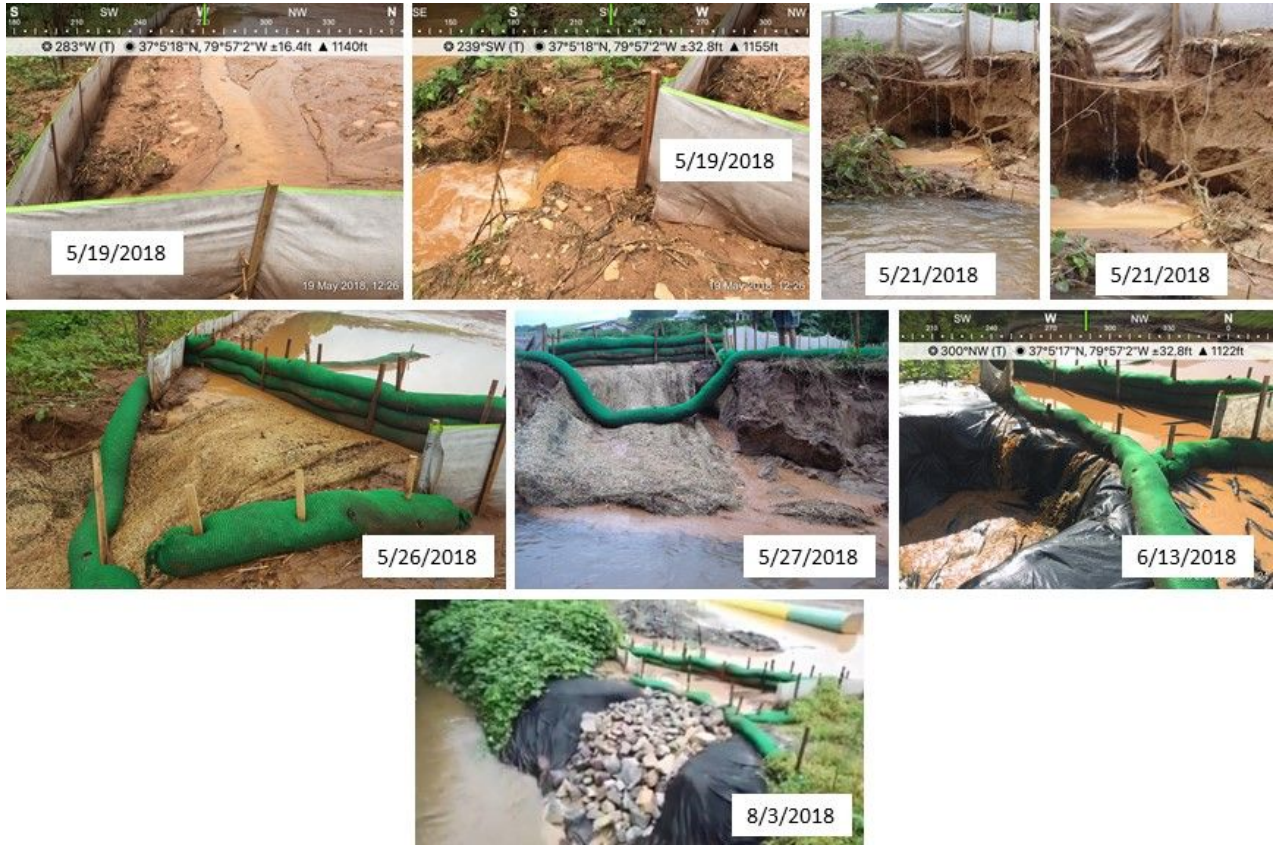
Figure 6: Sequence leading to bank failure on Teels Creek.

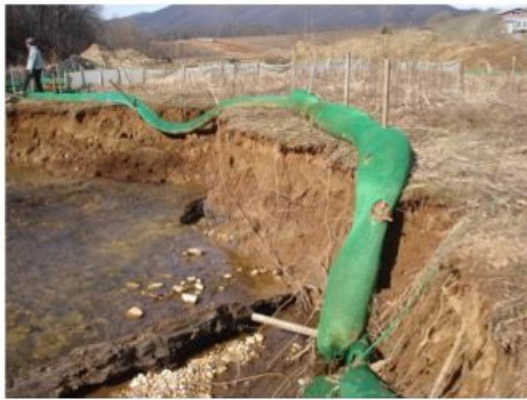
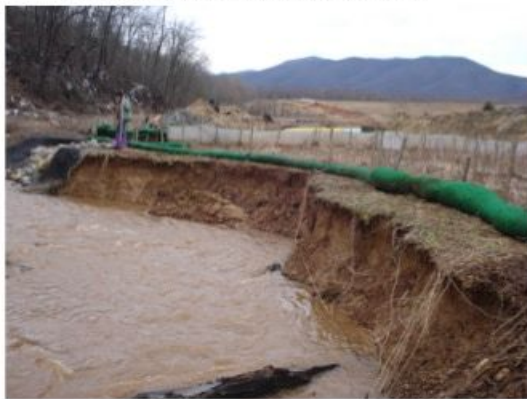
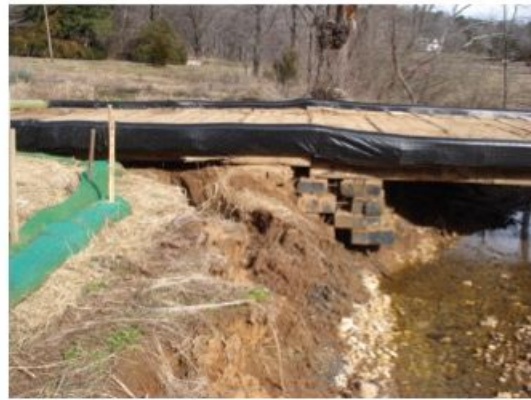
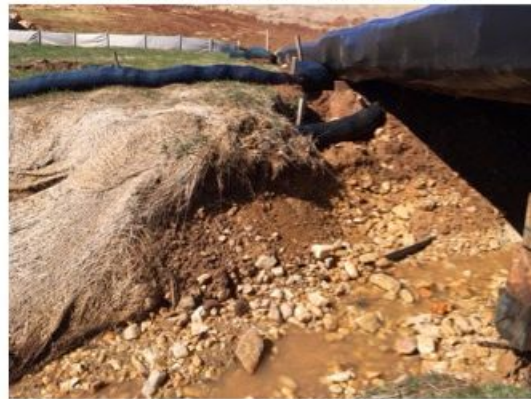
Figure 7: Stream bank failure is ongoing at this location, beginning in May 2018 and seen throughout February 2019. Jute fabric used placed only partially over scour at the bridge, and did not effectively stabilize the site.

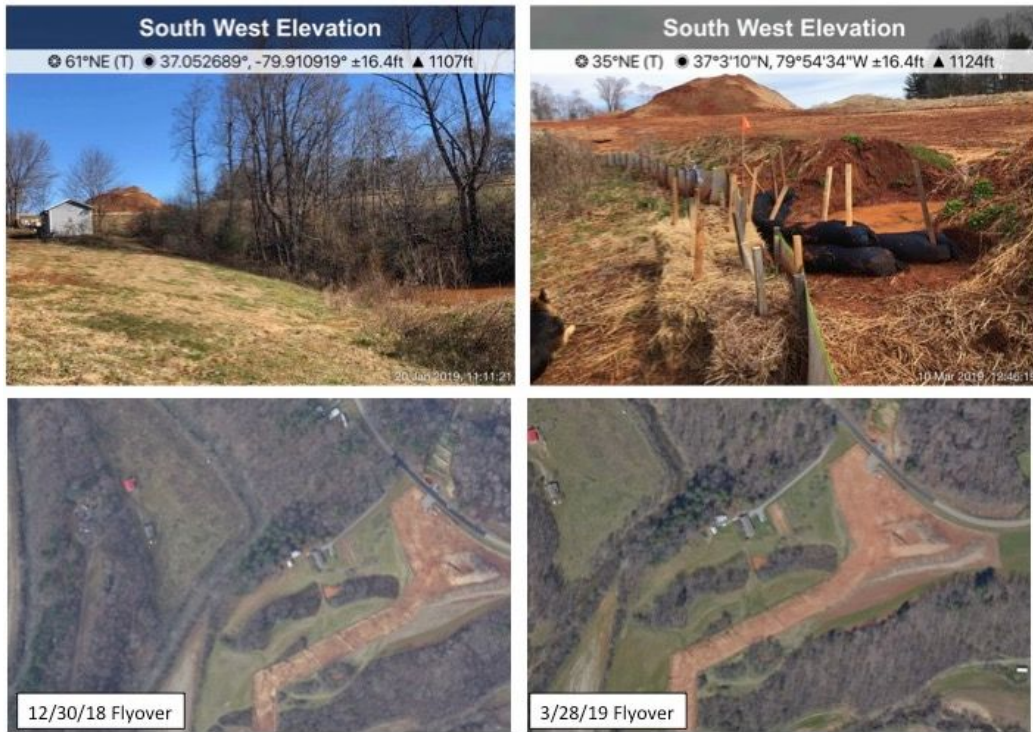
Figure 8: Ground and aerial images of unseeded earth pile on Angle property continuing through the winter months. Note pond filled with sediment mid-photo in the aerial images and bottom left in the January 20 ground image.

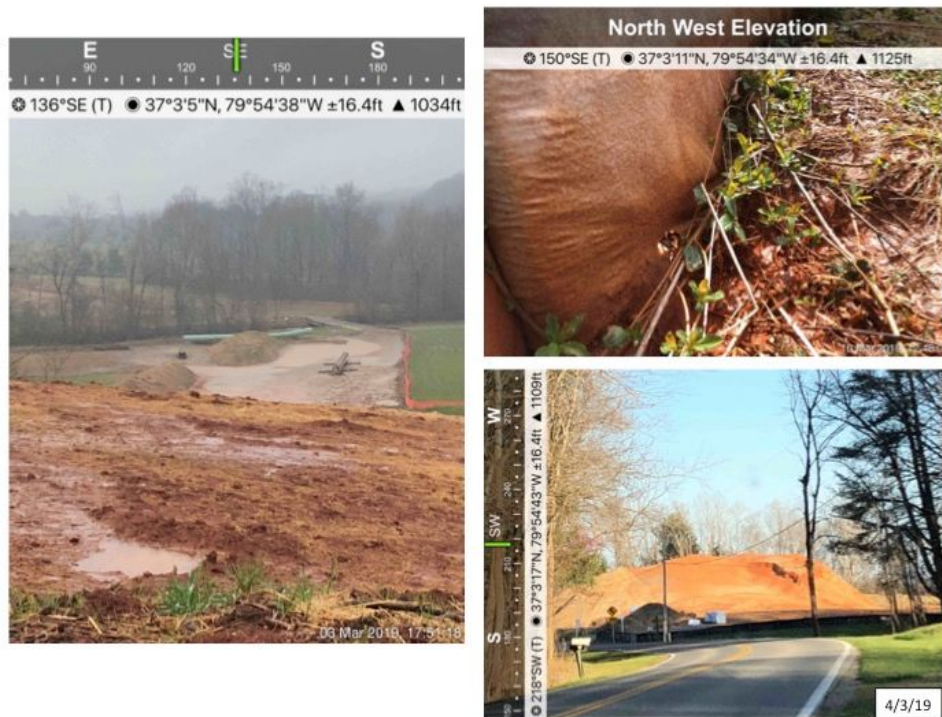
Figure 9: Images of bare earth and failing silt fences on the Angle property through March and April 2019. The right of way crosses Little Creek at the treeline in the image to the left. Note hole in silt fence, downhill from unsecured earth, which has remained in this condition leading up to and in the weeks following the March 1 Board meeting.

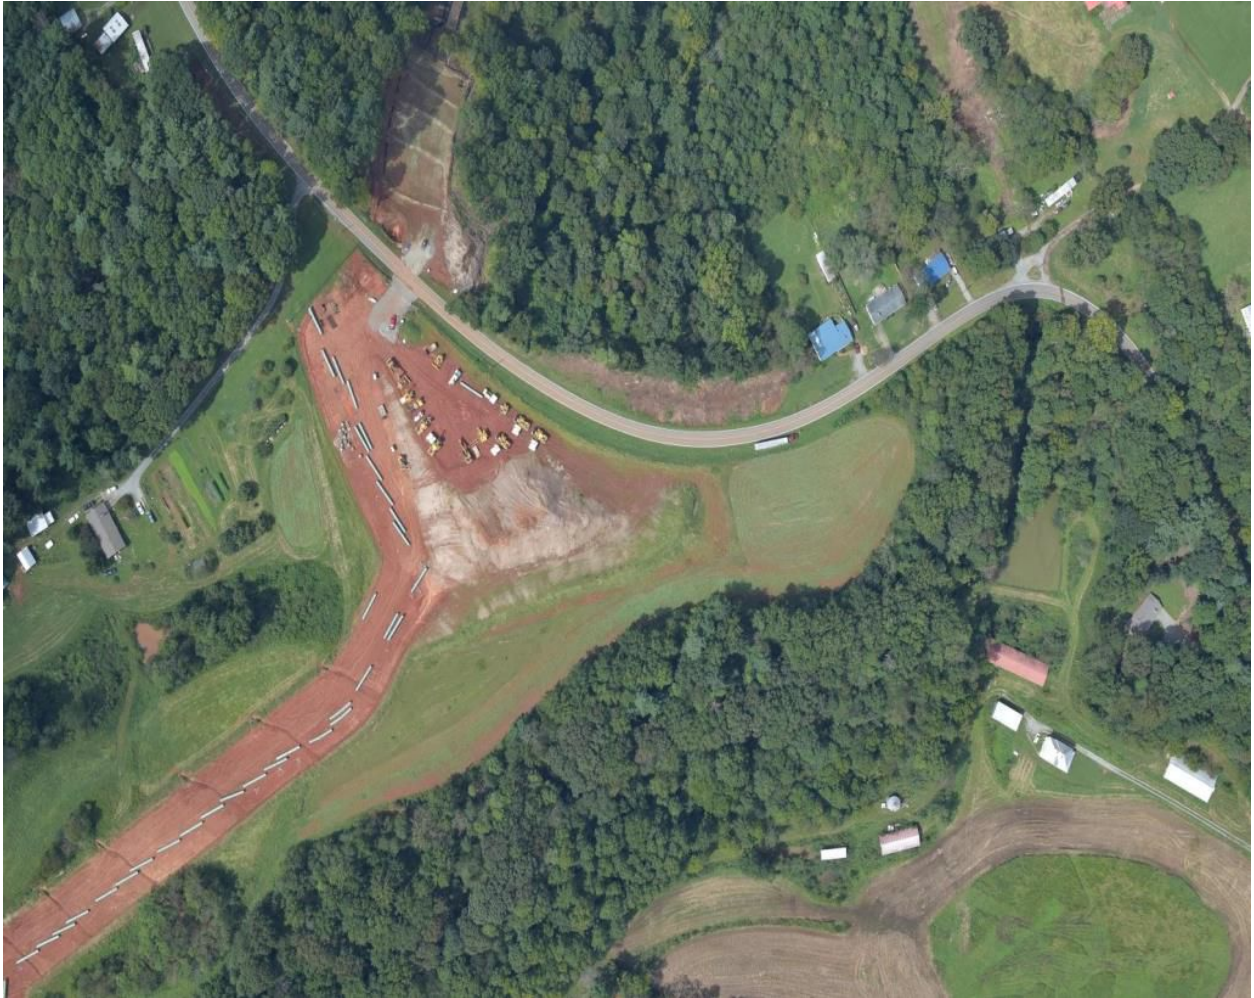
The aerial photo of the Angle farm below shows areas of bare soil present since at **least September 2018**.

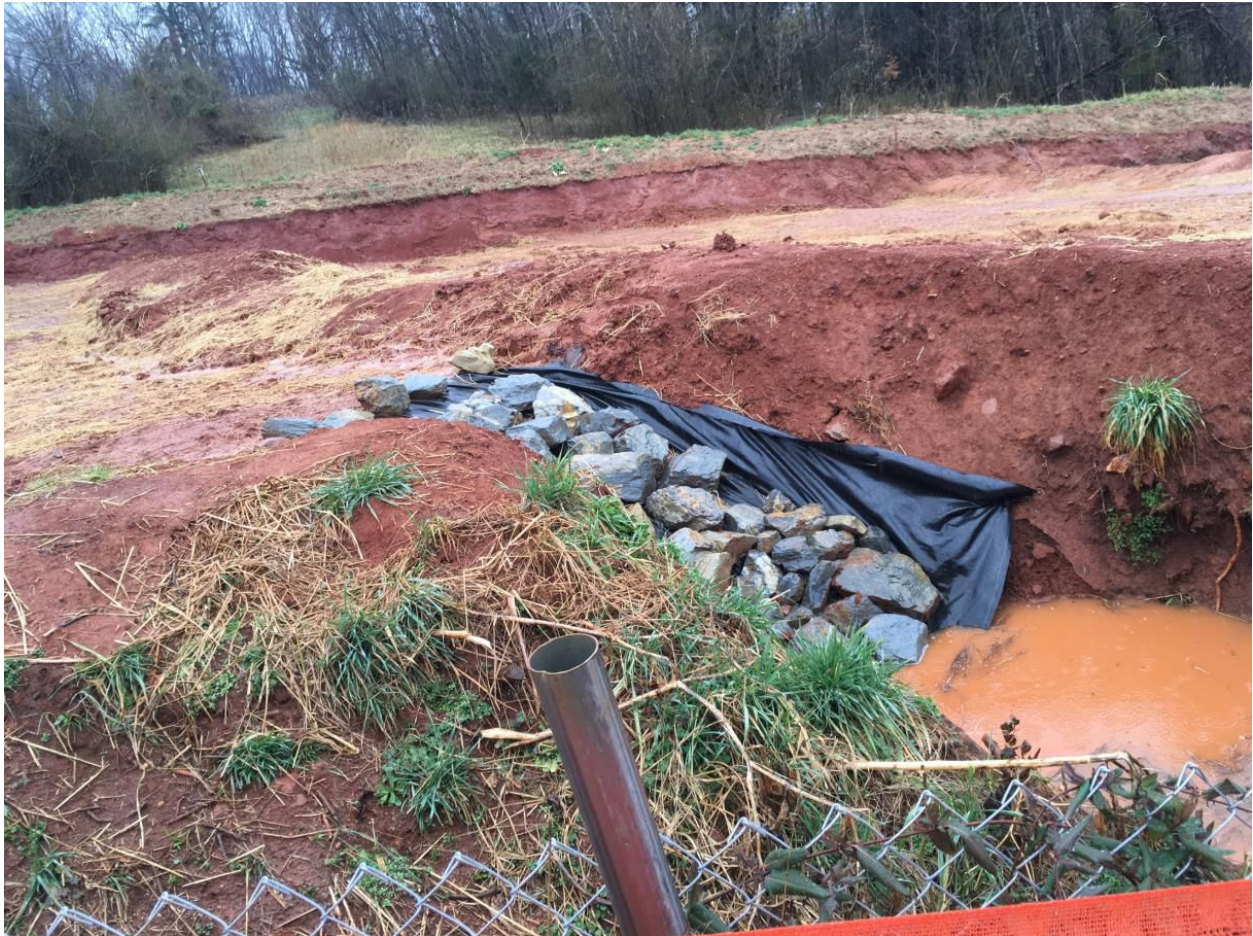
Angle Property, February 23, 2019

The photo below shows significant sections of bare, unstabilized soil that has been in that condition since October 2018. In the foreground is a “water bar” which is intended to channel water across the right-of-way to the settling basin seen in the lower right corner. Note that this water diversion structure is itself unstabilized and contributing eroded soil to the flows leaving the site.

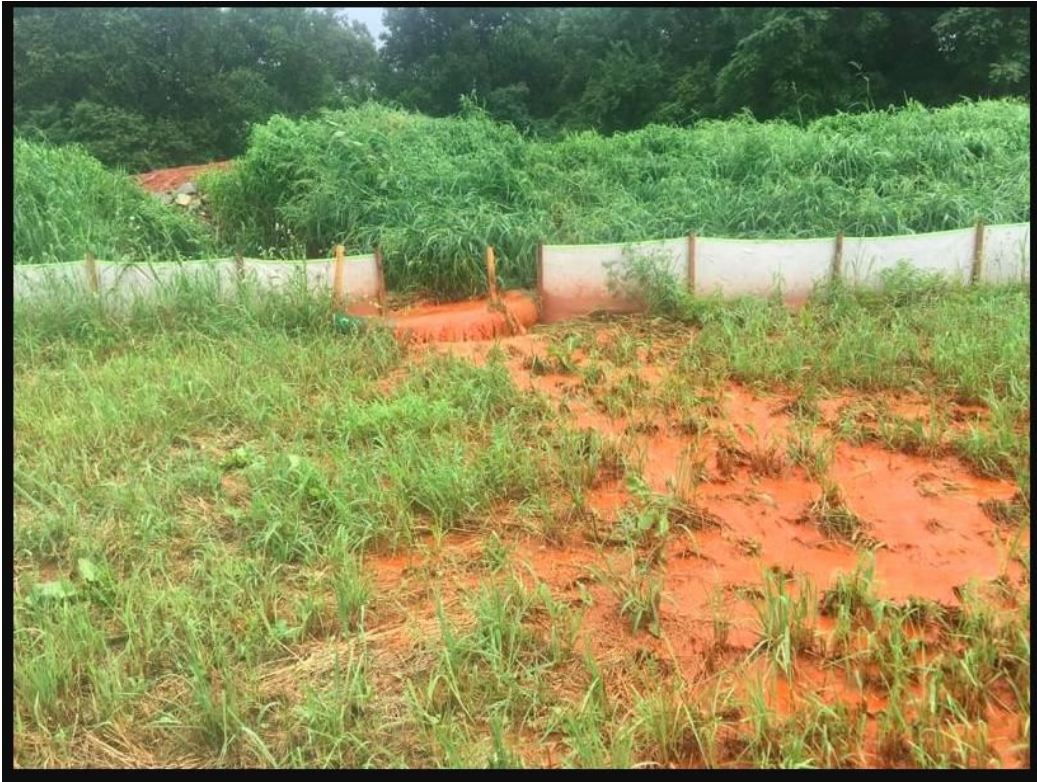
An example of failure of an outlet protection structure. Angle Property, August 3, 2018 (outlet from water bar failing).

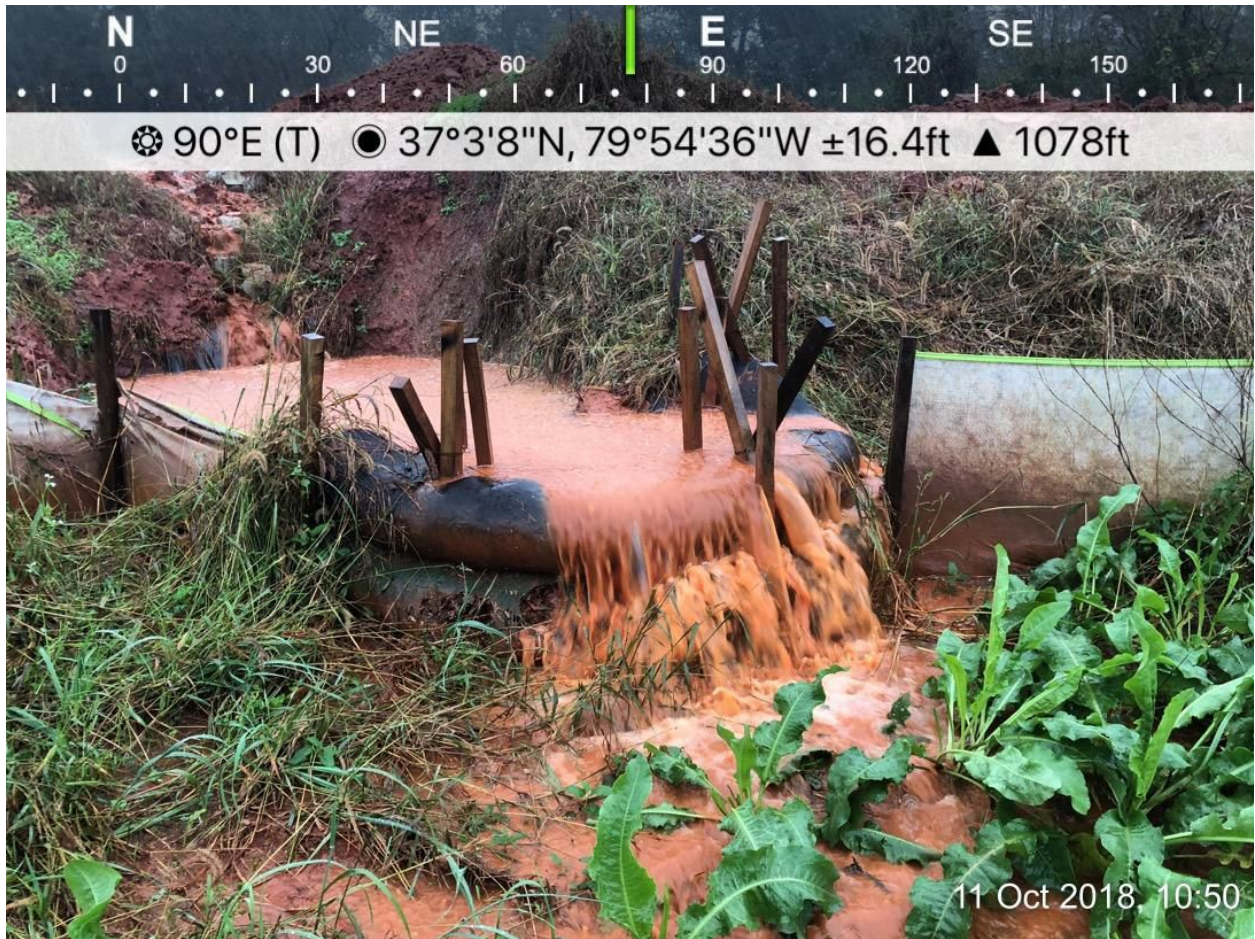
Outlet structure failure. Angle property, October 11, 2018

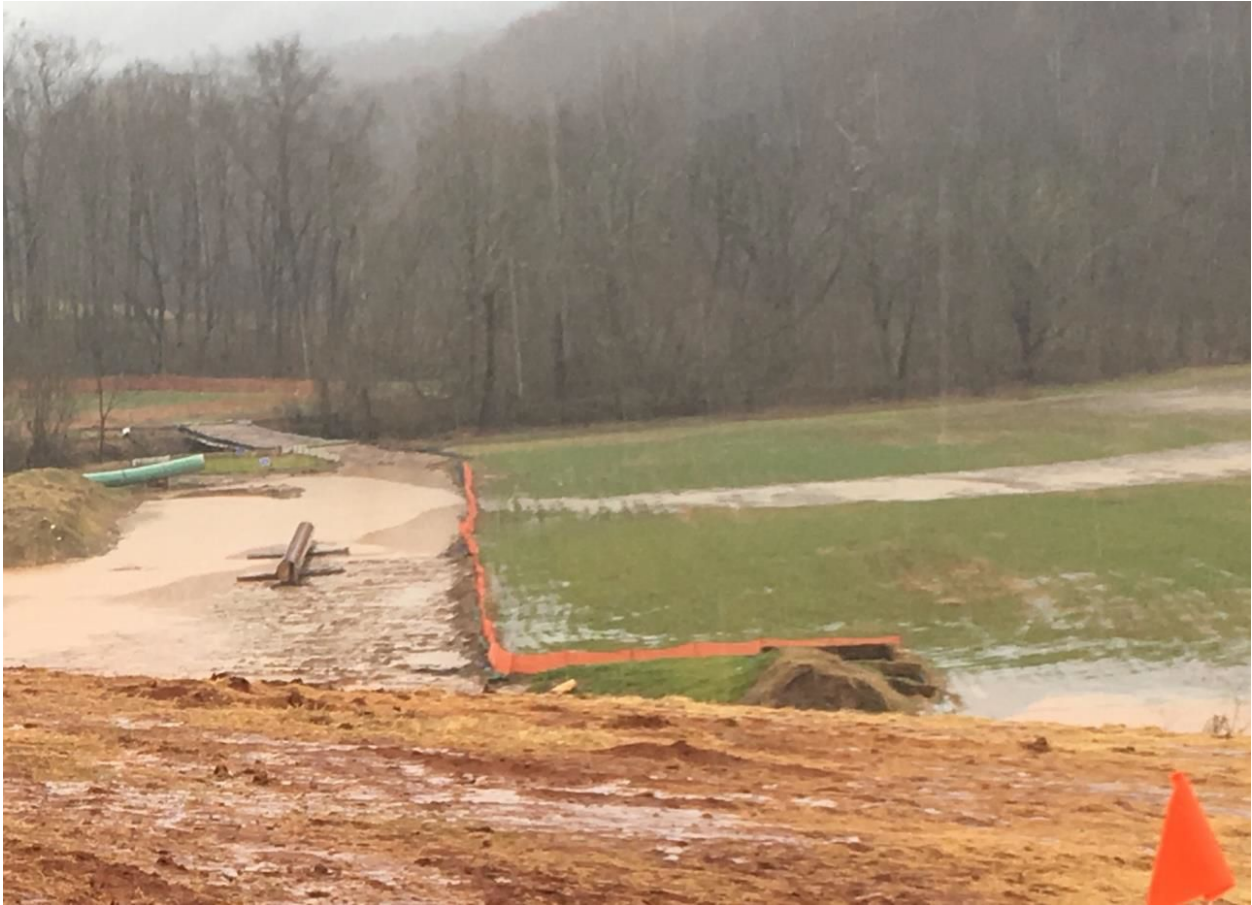
Angle Property, February 23, 2019

Sediment-laden water flowing from an impounded area onsite, through an outlet in the perimeter silt fence on the right, and across the Angle's property in a plume that discharges to the Blackwater River.

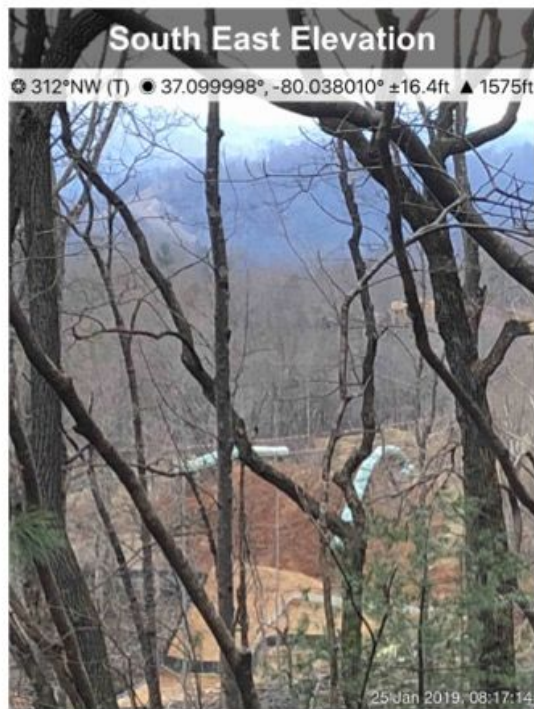
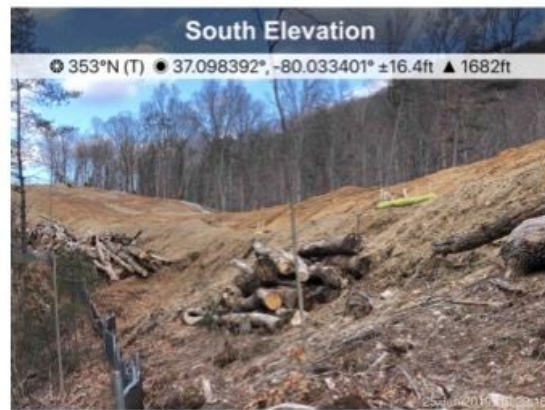
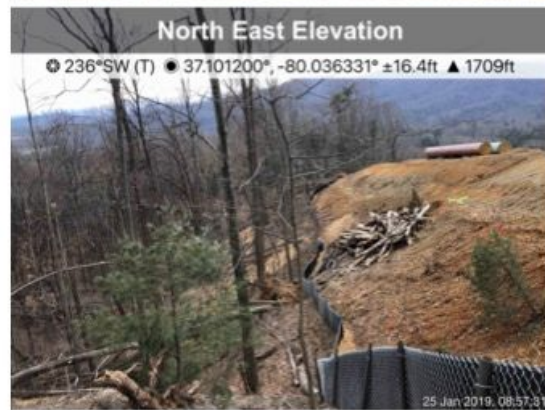
The ridge of Cahas Mountain has seen ongoing issues with sedimentation off the right of way and lack of stabilization through the winter months, during which little to no construction work was ongoing. Sedimentation from this site flows downhill into a stream.

Figure 10: Construction on the ridge of Cahas Mountain, unsecured earth above numbered stream crossing on January 25.

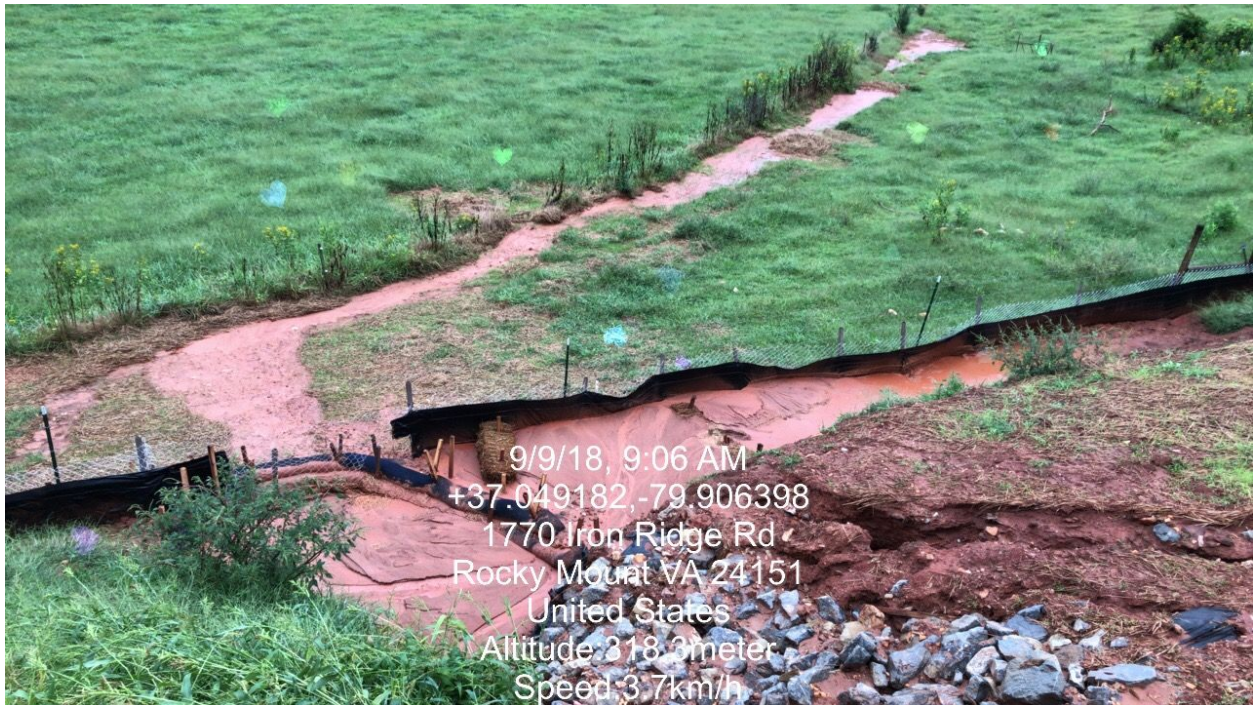
1. The construction plans as designed are not adequate. The erosion control devices selected for use do not have the capacity to prevent erosion from flowing offsite. Sediment trapping devices were not included in the plan. See photo below for illustration of inadequate plan design. The plans should have included a sediment trap at the toe of slope to contain sediment onsite. Instead, the plans show silt fence at the toe of the slope. Engineering design criteria for silt fence was not followed when the engineer designed the plan. Sediment flows offsite onto adjacent property despite efforts by the contractor to contain sediment with one straw bale. This is one of numerous examples where the construction plans fail to adequately contain sediment on site. See photo below.

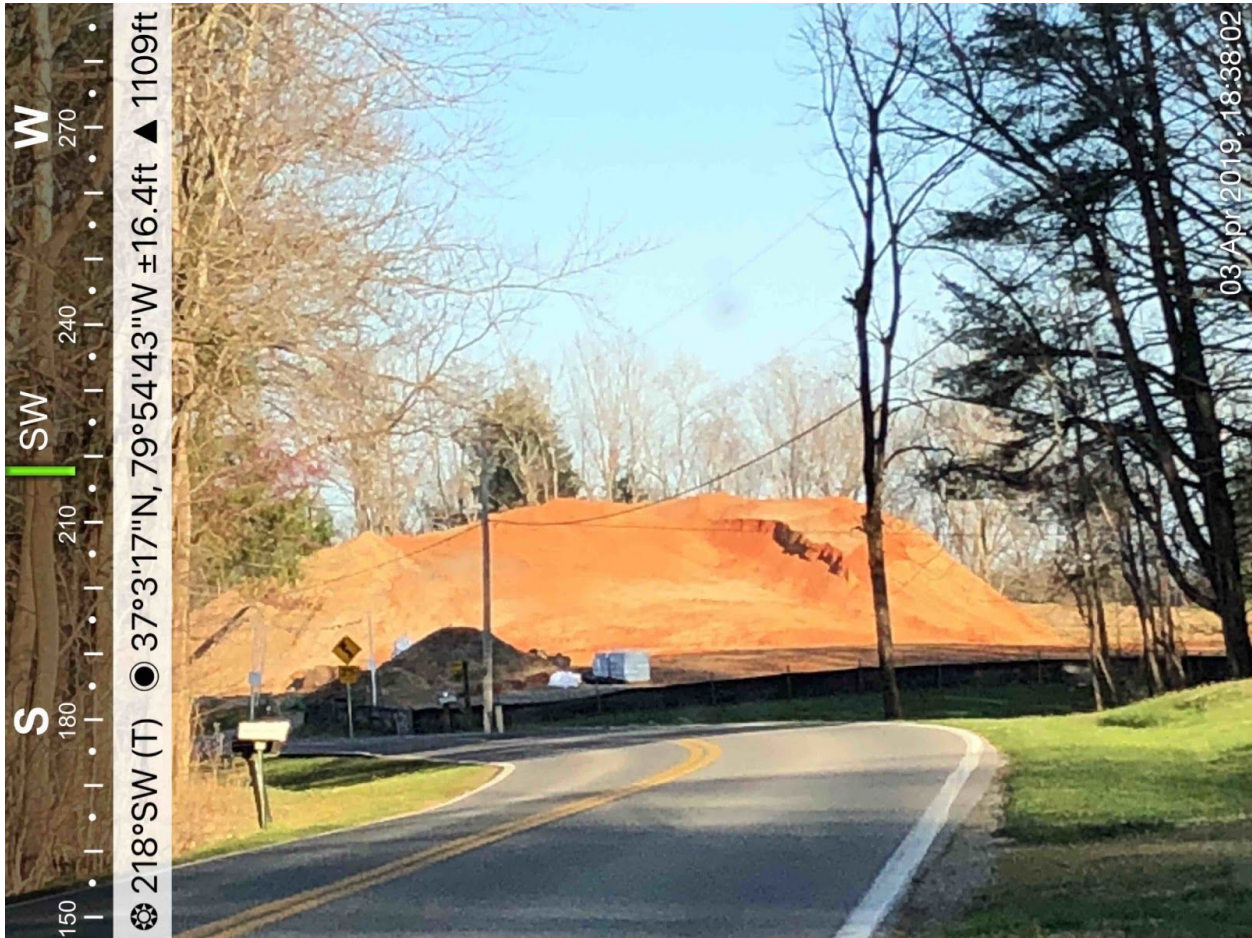
2. Lack of adequate vegetative cover on disturbed areas per Standards and Specifications and Minimum Standards 1 and 2. Despite efforts to seed the construction right of way by the contractor, there are many areas where grass is not growing. Aerial flyovers and observations by individuals have recorded many areas where soil stockpiles are not growing vegetative cover and are eroding into nearby streams and creeks. See soil stockpile photo below.

A Basic premise of erosion control is to disturb as little soil as possible and to quickly build the project in order to minimize environmental impacts. MVP has disturbed large areas of land and left these areas open to the elements exposing them to continuing erosion. MVP has exceeded Minimum Standard 1 repeatedly by not seeding open areas after 14 days of construction inactivity. This is a repeat pattern that deserves the Board's attention. See soil stockpile photo below for an example of lack of vegetative cover after prolonged exposure to the elements.
