Comments to State Water Control Board

August 10, 2018 (REVISED - August 13, 2018)

The following report was created by Mountain Valley Watch, a collaboration of public, private, and non-profit interests, and documents repeated failures of Mountain Valley Pipeline, LLC (Mountain Valley) and its contractors to protect water quality while constructing the Mountain Valley Pipeline (MVP). This information is relevant to the Board's consideration of the sufficiency of NWP 12 because it (1) documents harm to streams directly caused by crossings authorized by NWP 12 despite that permit's conditions and (2) documents harm to streams from sedimentation from upland areas. The information contained in this report further demonstrates that the Board must exercise its authority to require individual review of all waters crossed by the Mountain Valley Pipeline to determine if additional safeguards are necessary to protect Virginia water quality.

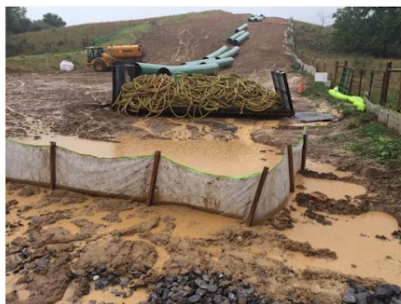
A. Pipeline centerline and working/parking area at southern terminus of MVP work site. Sediments were actively flowing from upslope pipeline areas. BMPS in place included oversized slope breaks with deeply dug sediment traps at the ends. Silt fencing and mulch-filled socks were in place to retain any sediment escaping from the primary control structures. (Figure 4)

Silt fence in photo failed and has been “reconstructed”, but still actively failing. Standing in approximate centerline, looking eastward toward highly sloping double bench system, and away from SGT.

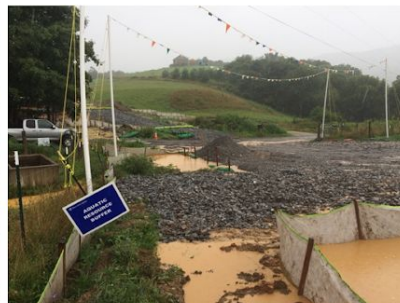
Looking westward toward SGT. Failed mulch socks and silt fencing. Note thick gravel layer placed to fill and hide pooling mud between silt fence and SGT, is not effective in slowing sediment loss. Besides BMP failure, sediments are clearly entering 1) an Aquatic Resource Buffer, 2) a State Road, 3) a

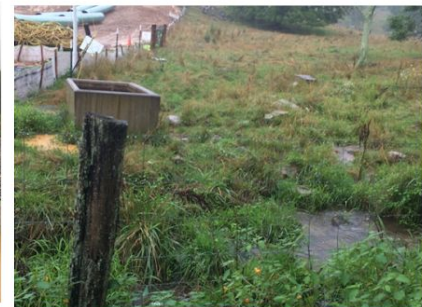
Stream coming from springs above the site is clear. Sediment above escaped the construction zone. Note position of cement water trough here and photo at left.

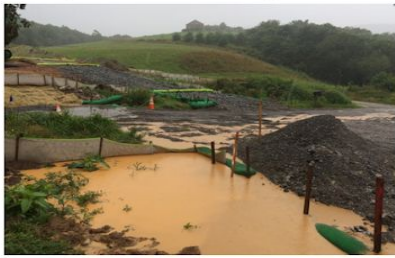
Ineffective silt fence and mulch socks allowing sediment to move into SGT.

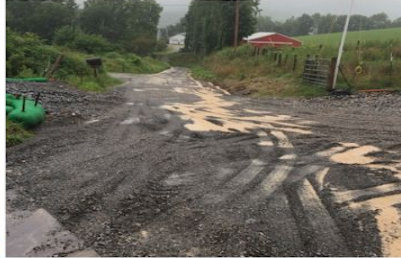
Ineffective gravel placement – now protecting stream crossing to left, but sediment is being channeled to the right side of the road into a recently dug ditch to move it offsite. No BMPs in place here to reduce sediment load within the ditch

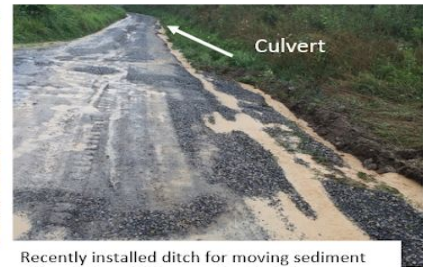
Recently installed ditch for moving sediment off worksite. Unfortunately, ditch is (purposefully) connected to a culvert intended to drain water from grassed bank (with no erosion). Now sediment entering culvert moves directly, with no BMPs in place, into the stream. Culvert is at the far end of this photo

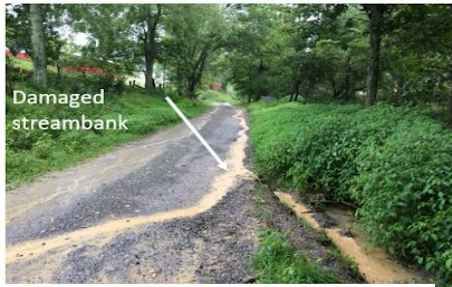
D. The ditch and culvert are still not stopping sediment flow down SGT. This photo at 7:12 am 05 Aug, over 24 hr after last significant rain on Thur, and before MVP Crews begin "cleanup". Why the strange diversion? This is where MVP traffic destroyed the stream bank.

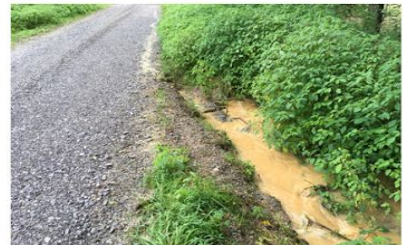
This is 05 Aug at 15:08 hr. Sediment is still still entering stream at damaged bank.

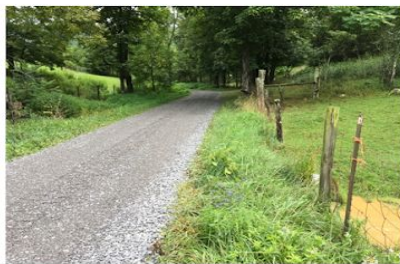
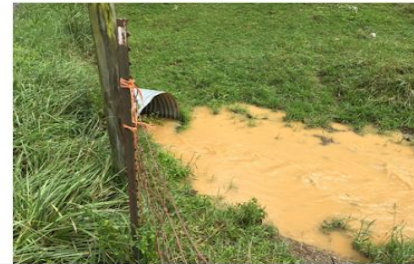
E. These photos taken 05 Aug shortly after 15:00 hr

Where does it go from here? Sediment laden water crosses under SGT just beyond mailbox in the distance, then back under SGT through a culvert

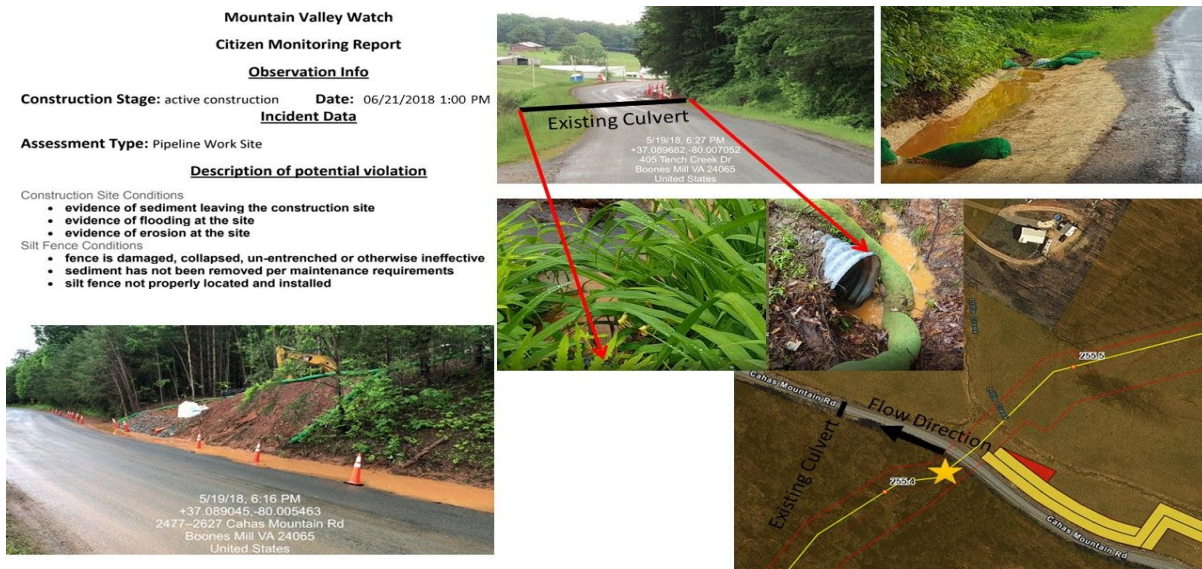
The first major impact to this location was on May 18, 2018 when a mudslide occurred on a 23% slope causing major impact to Little Creek. Approximately one foot of mud covered Cahas Mountain Road. Precision Pipeline, the MVP contractor constructing the pipeline, attempted to repair and mitigate the damage by shoveling the mud upstream to the roadside ditch, which then flowed to an existing culvert under Cahas Mountain Road and into Little Creek. During successive rain events, additional mud impacted Little Creek. See figures 9-12 for graphics explaining the mudslide event and flow path (black arrow to existing culvert). Additional pictures in figure 9 show the existing culvert location with a black line and red arrows to pictures of the up and downstream invert locations. Sediment can be seen entering the up invert and discharging into the creek at the down invert. Violations reported at this location show a series of repeated BMP failures and inadequate construction entrance on Cahas Mountain Road.

Figure 9: Cahas Mountain Road mudslide site showing location of sediment entry to Little Creek through an existing culvert beneath road.

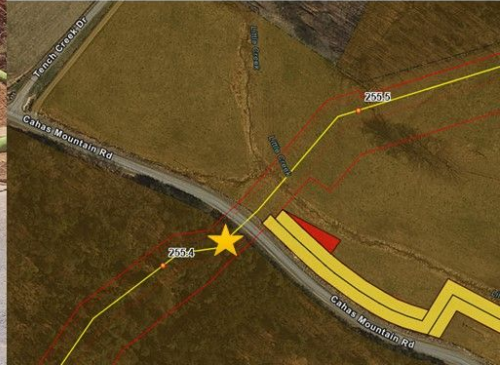
Figure 10: Potential violation reported - May 13, 2018

Lack of gravel; inadequate E&SC; mudslide; sediment leaving construction site; failed BMPs.

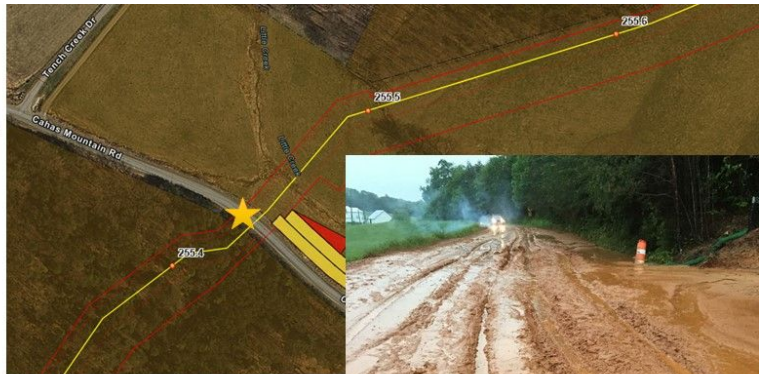
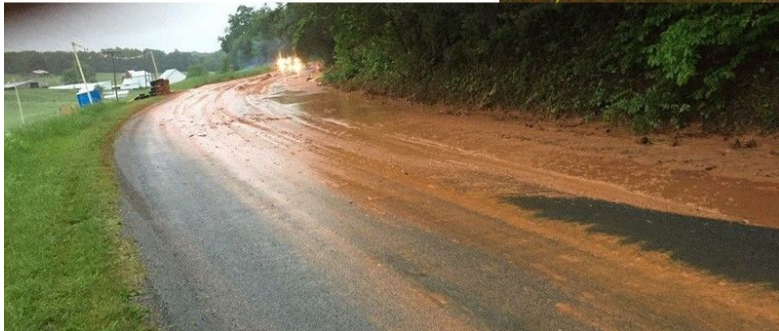
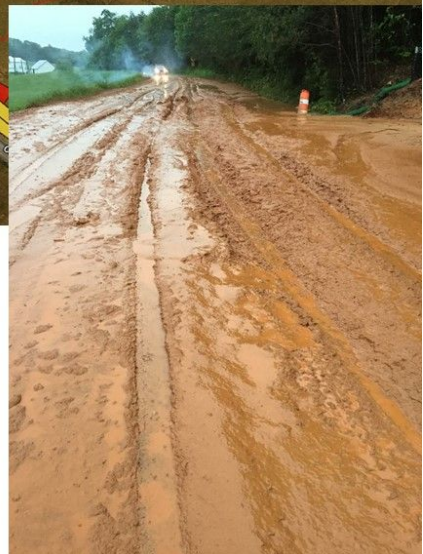
Figure 11: Potential violation reported - May 18, 2018

Erosion gullies , Bare soil - no mulch , Failing slopes , Failed BMPs , Sediment discharge outside construction area

Location Notes: Mudslide DEQ ref #134956

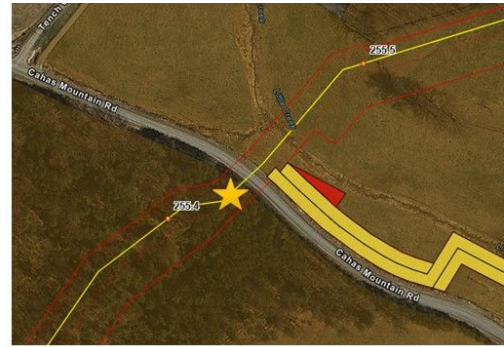
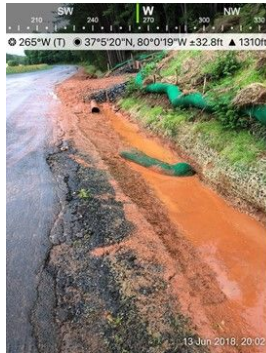
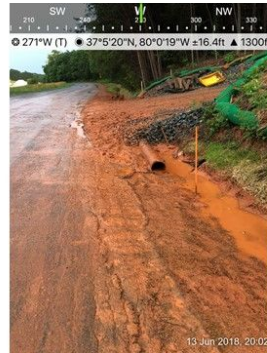
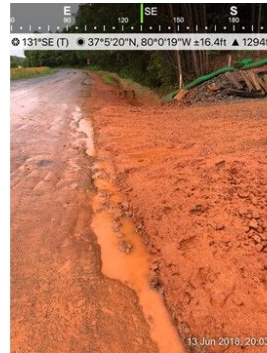
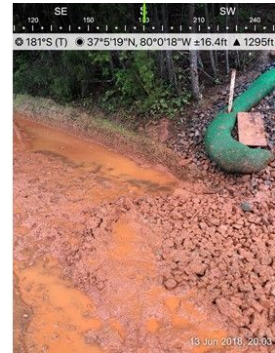
Figure 12: Potential violation reported - June 13, 2018

Lack of gravel , Mud or sediment on main road

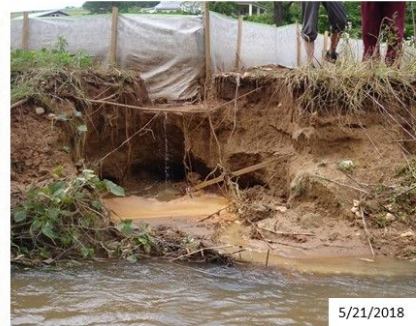
Figure 13: Potential violations reported - May 19 - 21, 2018

- fence is damaged, collapsed, un-entrained or otherwise ineffective
- sediment has not been removed per maintenance requirements
- silt fence not properly located and installed

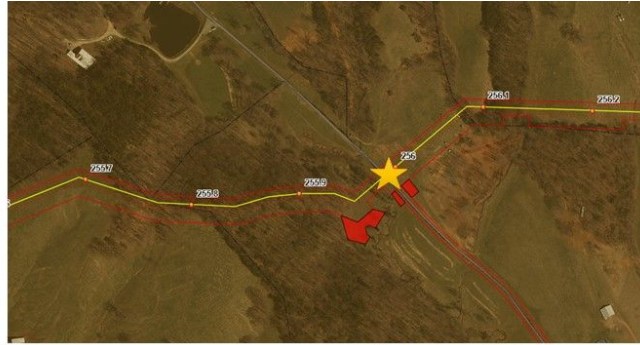
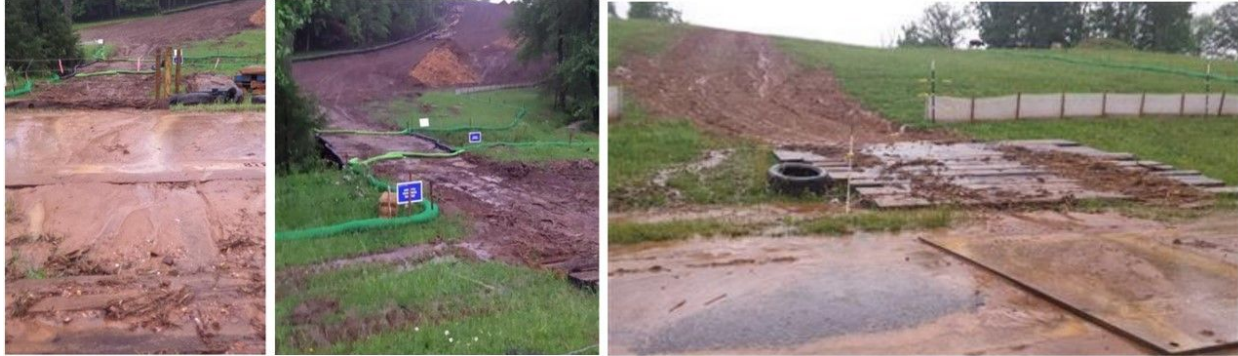
Figure 16: Potential violations reported May 18, 2018

RWDs in this section have been breached repeatedly due to improper installation on steep slopes and recent rains. RWDs do not meet the minimum size requirements, are not properly compacted, are not stabilized, nor do they have a stabilized outlet.

Bare soil - no mulch , Failed BMPs , Sediment discharge outside construction area

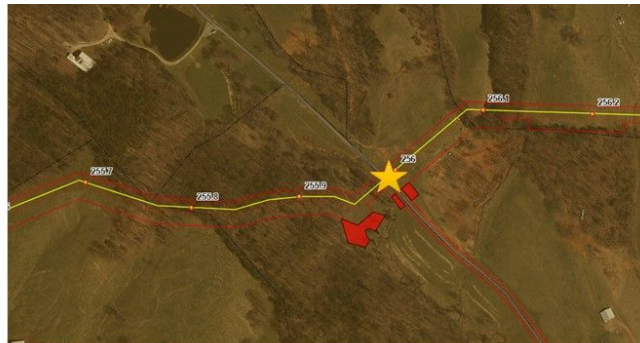
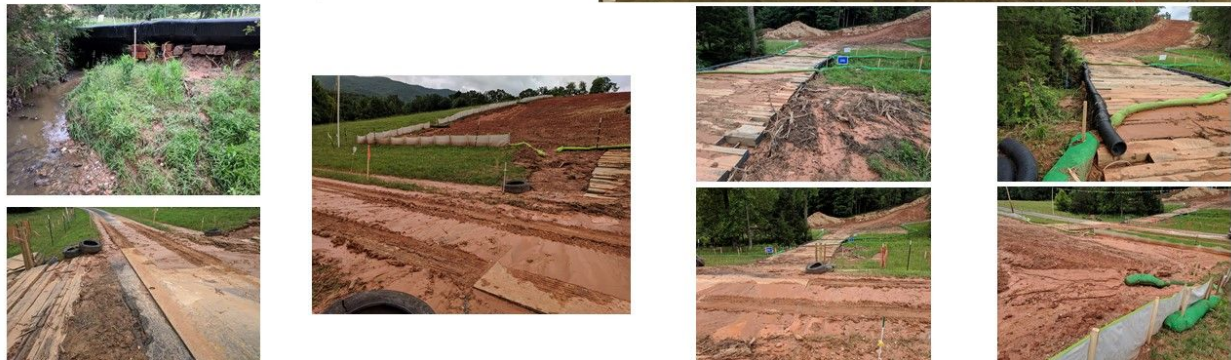
Figure 17: Potential violations reported May 28, 2018

Bare soil - no mulch , Failed BMPs , Sediment discharge outside construction area

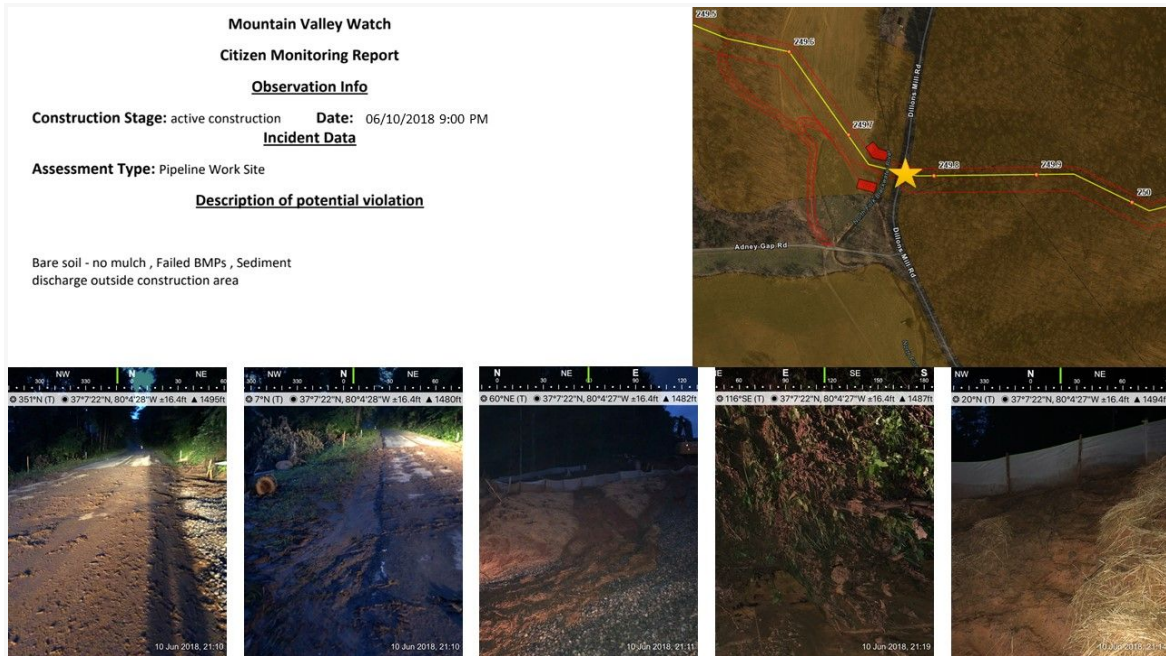
Temporary right-of-way diversions (RWD) were not properly installed. Per Std & Spec 3.11 of the Virginia Erosion Control Handbook. Violation reported - June 10, 2018

Figure 18: Violations reported - June 10, 2018

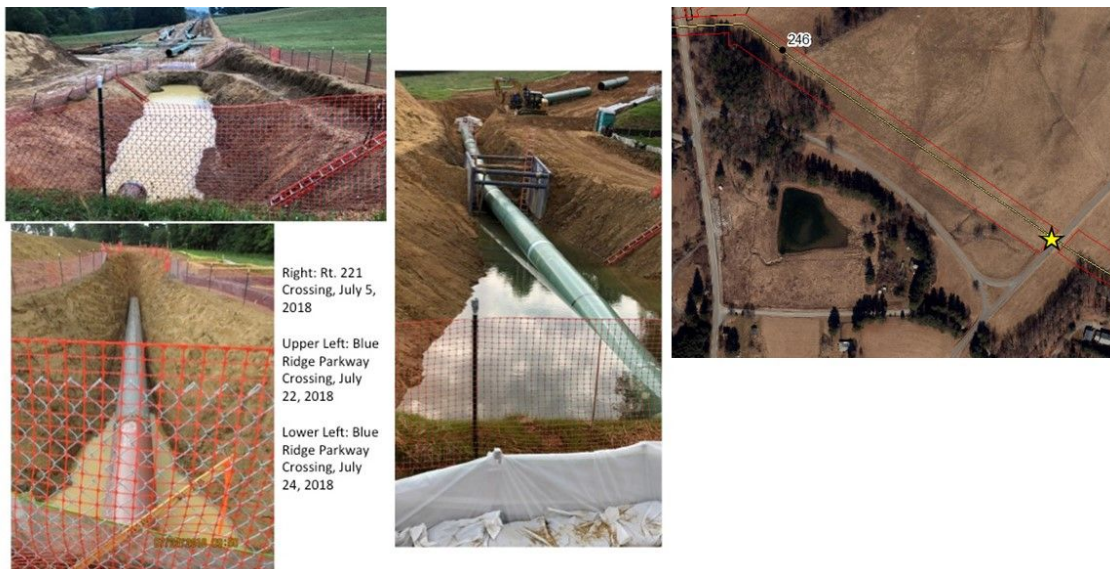
The perched aquifer has been breached at the Blue Ridge Parkway crossing. During both rain events and dry periods, the pipe beneath Route 221 and the Blue Ridge Parkway has been submerged in groundwater that continues to pool in the trench. This perched aquifer is the groundwater for the Bent Mountain community, and feeds residents' wells — their only source of drinking water. Dr. Pamela Dodds, an expert hydrogeologist, prepared a report on the perched aquifer of Bent Mountain in which she stated that "deforestation, soil compaction, and dewatering [during pipeline construction] will permanently deplete groundwater flow through perched aquifers in the Mill Creek watershed to seeps and springs that provide water to wetlands, headwater areas, stream baseflow, and residential wells, and will permanently reduce the groundwater hydraulic gradient." (Dodds, P.C. 2017) See figures 20 and 21 for location of the Blue Ridge Parkway crossing, pictures of groundwater in the trench, and an aerial photo showing sedimentation of source water point for Mill Creek.

Figure 20: Images from Rt. 221 and Blue Ridge Parkway crossings in Roanoke County in July 2018

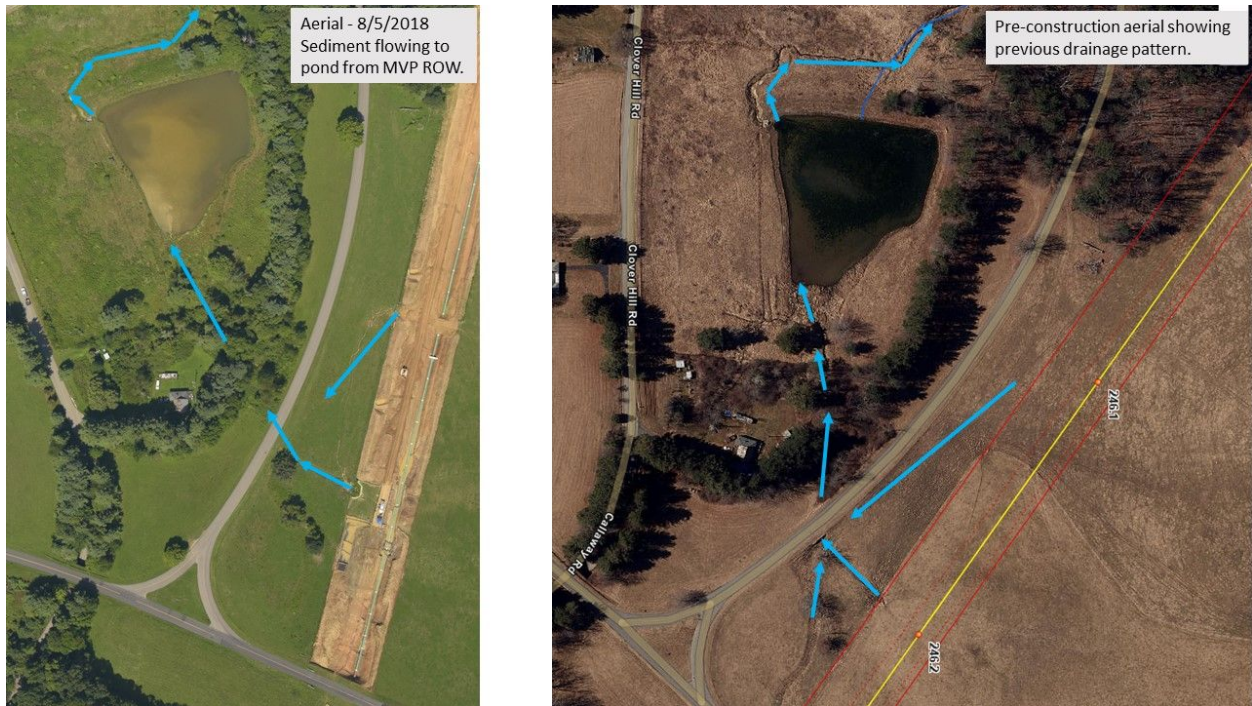
Figure 21: Aerial image from 8/5/2018 (left) and a pre-construction aerial (right) show drainage and sediment impacts from MVP construction ROW to neighboring pond. Blue lines indicate flow direction into and out of the pond.

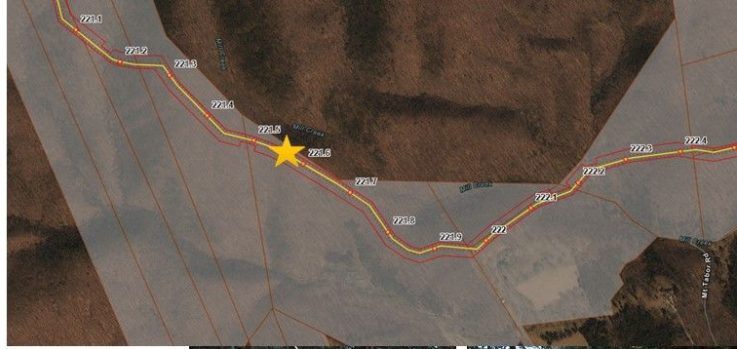
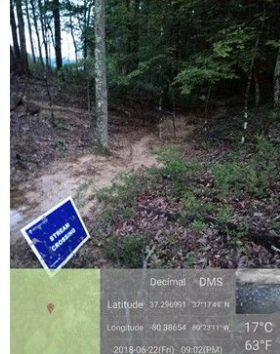
Figure 25: Images from incident reported on June 22, 2018. SMN-21 impacted.

- evidence of sediment leaving the construction site
- evidence of flooding at the site
- evidence of structural damage at the site
- evidence of erosion at the site
- ROW diversions are not installed or functioning properly

- fence is damaged, collapsed, un-entrenched or otherwise ineffective
- sediment has not been removed per maintenance requirements
- silt fence not properly located and installed

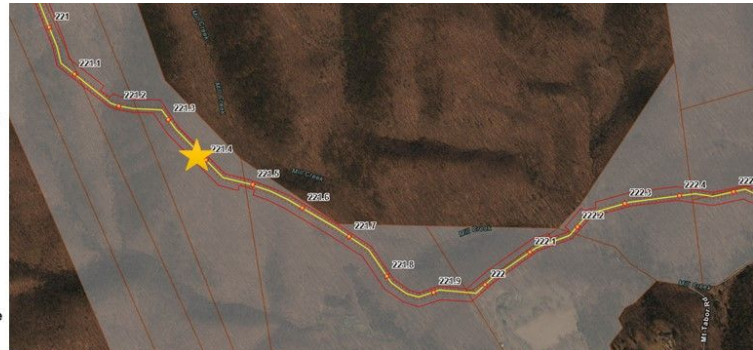
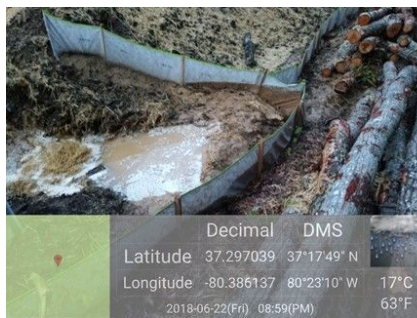
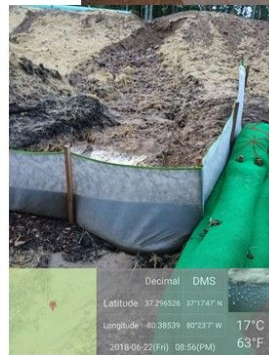
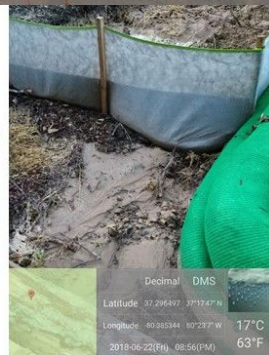
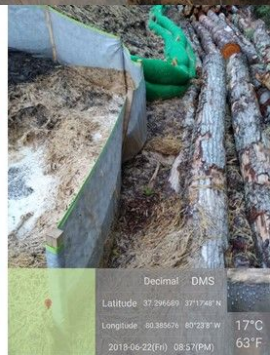
Figure 26: Images from incident reported on June 22, 2018. SMN-21 impacted.

- fence is damaged, collapsed, un-entrenched or otherwise ineffective
- sediment has not been removed per maintenance requirements
- silt fence not properly located and installed

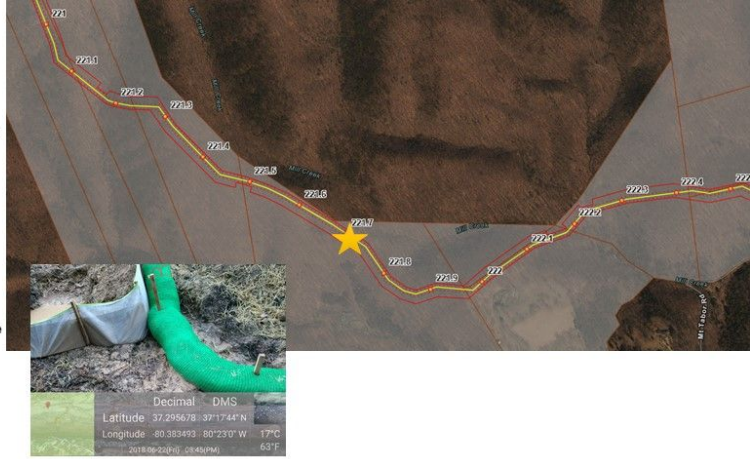
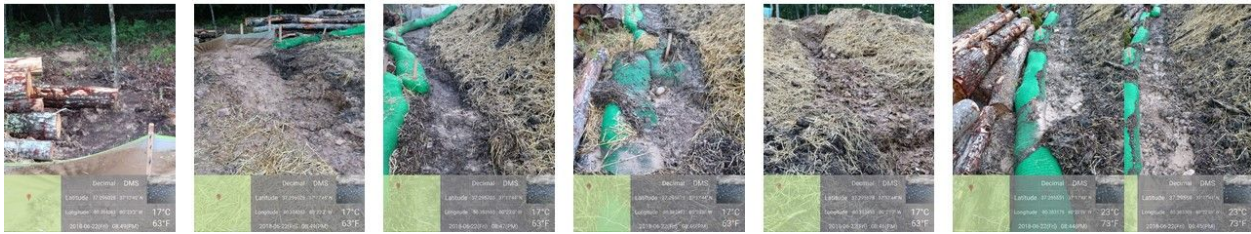
Figure 27: Photos from June 22, 2018 reported incidents on Slayton property

- fence is damaged, collapsed, un-entranced or otherwise ineffective
- sediment has not been removed per maintenance requirements

- mulch not distributed uniformly on all disturbed areas
- mulch not applied at an adequate rate

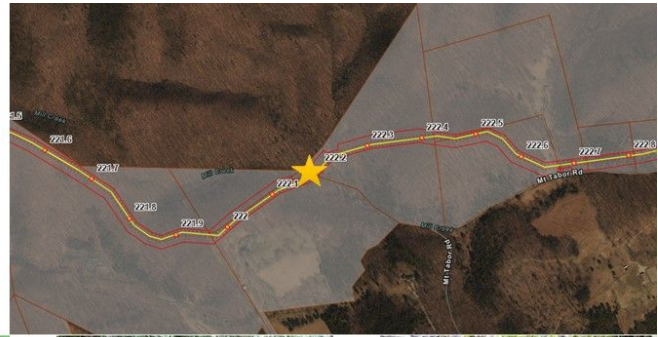
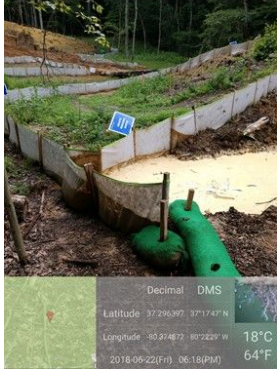
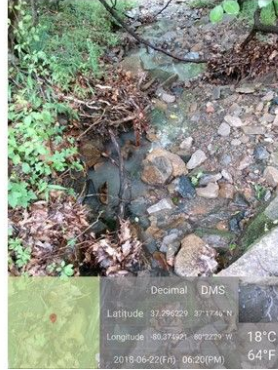
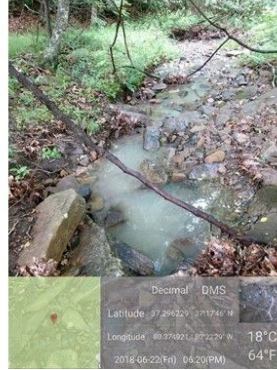
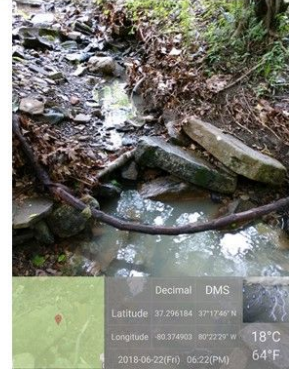
Figure 29: Photos from June 22, 2018 reported incident on Triplet property

- evidence of sediment leaving the construction site
- evidence of flooding at the site
- evidence of erosion at the site

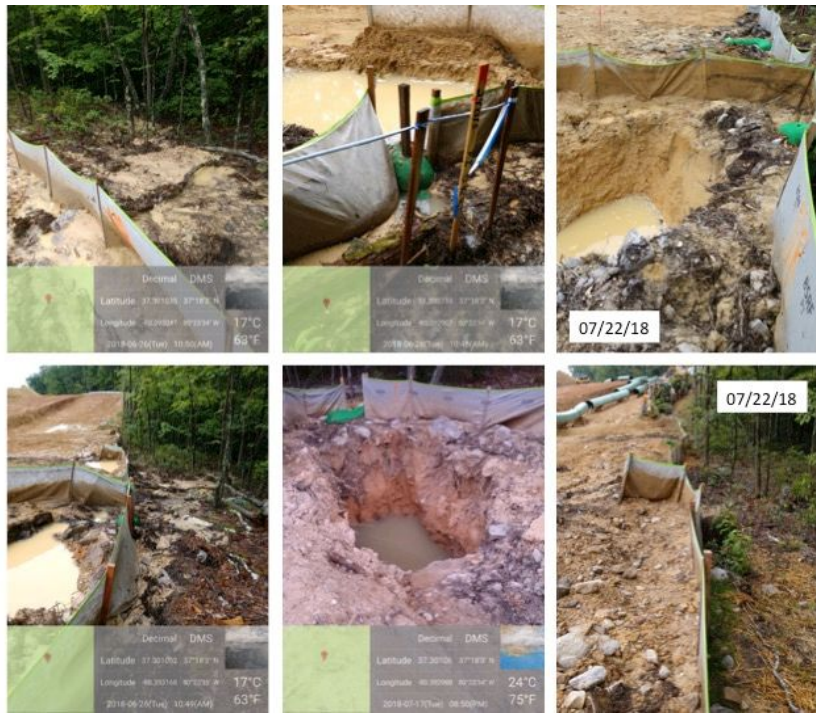
Failures in the area continued to June 26, 2018 on the Dyer property, shown in three photos below where sediment is leaving MVP's construction right of way.

Figure 30: Photos from June 26, July 17, and July 22, 2018 reported incidents on Dyer property

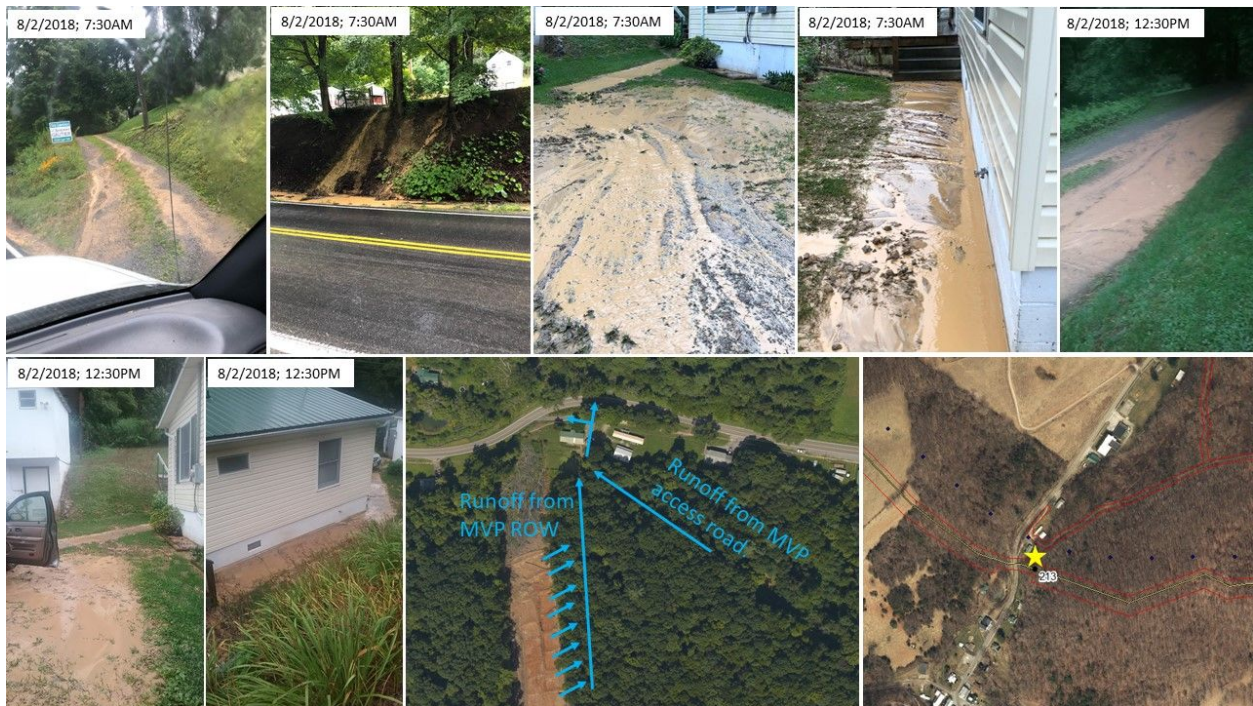
This is the first major failure observed in Historic Newport Virginia. This is the pattern for future rain events and impacts to Sinking Creek. See images of potential violation below. The drainage area for stormwater runoff includes a portion of an access road and a large area from the MVP right of way. Overwhelmed outlet structures at the discharge point of diversion bars cause rain water to create new runoff gullies adjacent to the ROW. Runoff from the access road combines with ROW runoff and result in the sedimentation shown in figure 32. A snapshot of the USGS water quality gauge, figure 33, located 1.71 miles downstream in Sinking Creek indicates a large spike in sediment loading on August 2, 2018.

Figure 32: Photos from August 2, 2018 reported incident in Historic Newport.

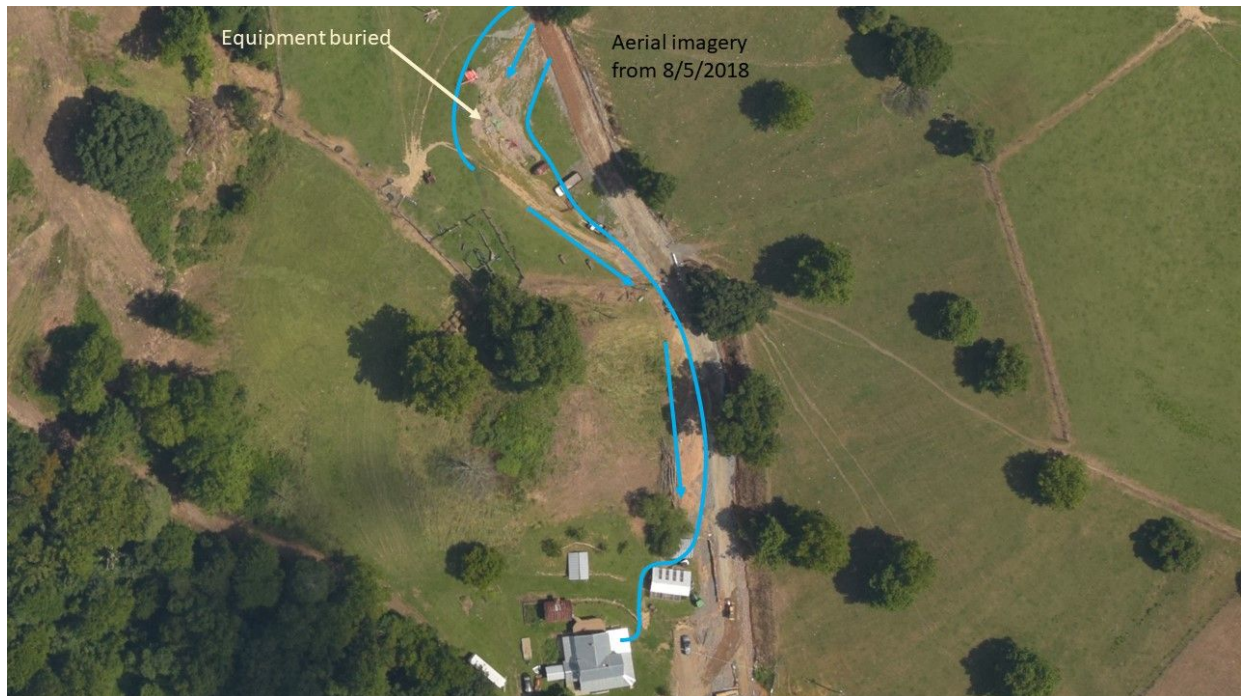
As of the writing of this report, three major failures (on 7/21, 7/31 and 8/2) had occurred at the Gallagher property. Grading for an access road redirected runoff toward the house and chicken coop. Both the chicken coop and basement of the house were flooded. Figures 34-36 illustrate the resulting damage. As part of the continued updating of this report a fourth and the most significant failure to date occurred today 8/13/2018. We are collecting images and will update report.

Figure 36: Aerial image from August 5, 2018 flight showing buried farm equipment and flow path at the Gallagher property.
