December Report

2018

Monthly Citizen Reports

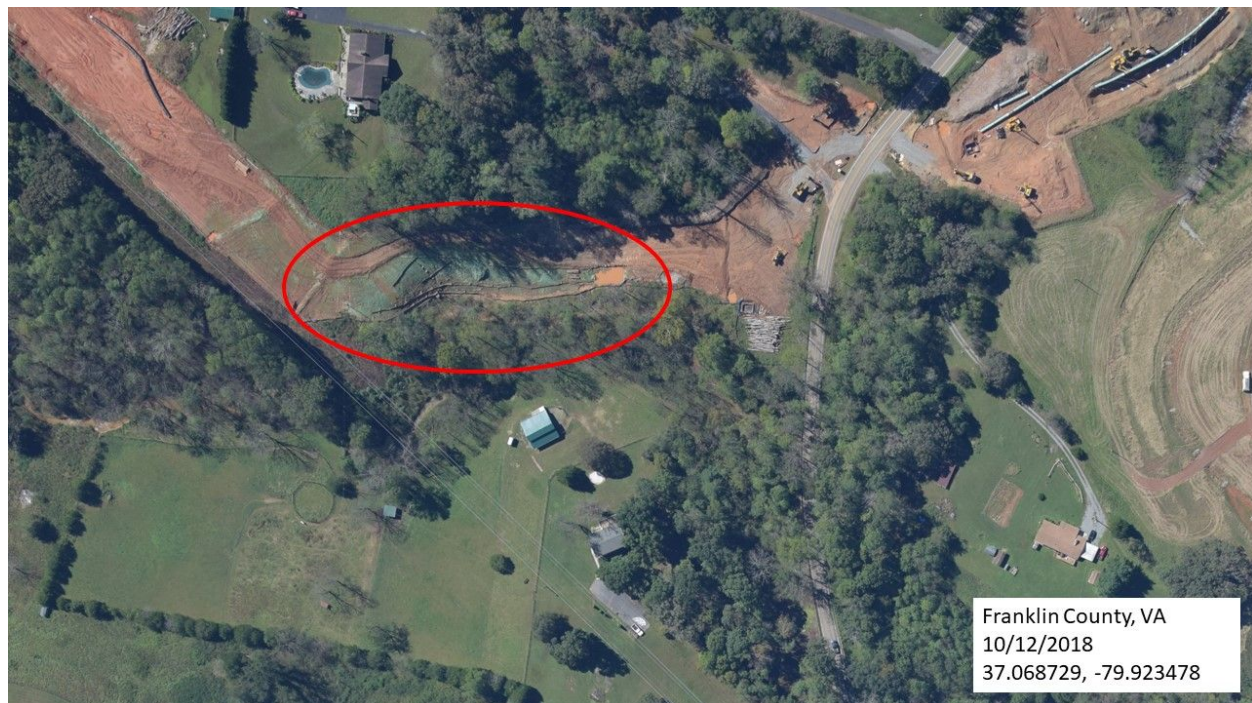
Figure 3: Image from 10/12/2018 shows E&S issues in area identified by red circle.

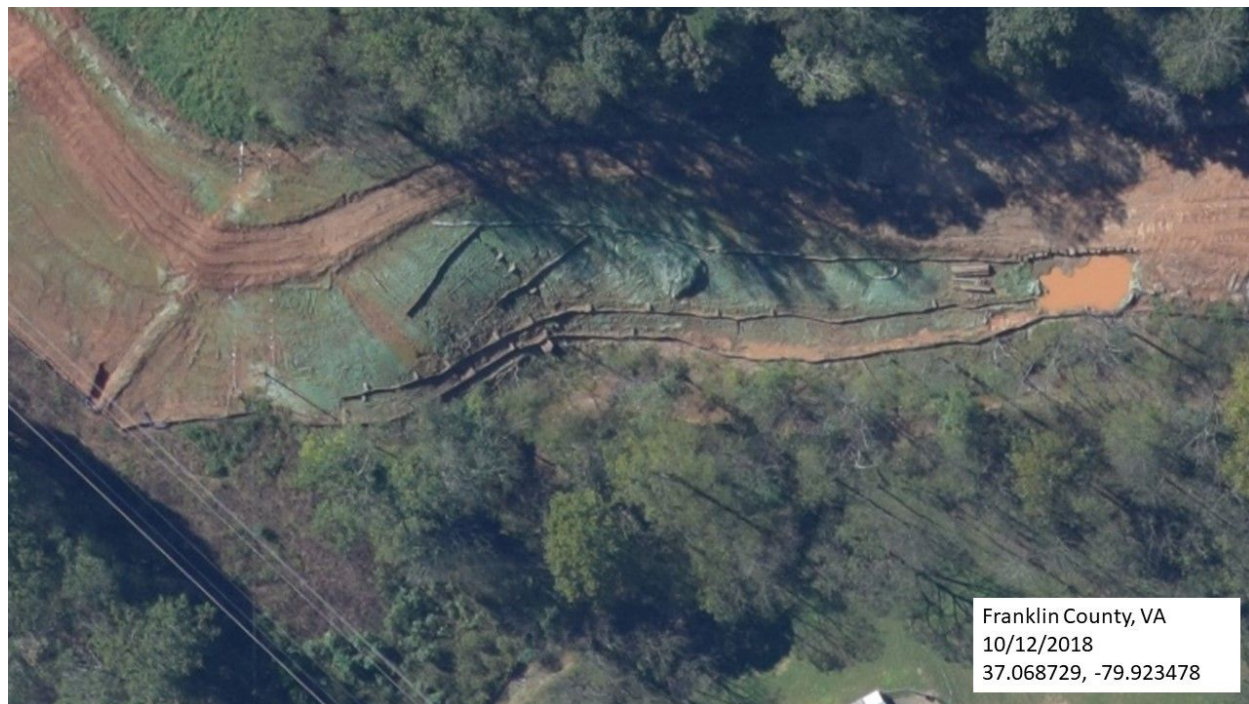
Figure 4: A closer view.

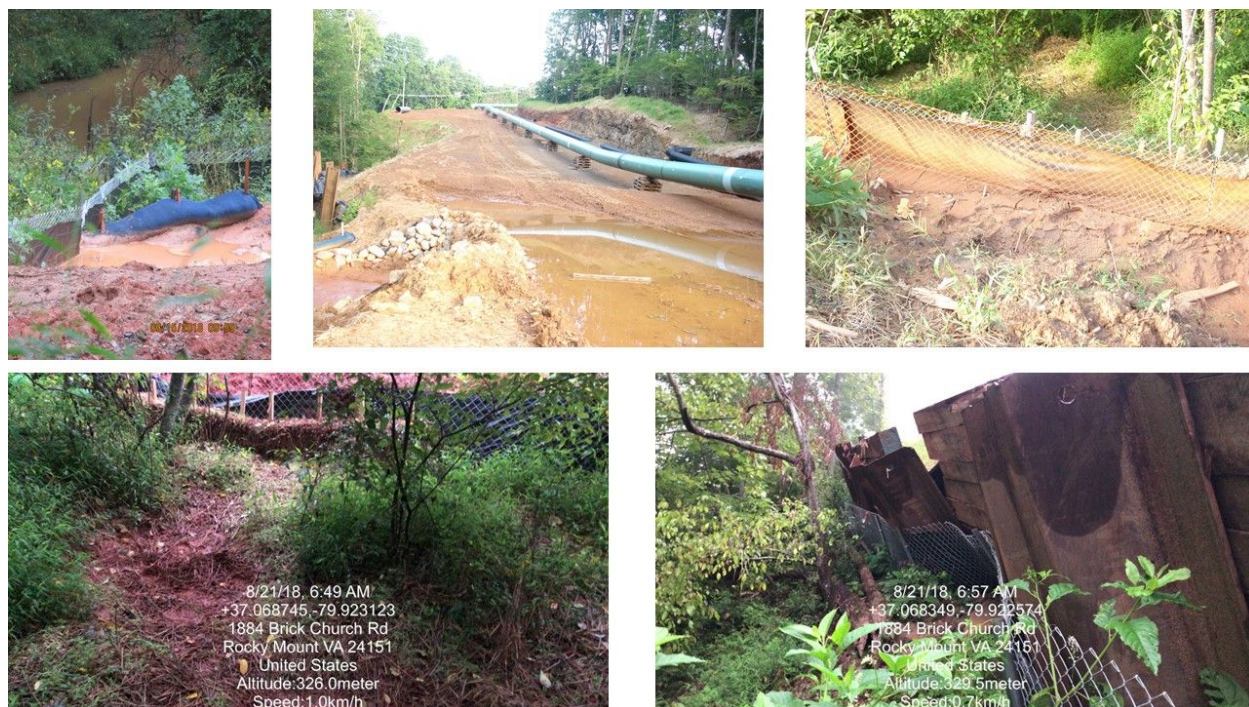
Figure 5: Ground support images. Pallets and plywood sheeting used as sediment barriers.

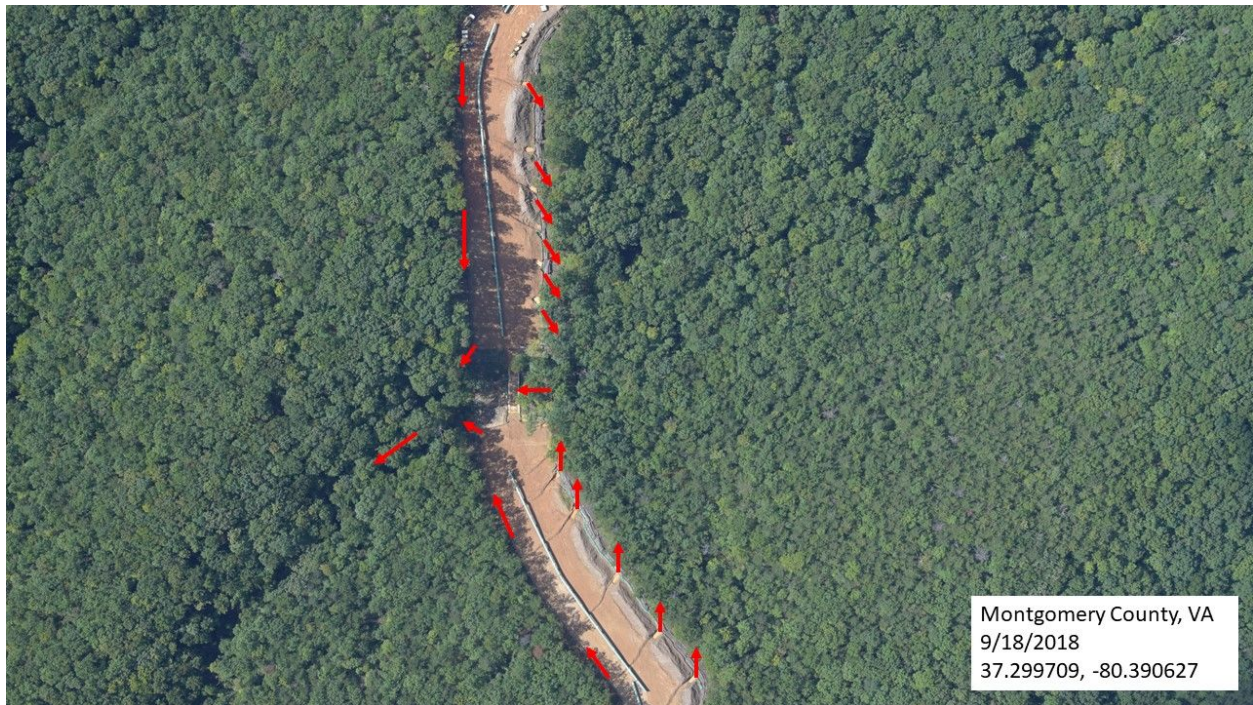
Figure 6: Brush Mountain in Montgomery County, Virginia; Flight date 9/18/2018; Flow lines indicated by red arrows.

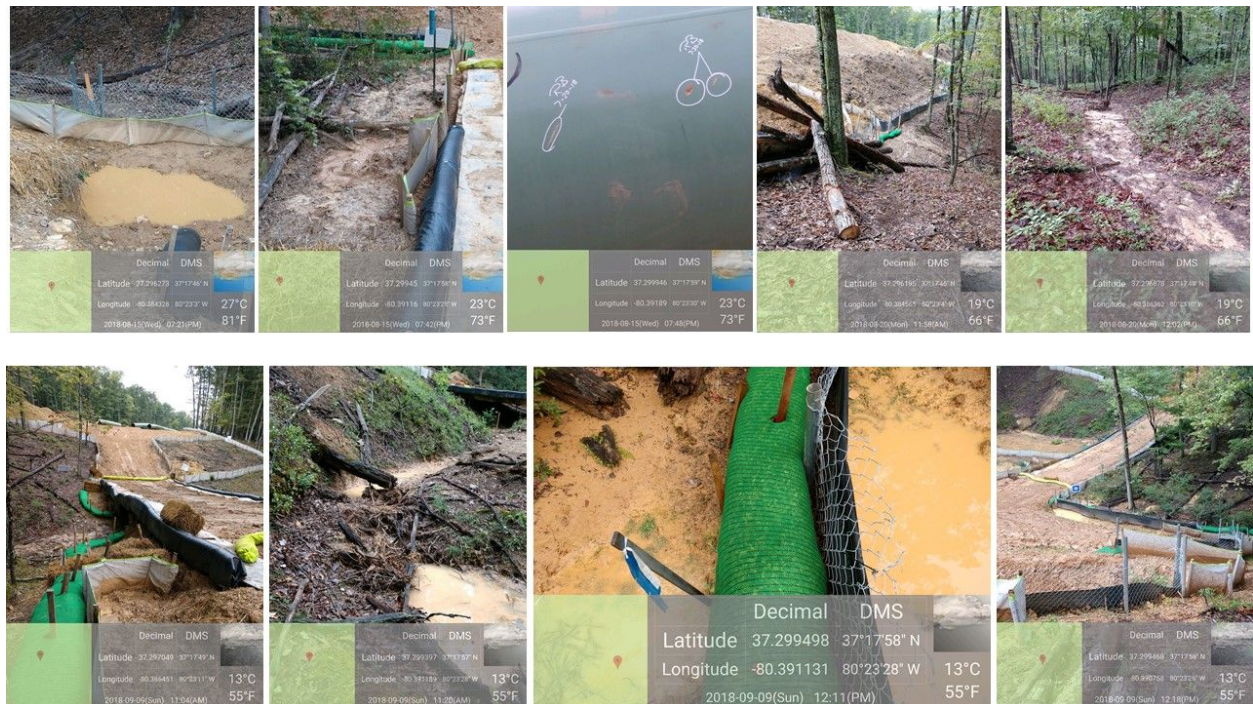
Figure 7: Ground images showing issues along the MVP construction LOD

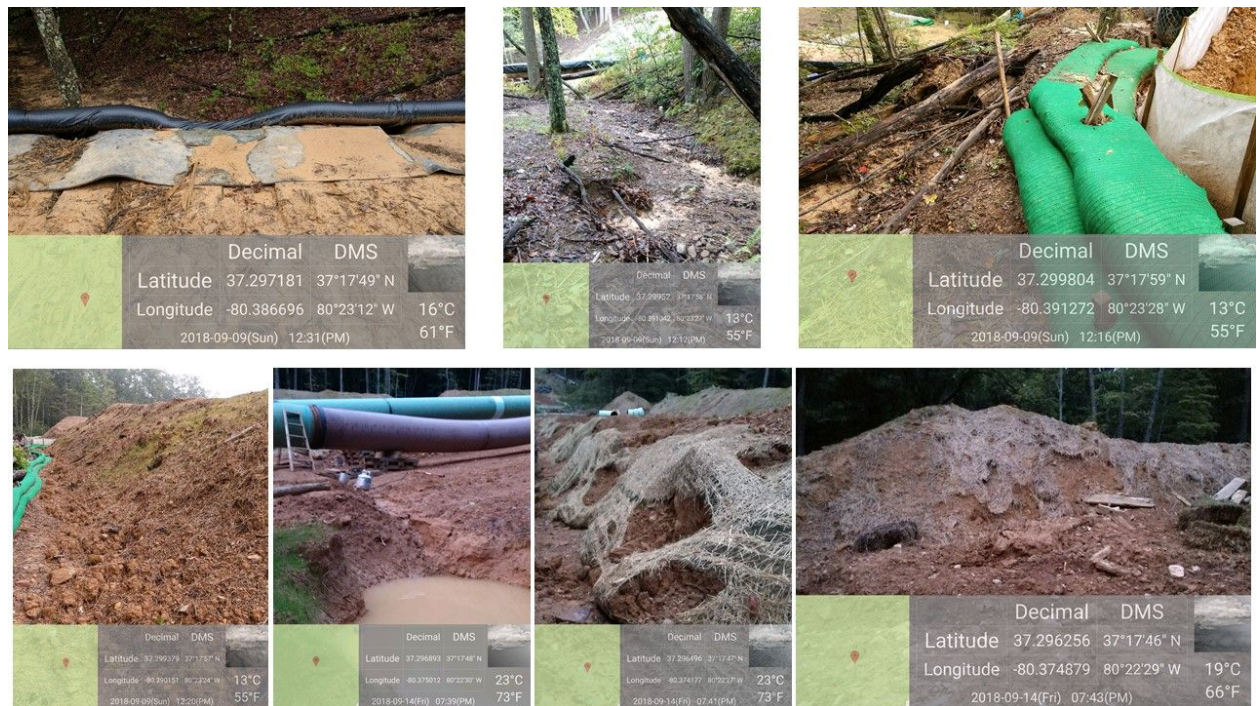
Figure 8: Additional ground images showing erosion & sedimentation as well as lack of stabilization on soil stockpiles.

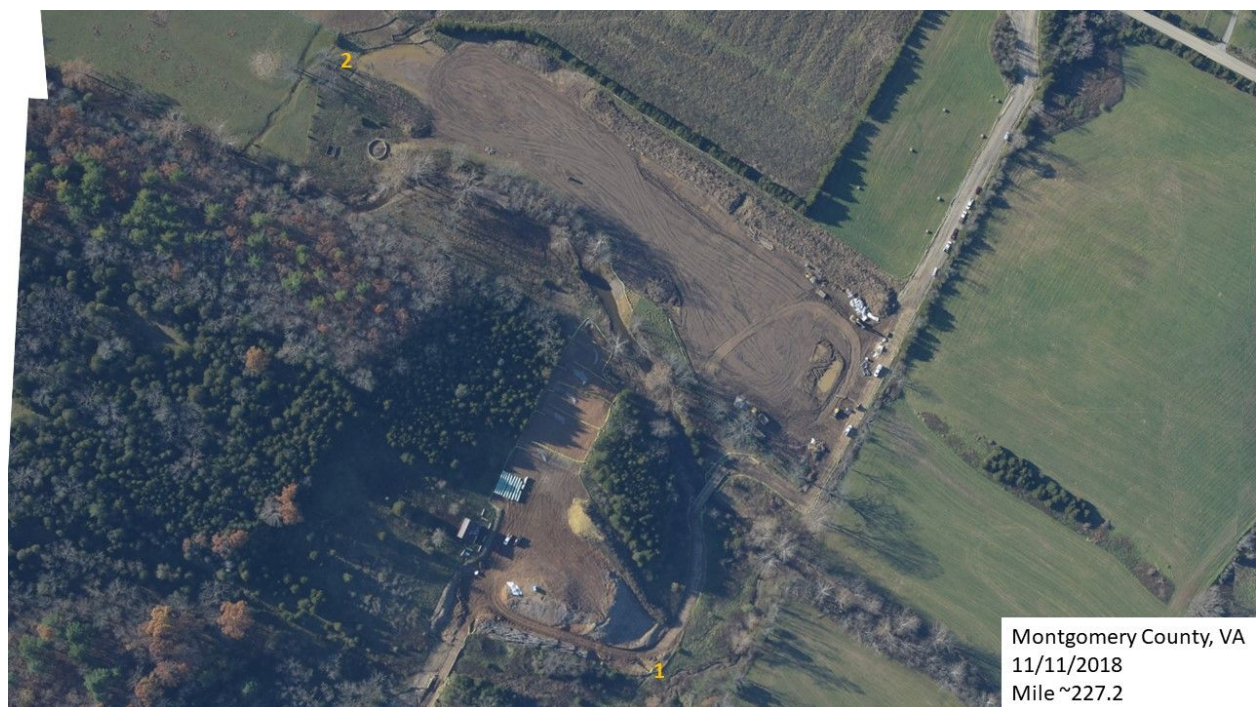
Figure 9: Base of Paris Mountain in Catawba. Numbers 1 & 2 indicate locations of constant overflow. Closer views in figure 10 & 11.

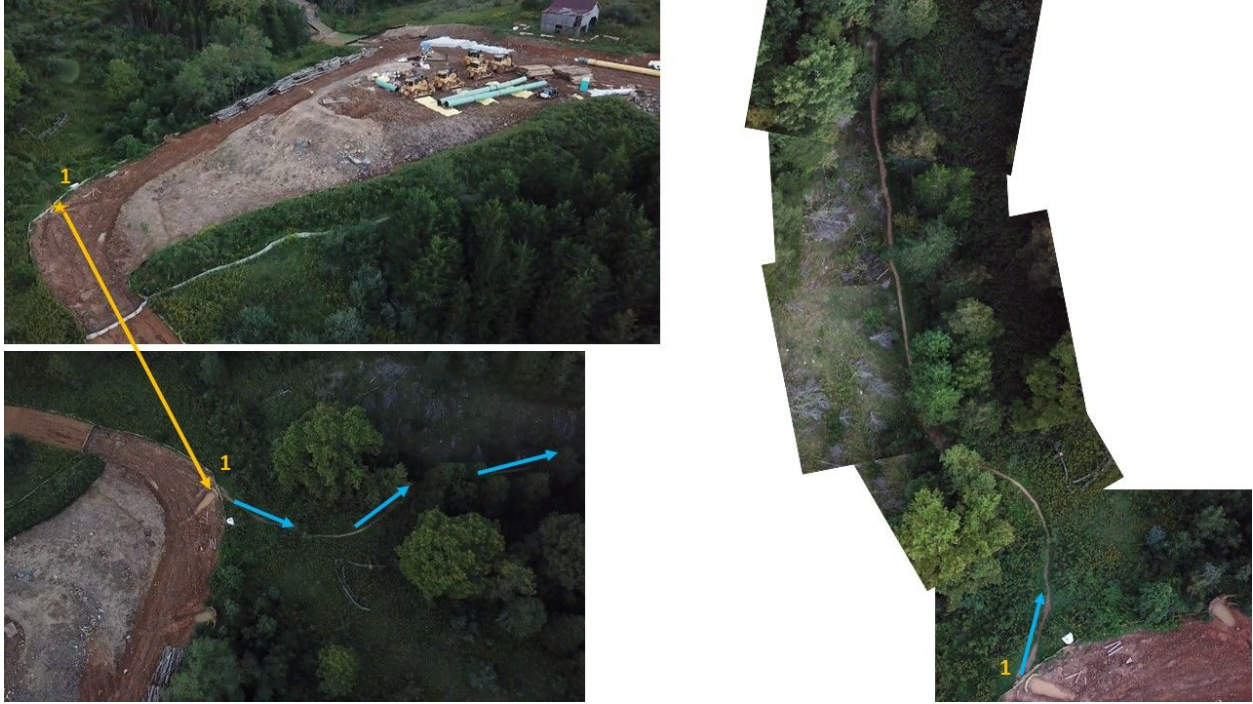
Figure 10: Location 1 shows full catch basins and sediment laden stormwater flowing to the North Fork of the Roanoke River. Flows are constant during every rain event.

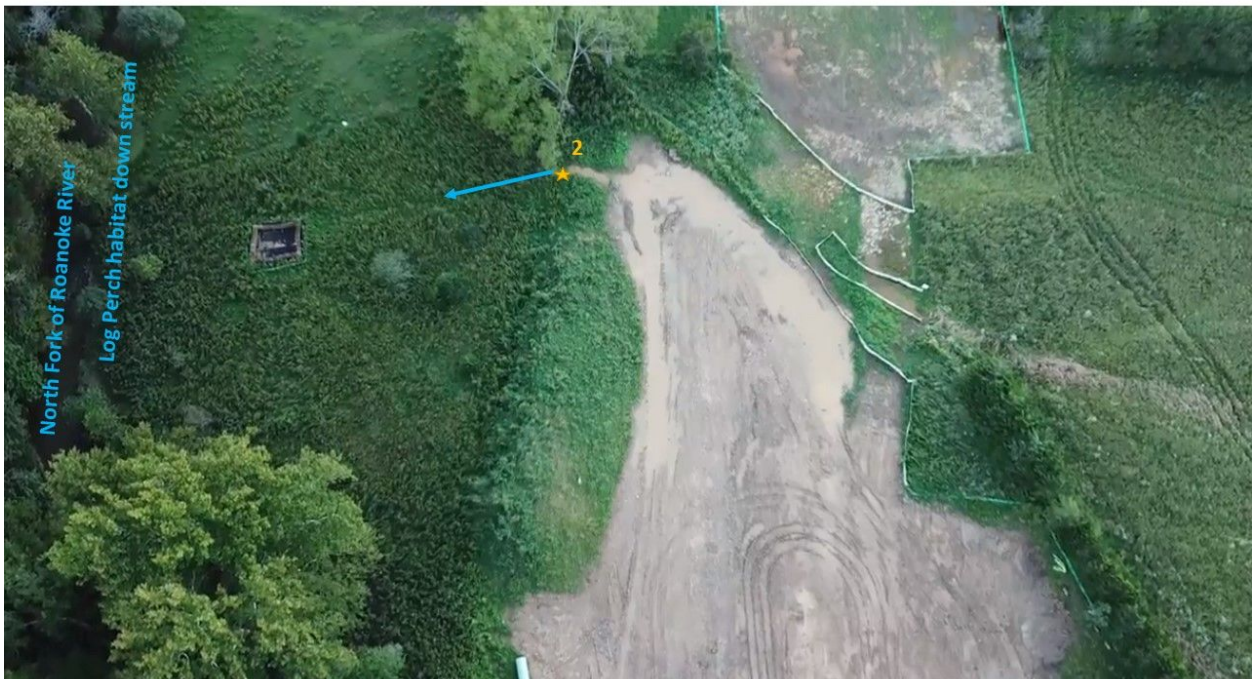
Figure 11: Location 2 is another location at this site where sediment laden stormwater continually flows into the North Fork of the Roanoke River during rain events.

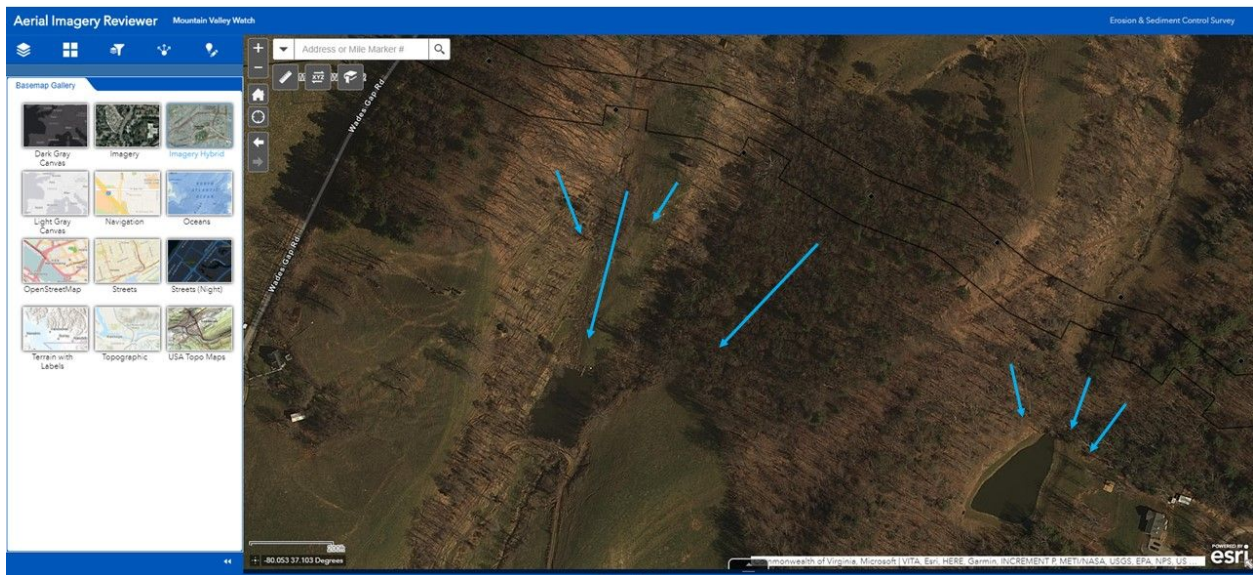
Figure 12: Runoff drainage flow patterns from MVP construction LOD, aerial image prior to construction.

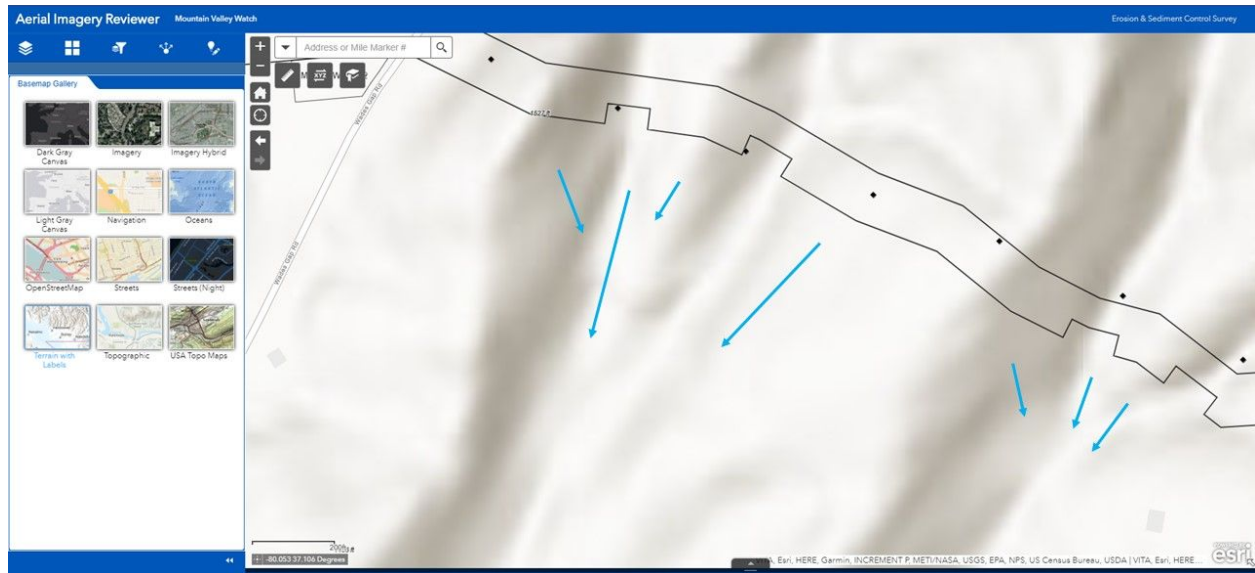
Figure 13: Same location as figure 6, shaded relief map used as basemap showing drainage flow patterns.

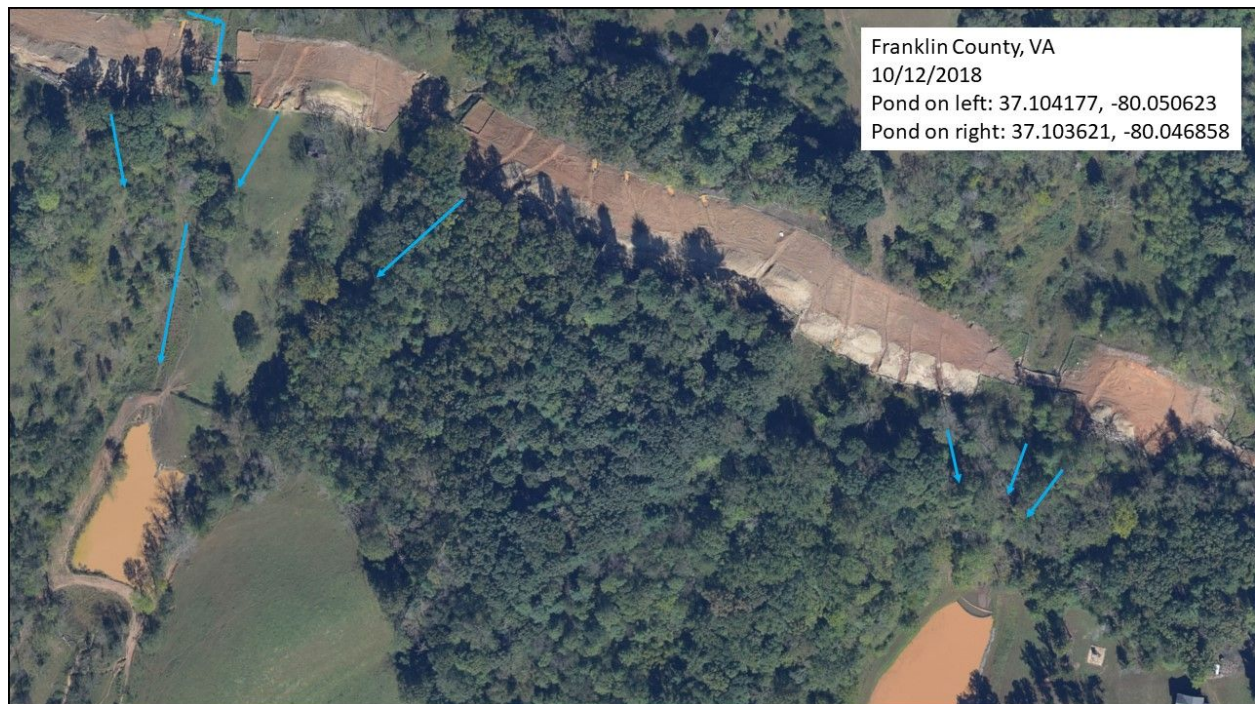
Locations all along the pipeline have clay rich soils. Full catchment basins at the edge of the LOD take much longer to drain in clay rich soils, so each successive rain event causes the basin to overflow and overwhelm adjacent E&S controls. The result is sediment laden ponds on adjacent landowners properties as seen by the tan color of the two ponds shown.

Figure 14: Same location as figures 6 & 7. Sediment laden **ponds** and flow pattern arrows from MVP construction LOD indicate potential source.

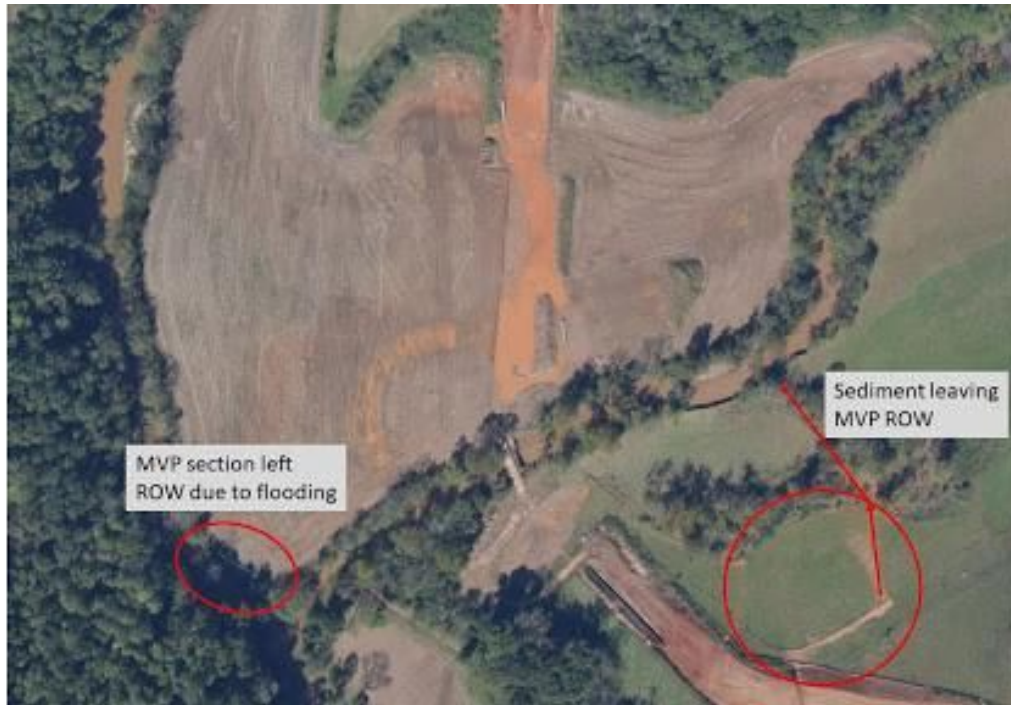
Figure 15: Franklin County, Virginia image (10/12/2018) showing a large section of pipe washed from MVP construction ROW due to flooding.

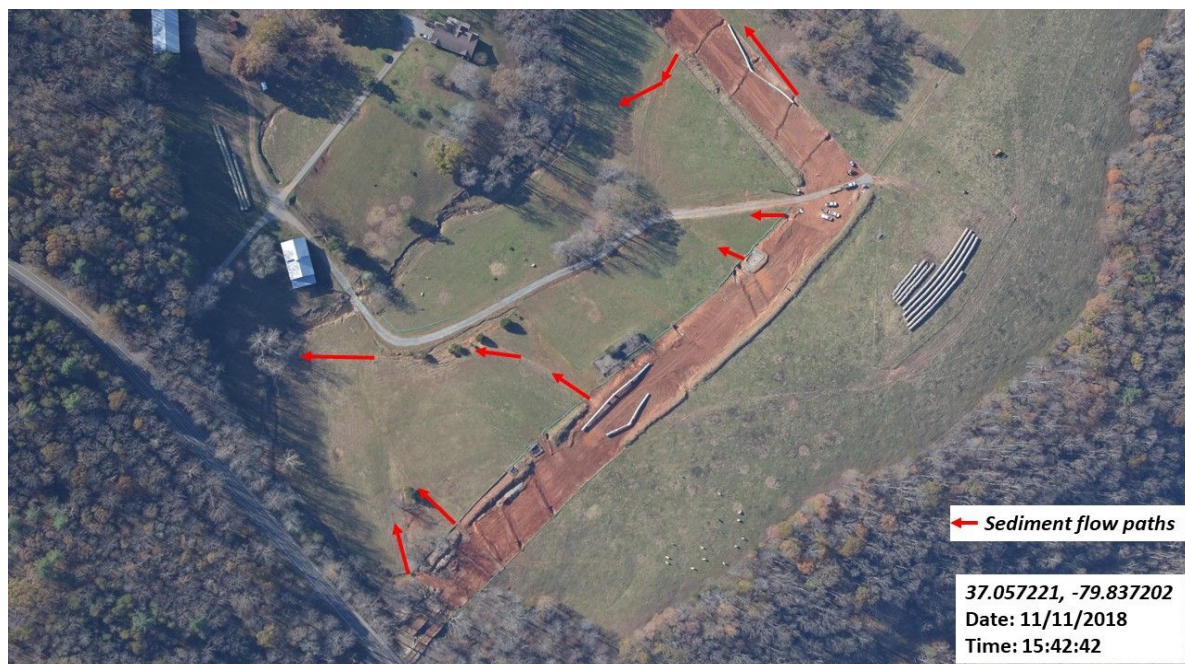
Figure 16: Flow paths where sediment leaves MVP construction ROW during rain events.

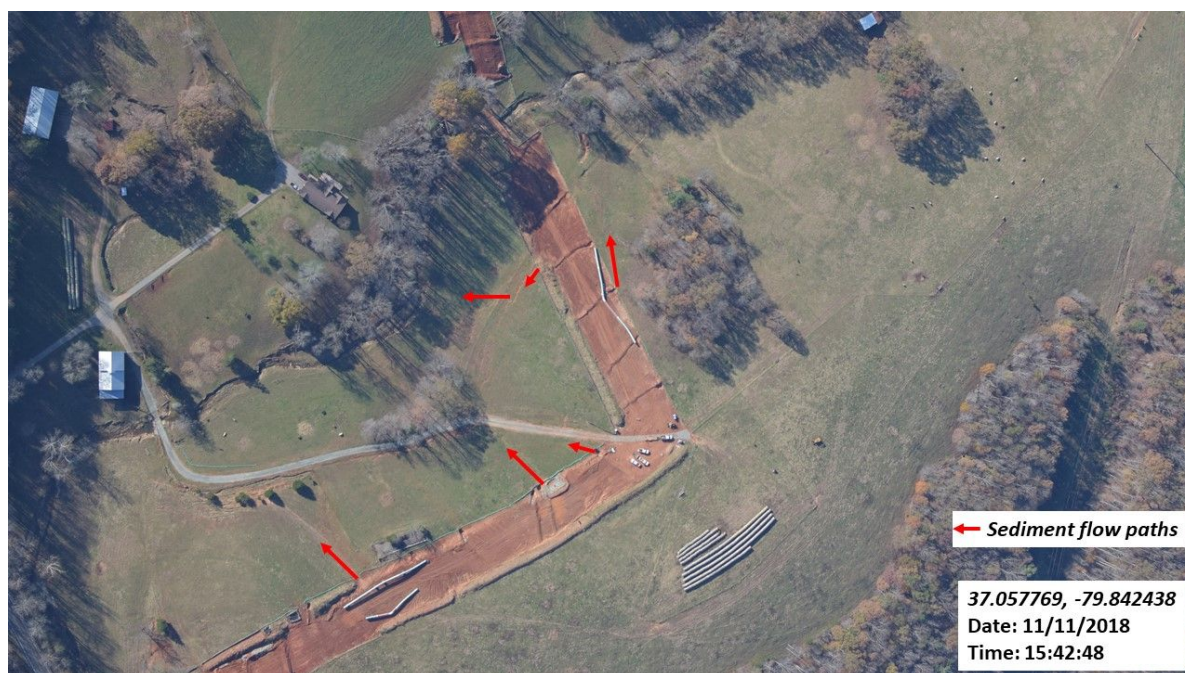
Figure 17: Flow paths where sediment leaves the MVP construction ROW during rain events.

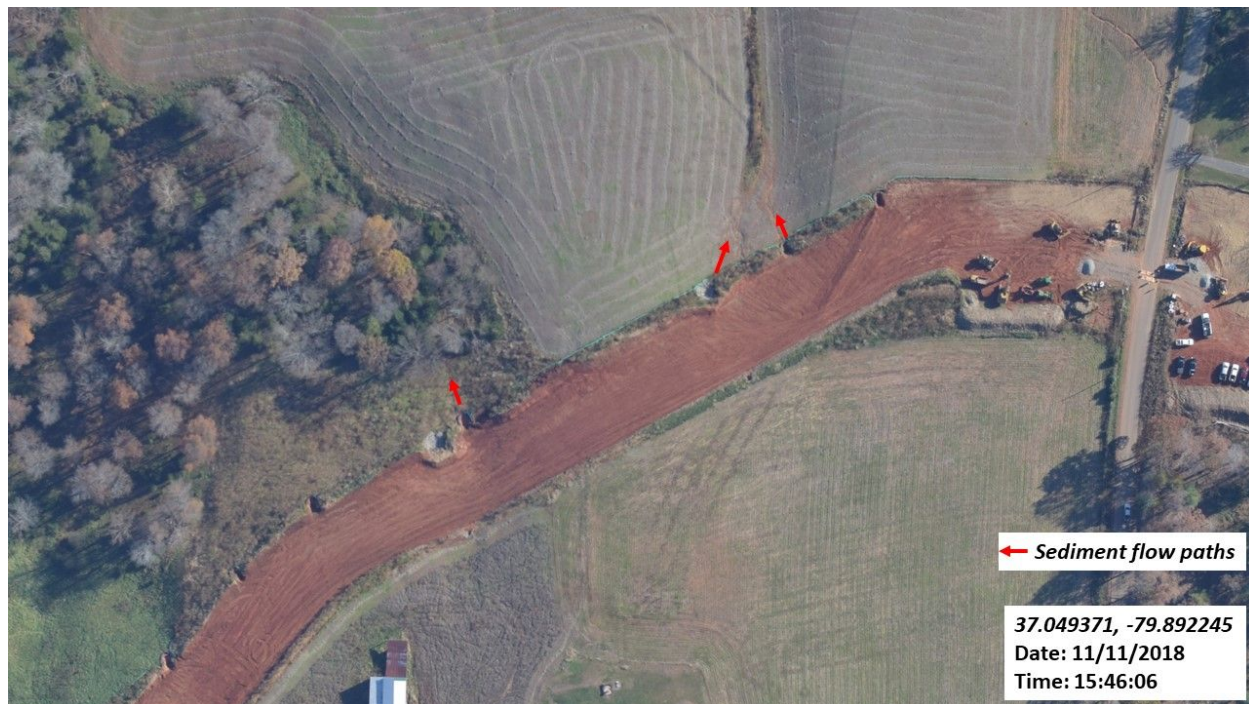
Figure 18: Sediment flowing off pipeline corridor onto adjacent properties.

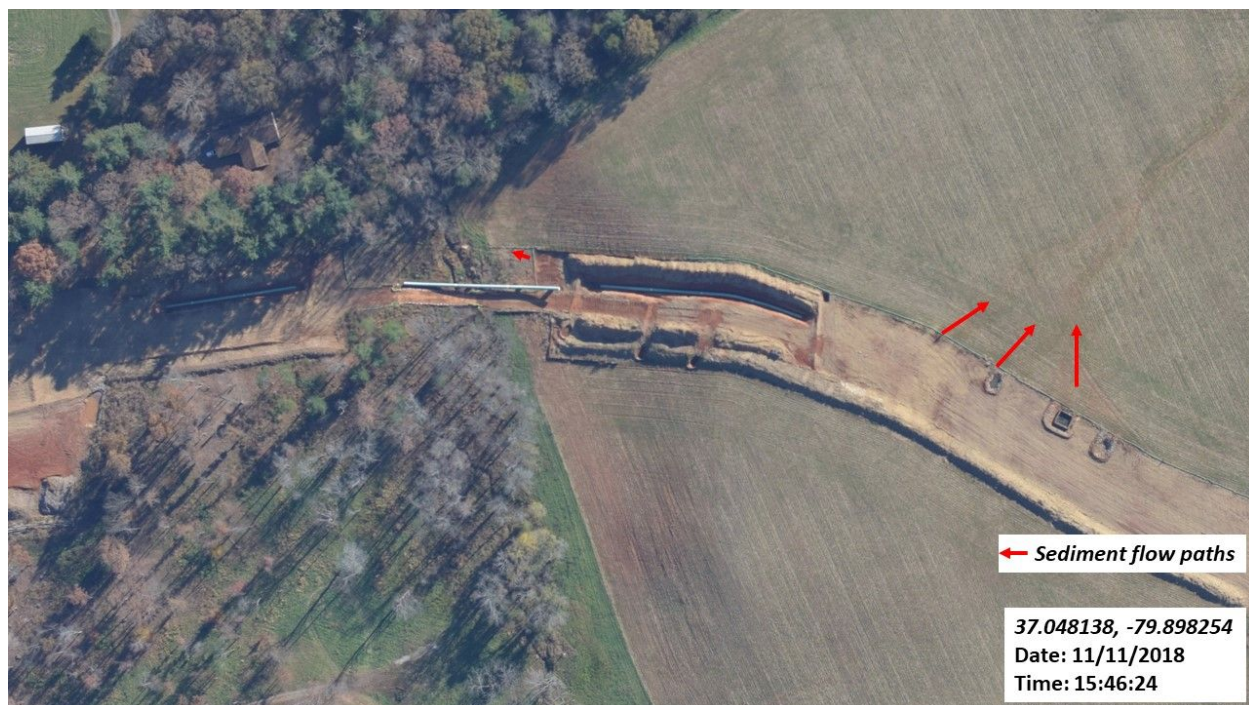
Figure 19: Sediment flowing into adjacent field.

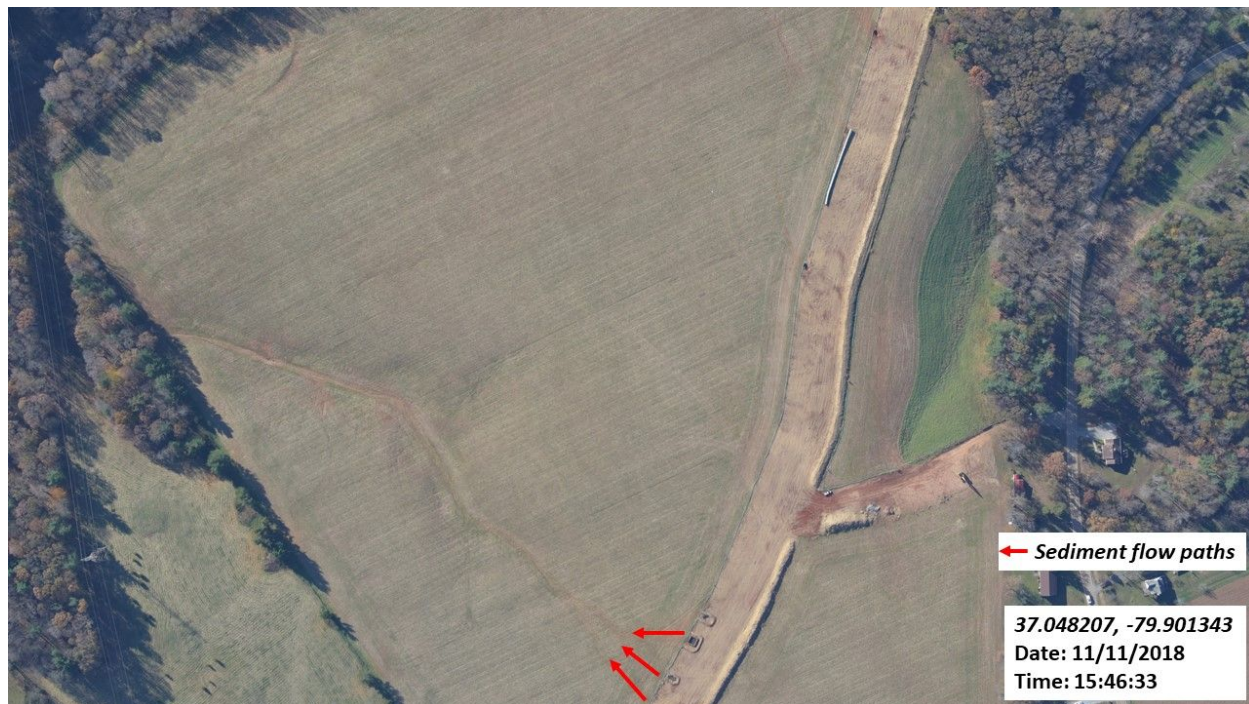
Figure 20: Sediment flowing into adjacent field into drainage channel conveying sediment to stream.

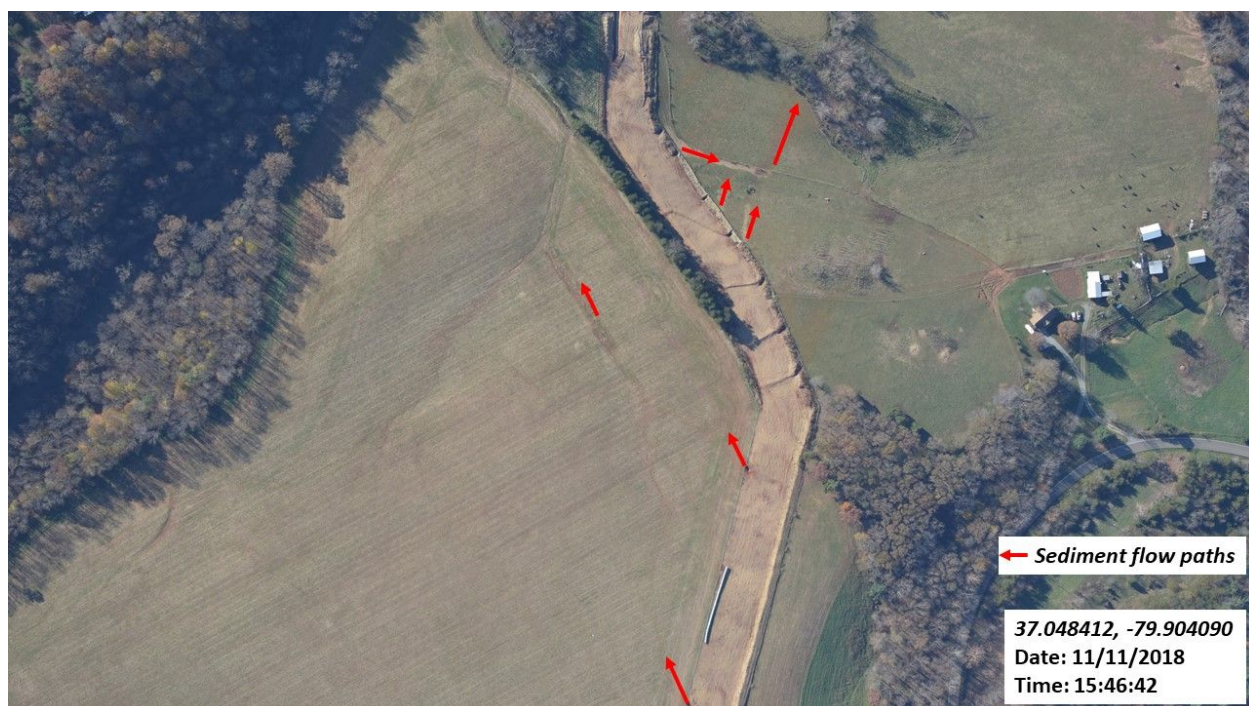
Figure 21: Sediment flowing into field from right of way diversions.

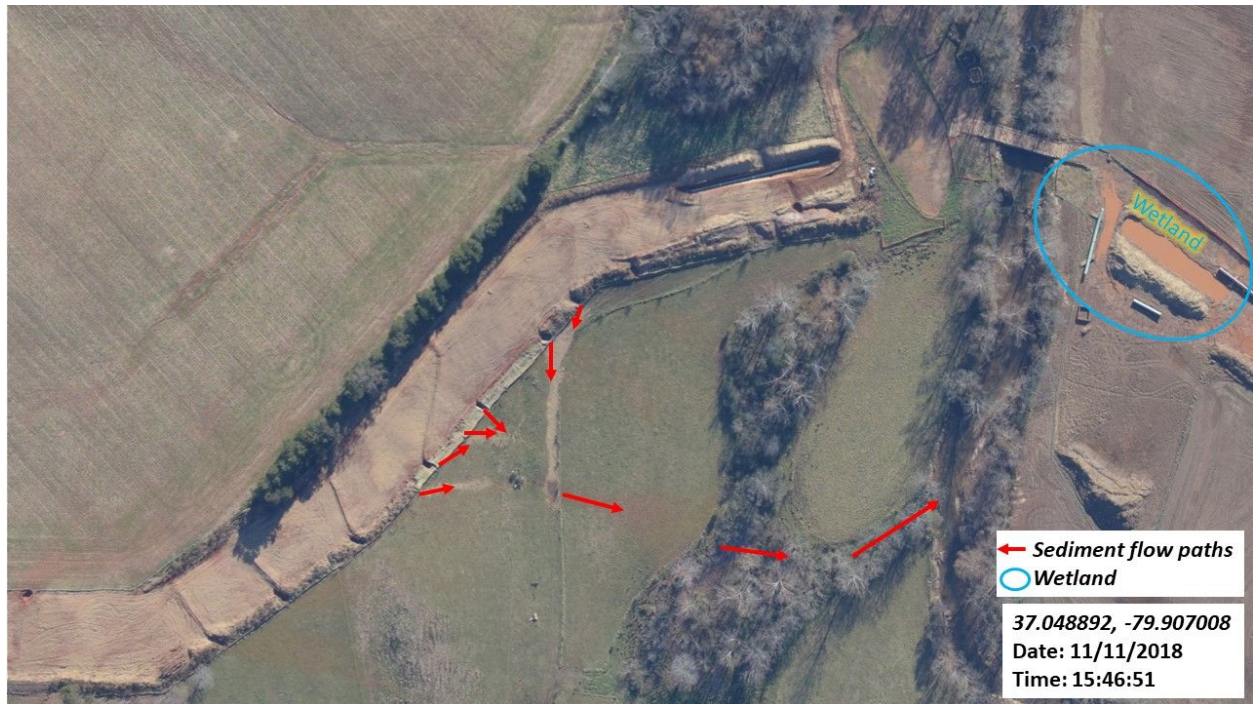
Figure 22: Sediment flowing into adjacent fields and drainage channels flowing to stream. Sediment ponding in delineated wetlands.

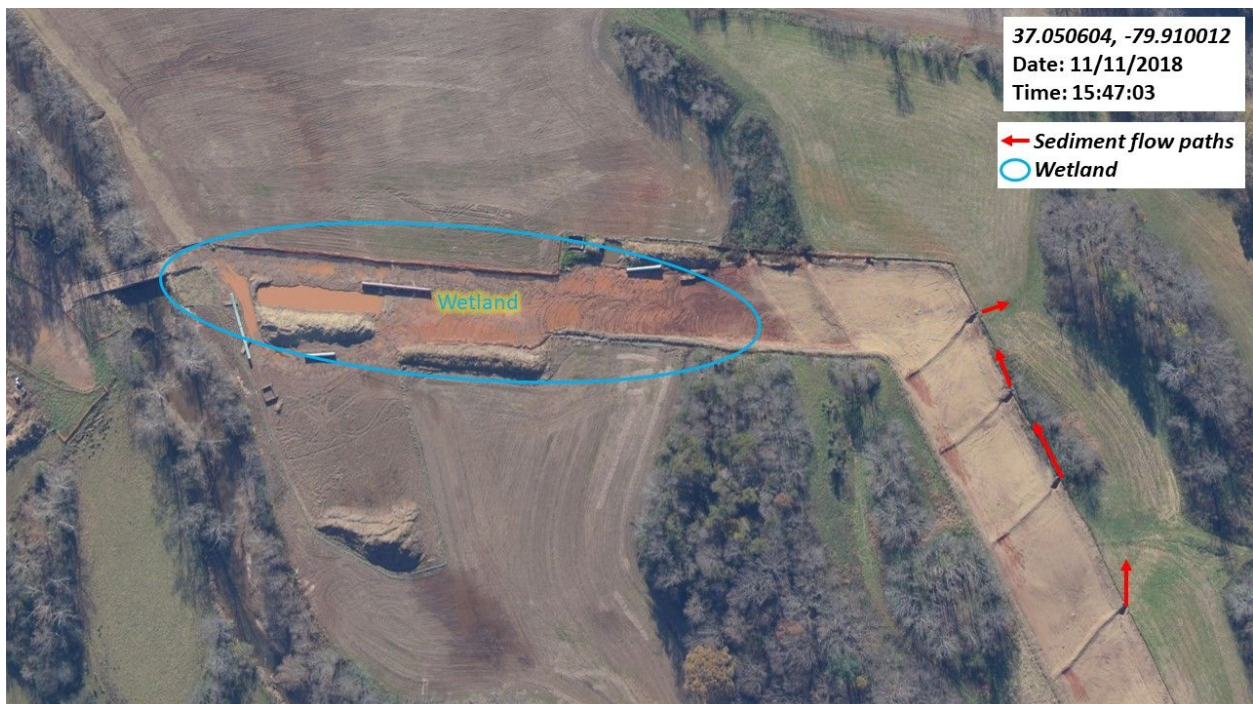
Figure 23: Sediment flowing from waterbars off of pipeline corridor. Sediment ponding in delineated wetlands.

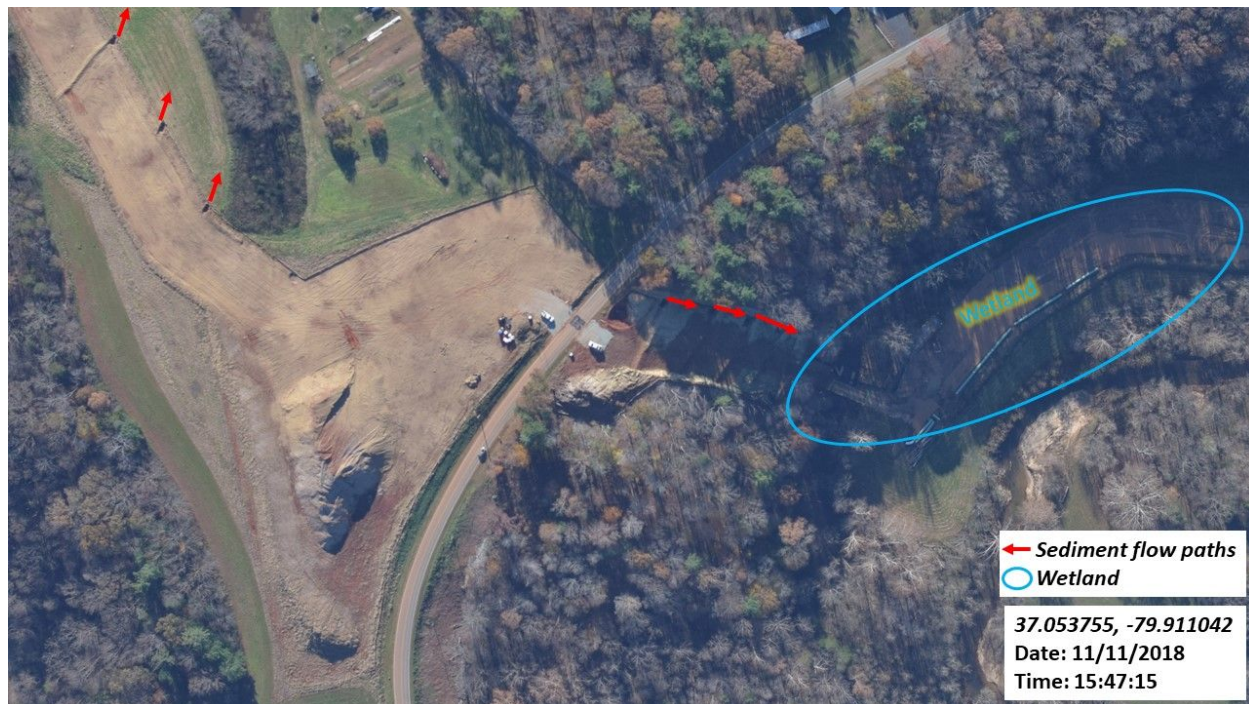
Figure 24: Iron Ridge Road shows discoloration from mud in roadway. Flow paths and wetland identified.

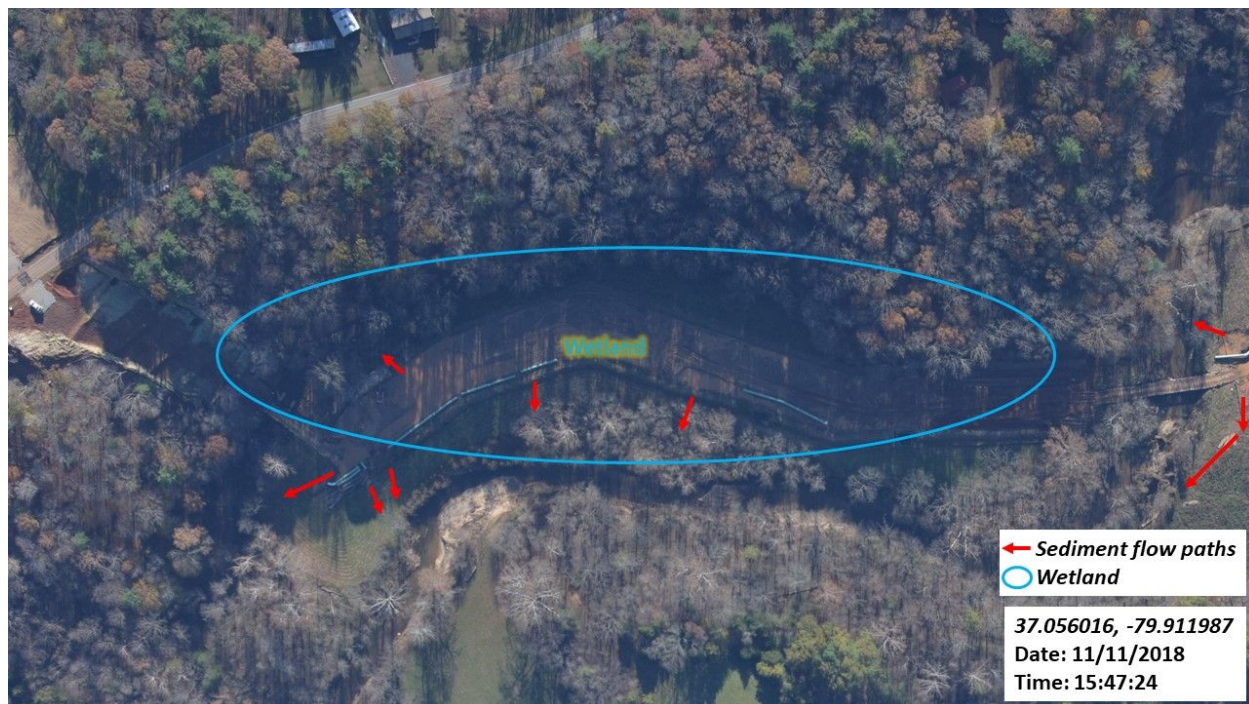
Figure 25: Sediment flowing off right of way into adjacent stream. Sediment deposits may be seen along stream.

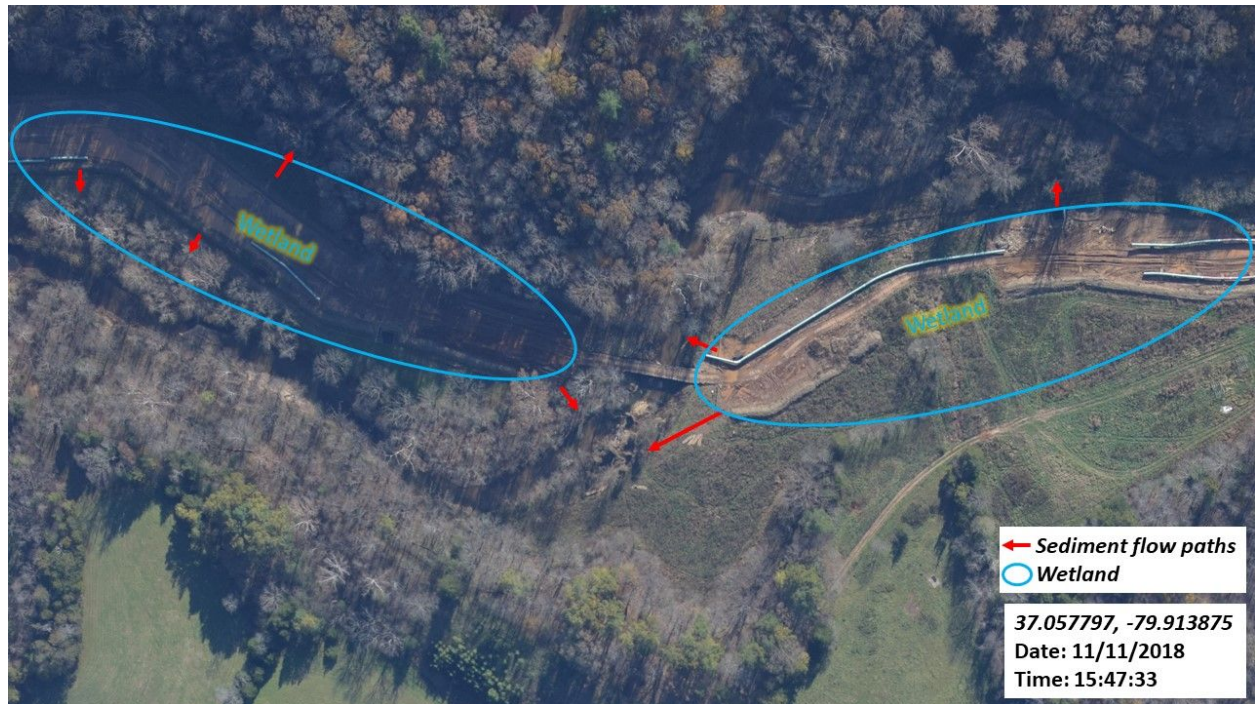
Figure 26: Sediment flowing off of right of way into stream and wetland areas.

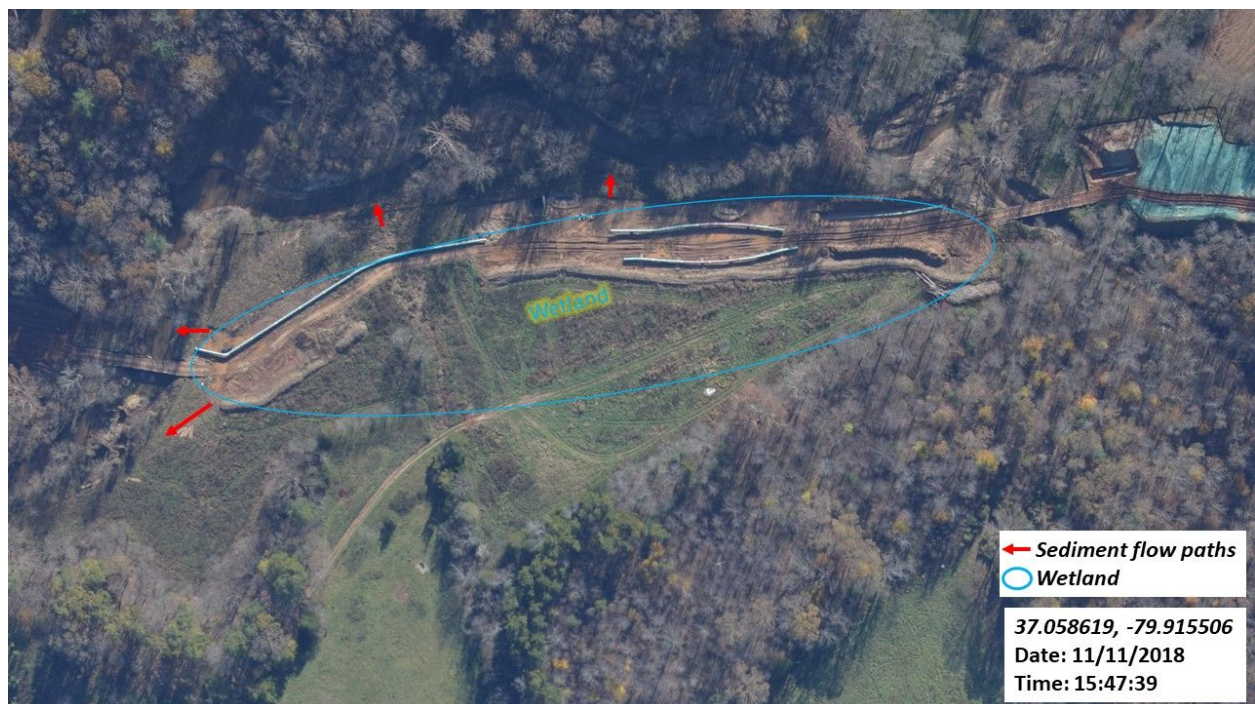
Figure 27: Trenching in a wetland; area is shown in ground photos below from table 1 & 2.
