December Report

2018

Monthly Citizen Reports

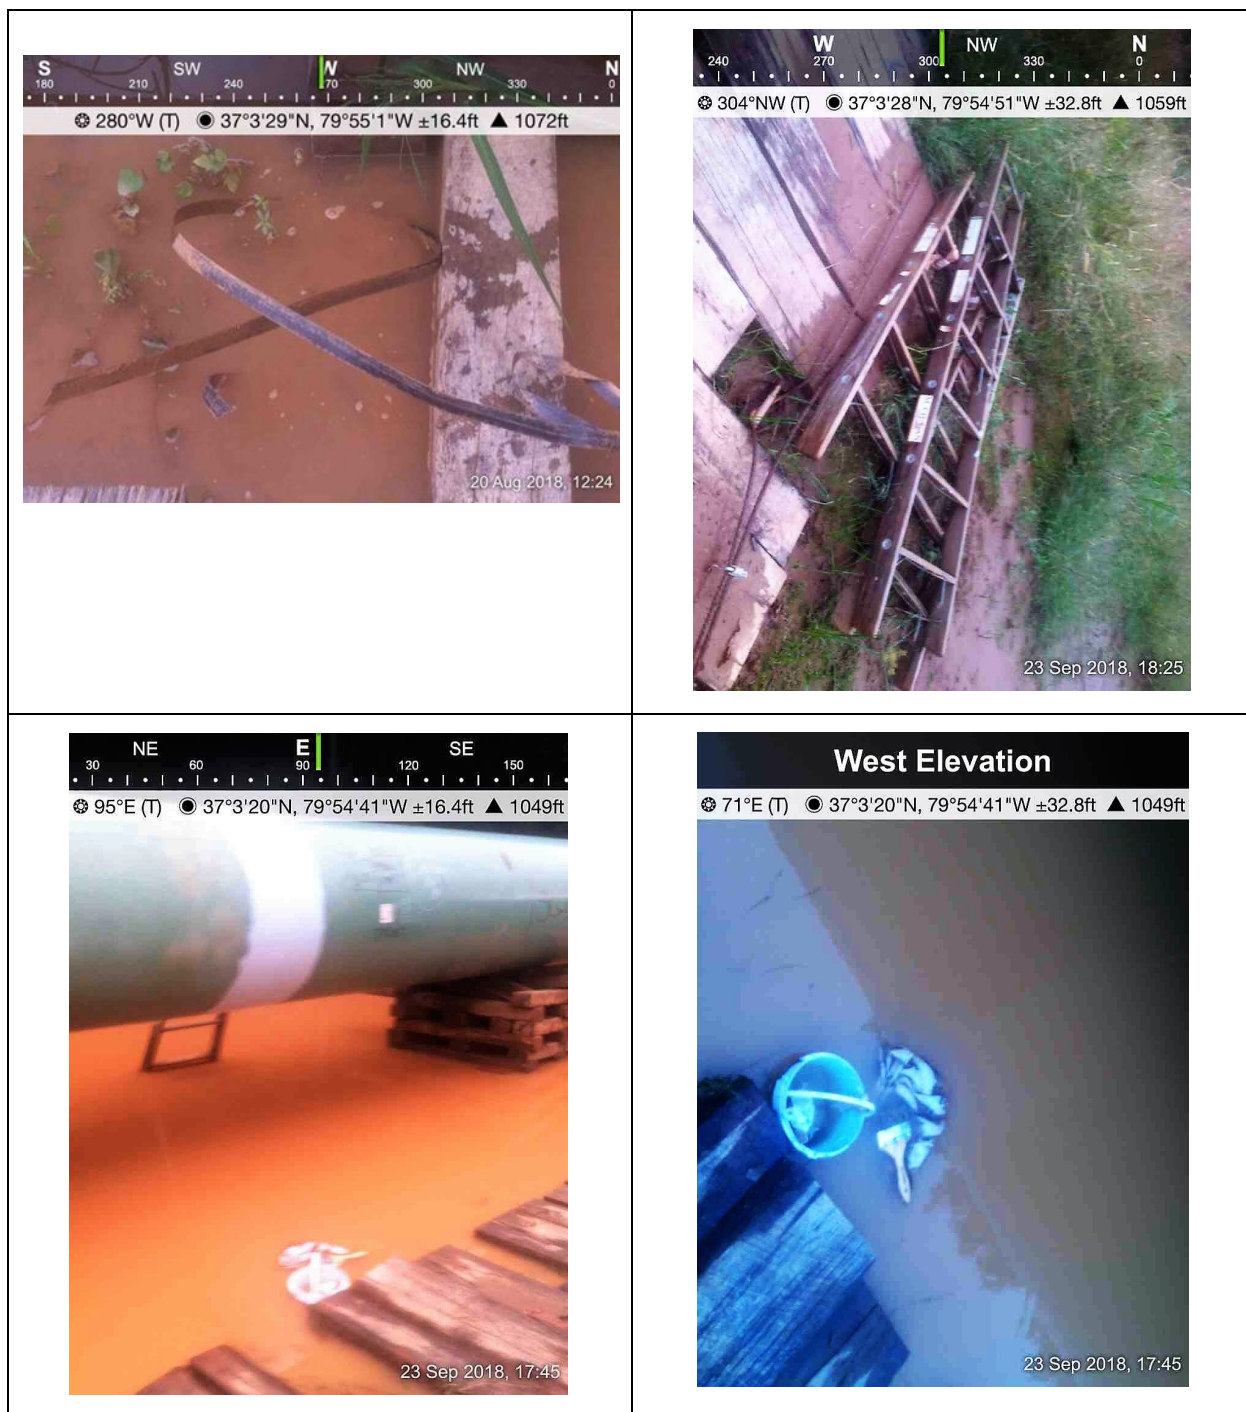
Table 1: Four Corners Farm flooding and poor MVP construction site management.

Table 2: Pictures of Four Corners Farm during a rain event showing sediment laden water piping through a cavity from LOD to creek.

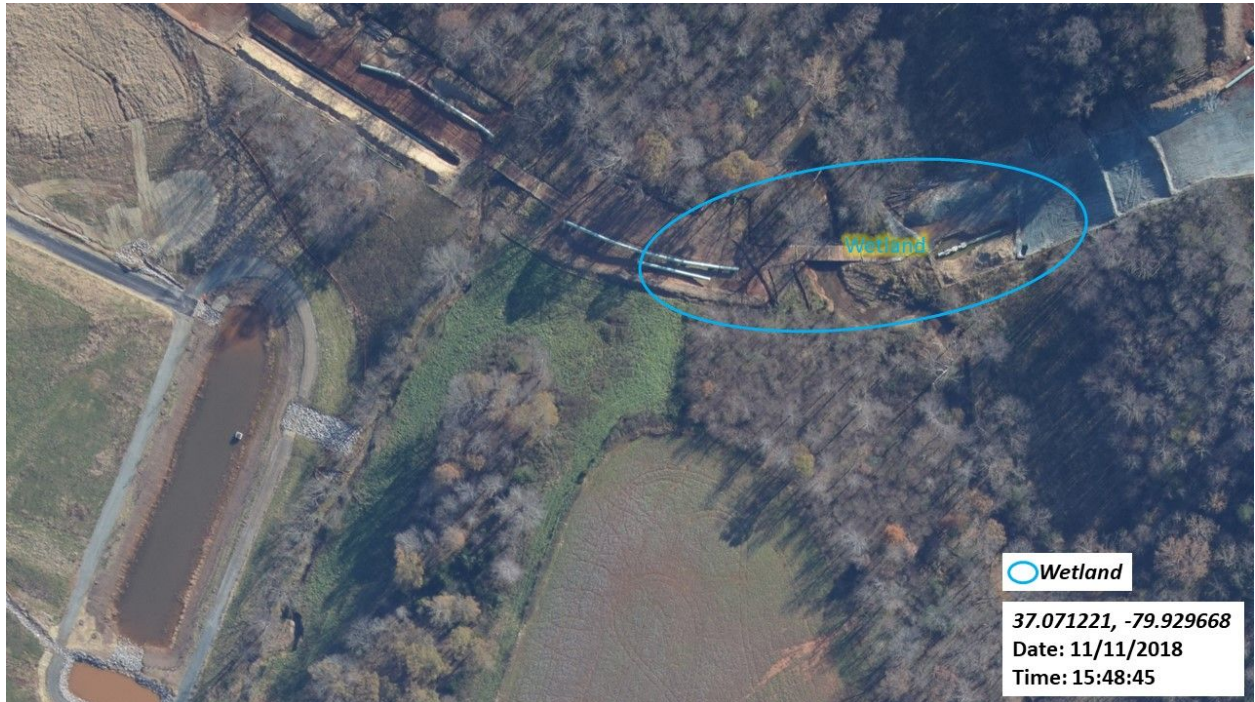
Figure 28: Wetlands and stream show evidence of sediment contamination.

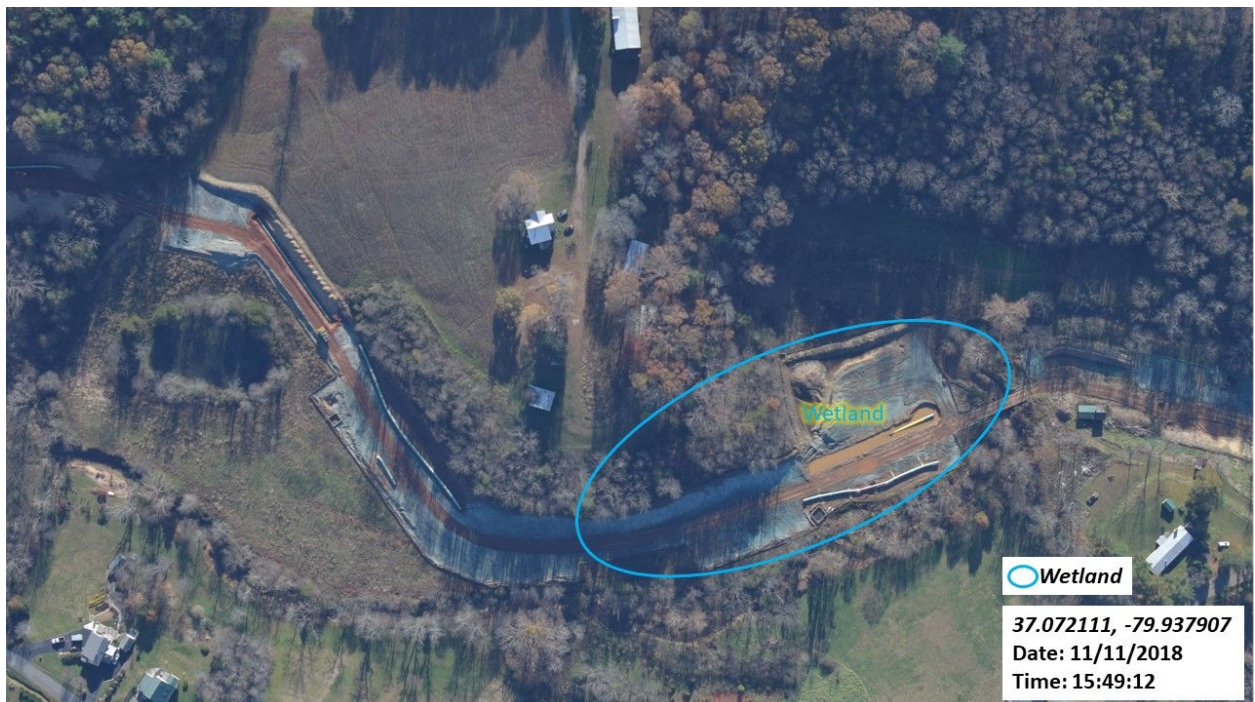
Figure 29: Sediment flowing into wetlands and adjacent stream.

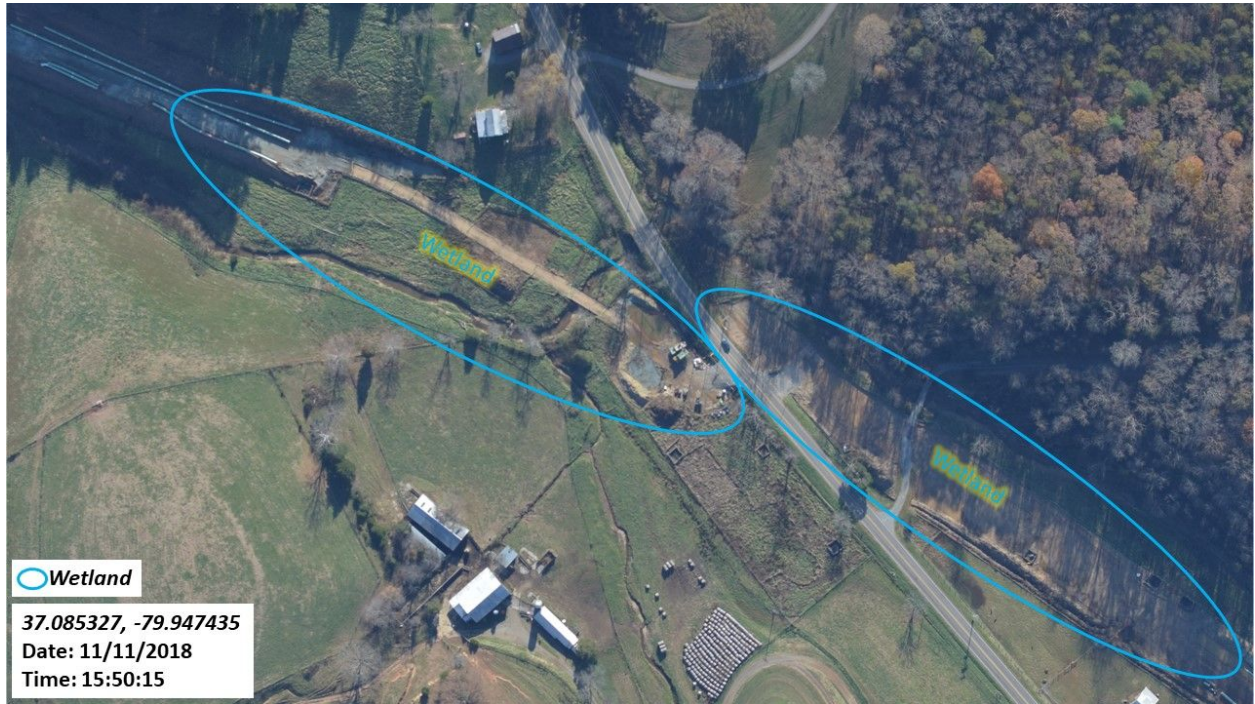
Figure 30: Wetlands area encroachment.

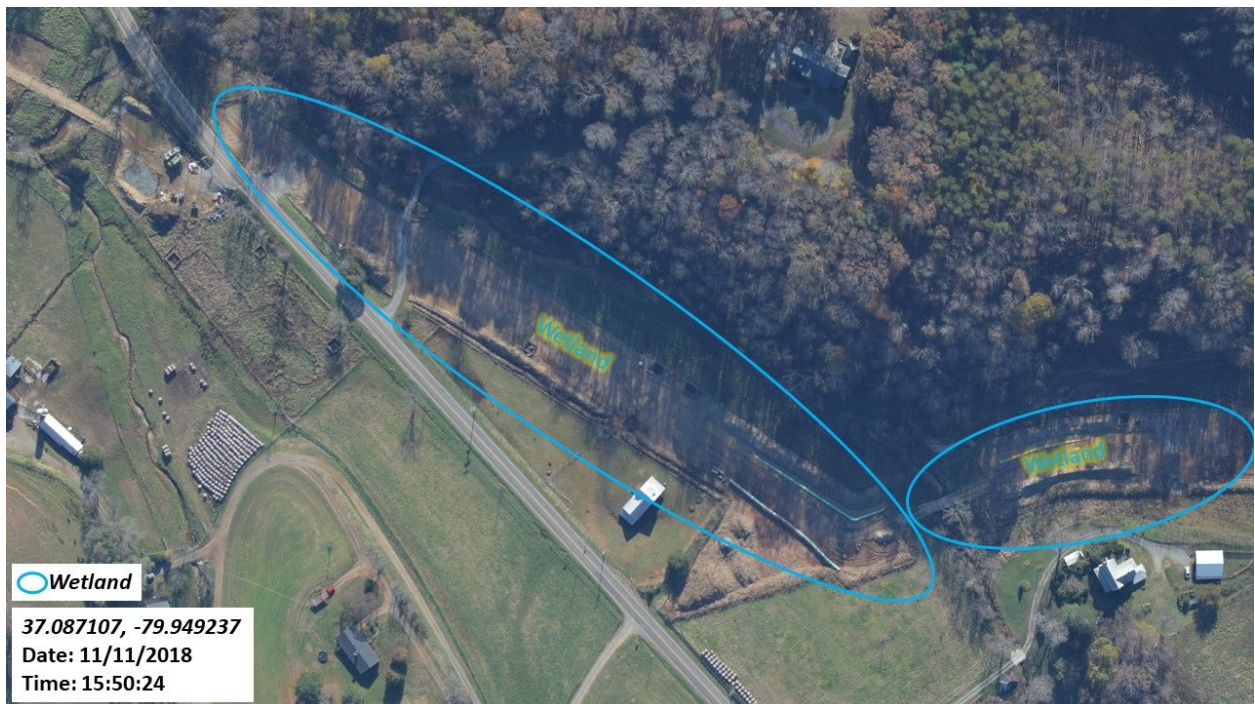
Figure 31: Wetlands area and floodplain encroachment. Stream channels inundated with sediment.

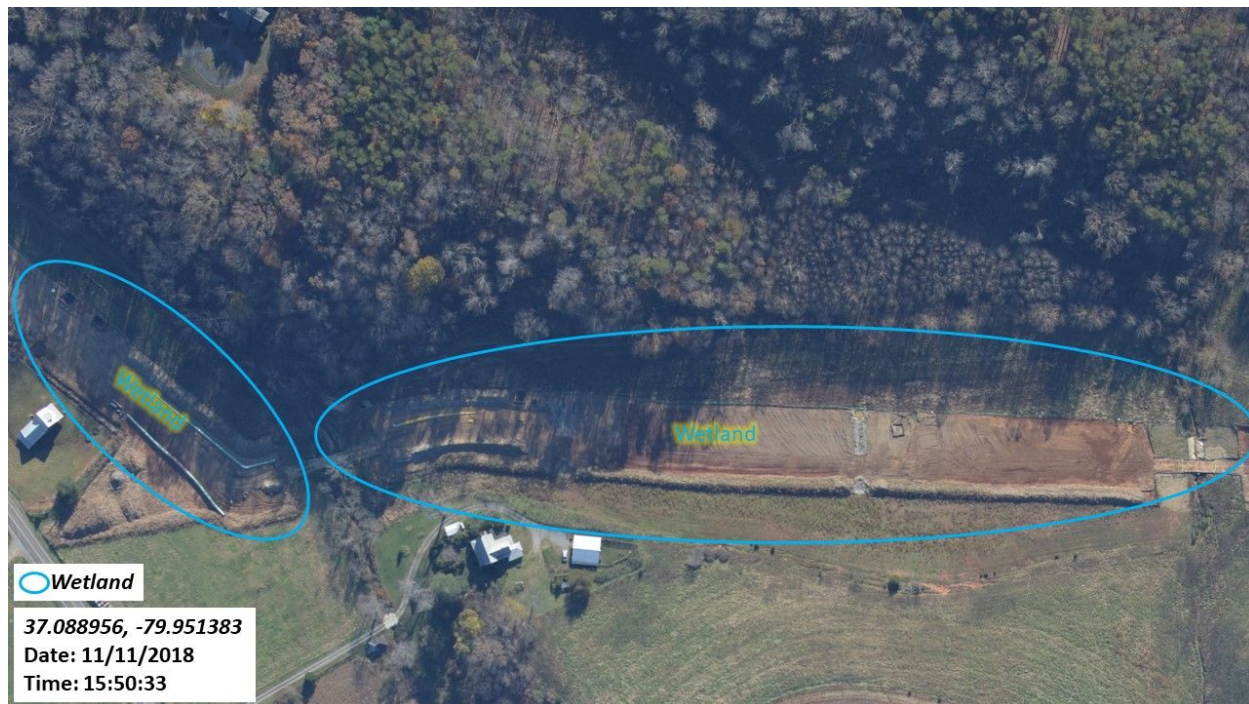
Figure 32: Wetlands area encroachment.

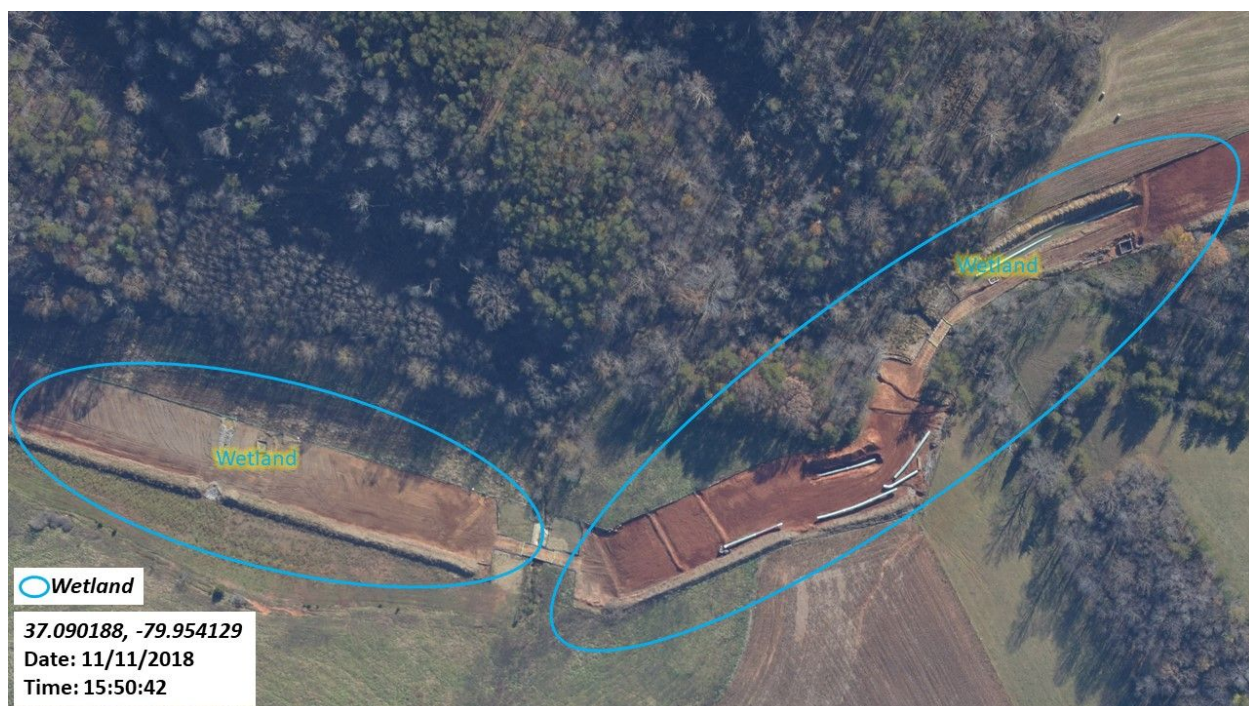
Figure 33: Wetlands area encroachment. Flooding occurred in these areas.

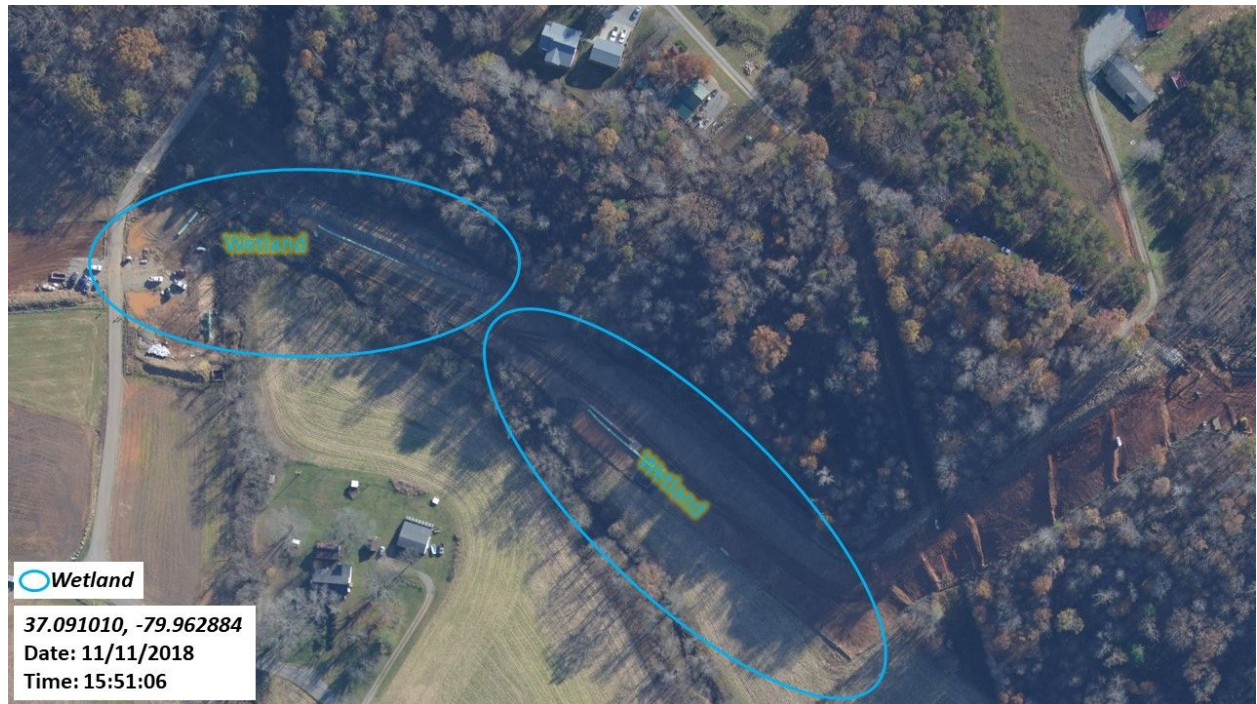
Figure 34: Wetlands area encroachment. Sediment flowing into stream adjacent to right of way.

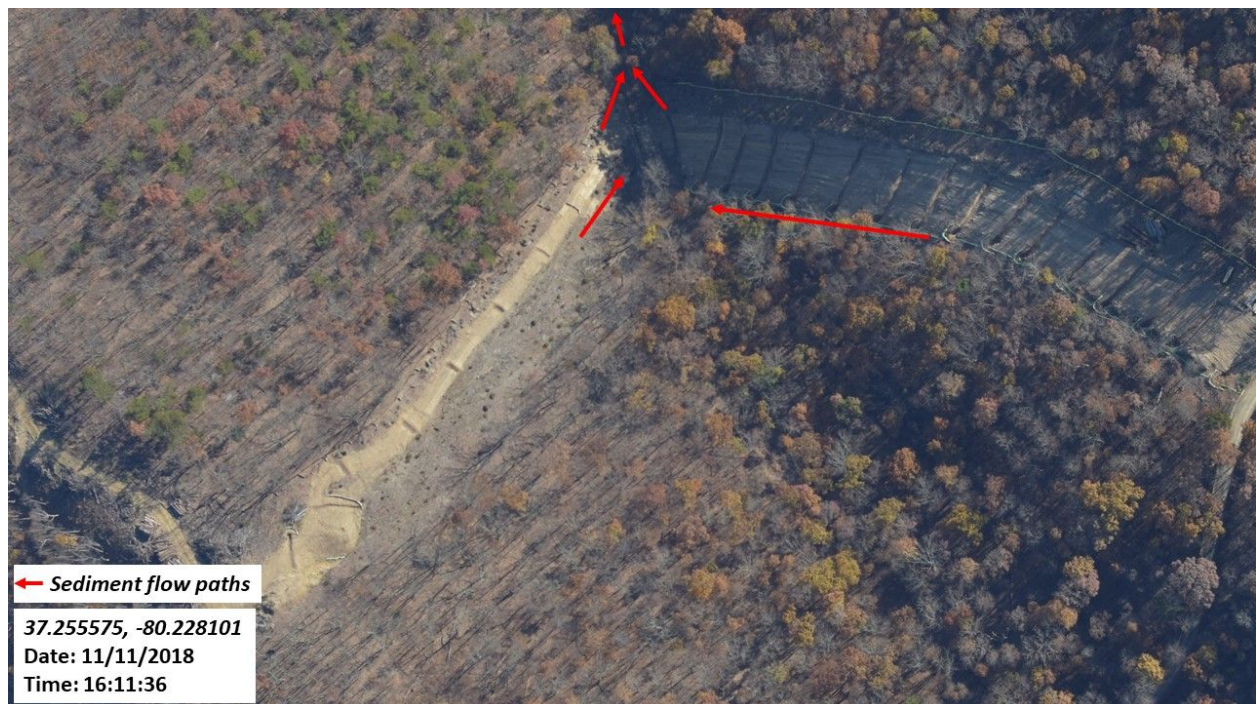
Figure 35: Sediment flowing into stream channel from pipeline right of way. Stream channel is at bottom or slopes.

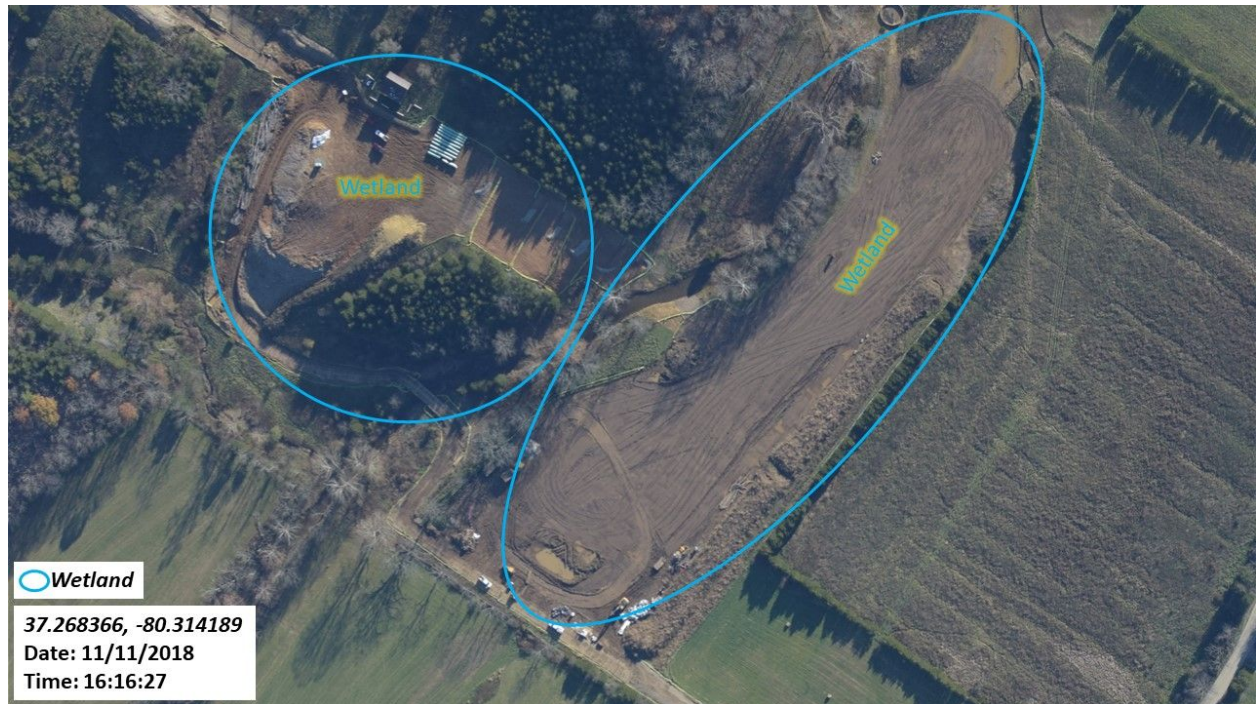
Figure 36: Wetlands area encroachment. Sediment flowing into North Fork Roanoke River.

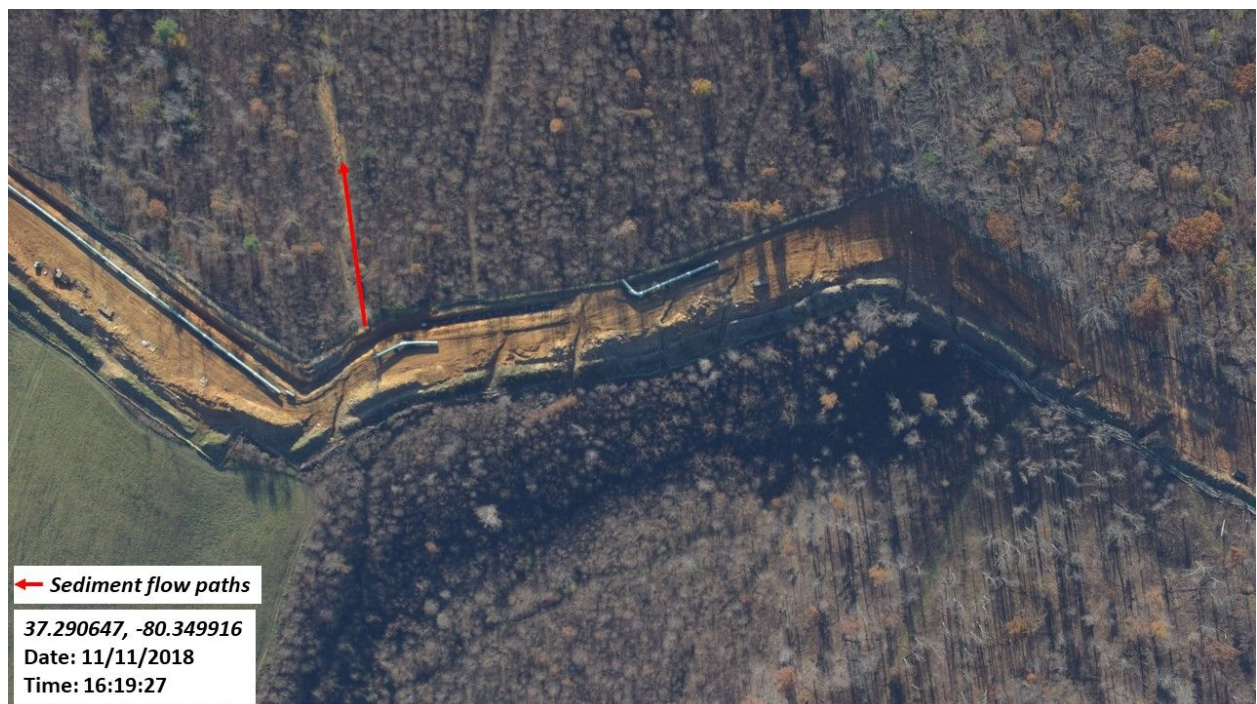
Figure 37: Sediment flowing into stream channel from right of way.
