Mountain Valley Watch

June 2019 Report

Introduction

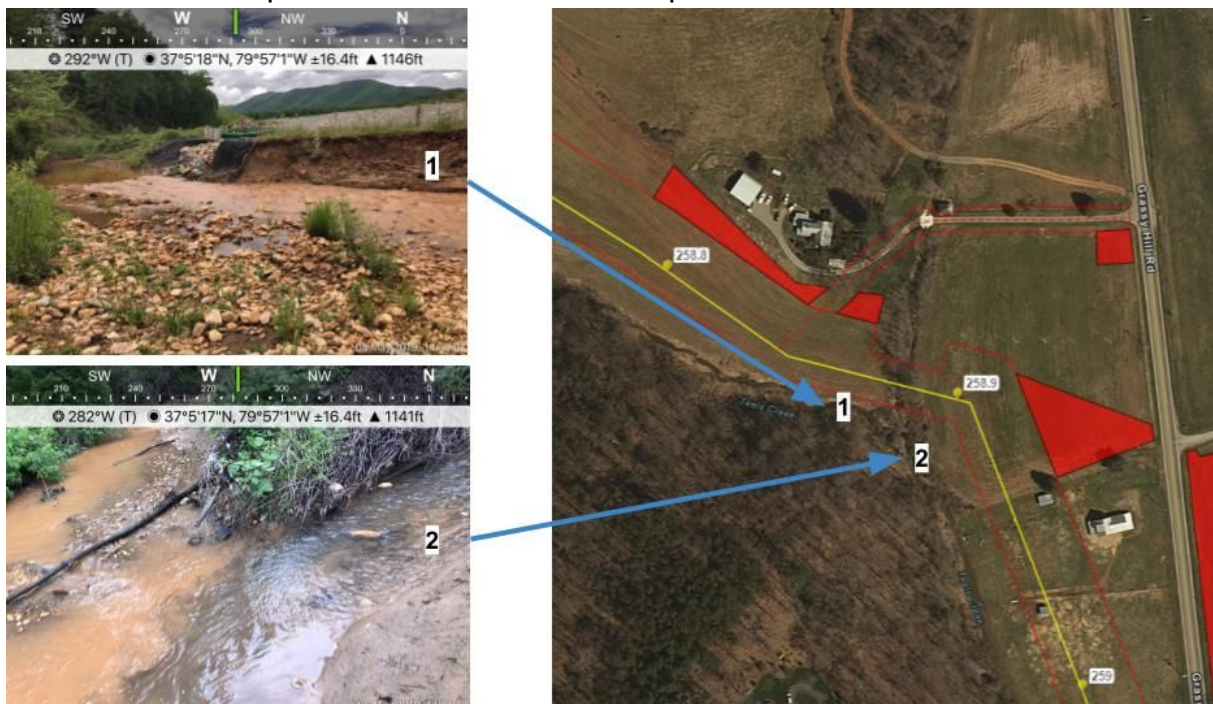
Grassy Hill Road in Franklin County Virginia is a site with recurrent sedimentation issues during each rain event. Sediment flowing from the riprap area is visible in the top photo along Teels Creek and the convergence with a clear stream just downstream from the sediment plume is shown in the lower photo.

Figure 1: Location 1 shows sediment leaving ROW. Location 2 shows a convergence of Teels Creek with a clear running stream.

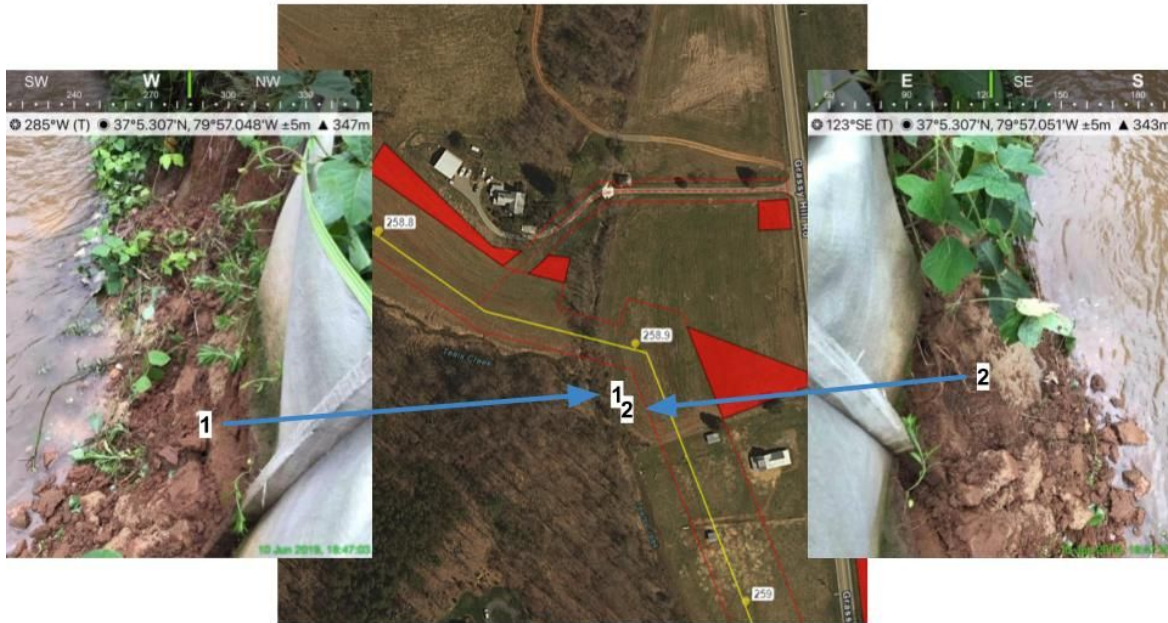
Directly below convergence of Teels Creek, the stream bank has shifted due to channel erosion created by increased runoff from the MVP right of way. Scouring of the stream bank has moved the bank several feet from its original location before construction began for the MVP. The bank continues to erode as illustrated in the photos below.

Figure 2: Stream bank scour is about to undercut the silt fence on Grassy Hill Road, 5/10/2019.

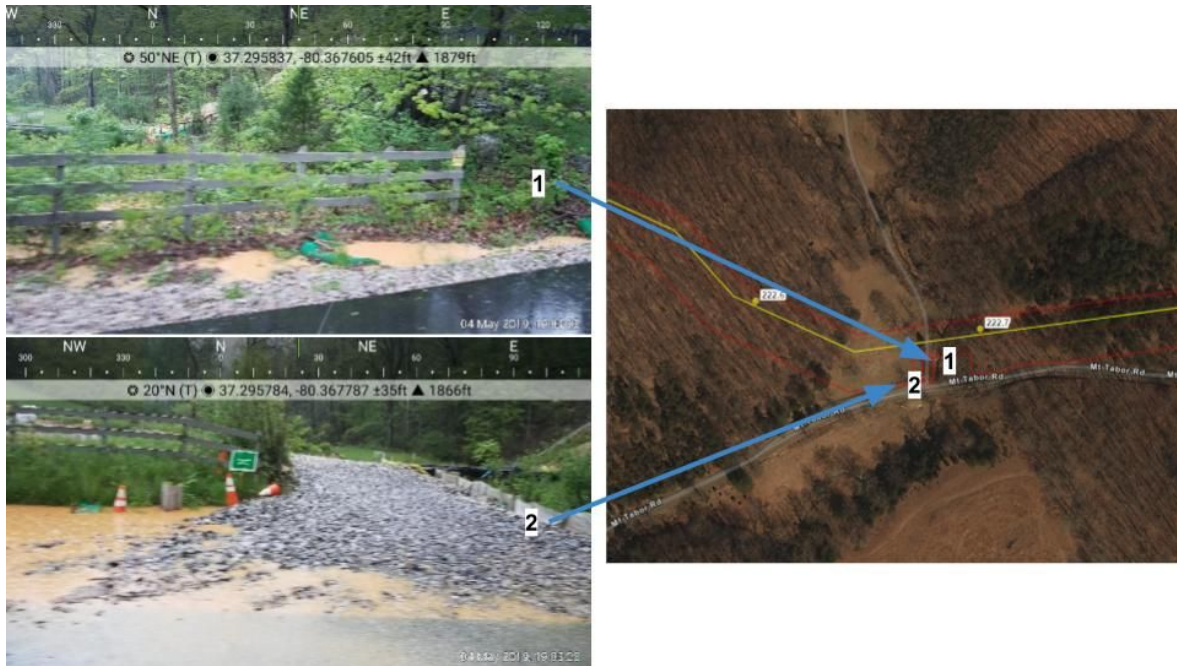
Erosion & Sediment control devices are continually overwhelmed by normal precipitation events in areas of Brush Mountain and Mount Tabor Road in Montgomery County. There are recurrent issues as illustrated in the pictures below taken on May 5, 2019. The devices used in this area are not adequate to control runoff from the construction right of way. As seen in the photos, runoff exceeds the capacity of filter socks to contain sediment on site. Sediment flows around or over filter socks and flows into adjacent stream. See photos below.

Figure 3: Mount Tabor Road. Location 1 is downstream from location 2. Sediment is flowing off slope from MVP ROW into adjacent stream.

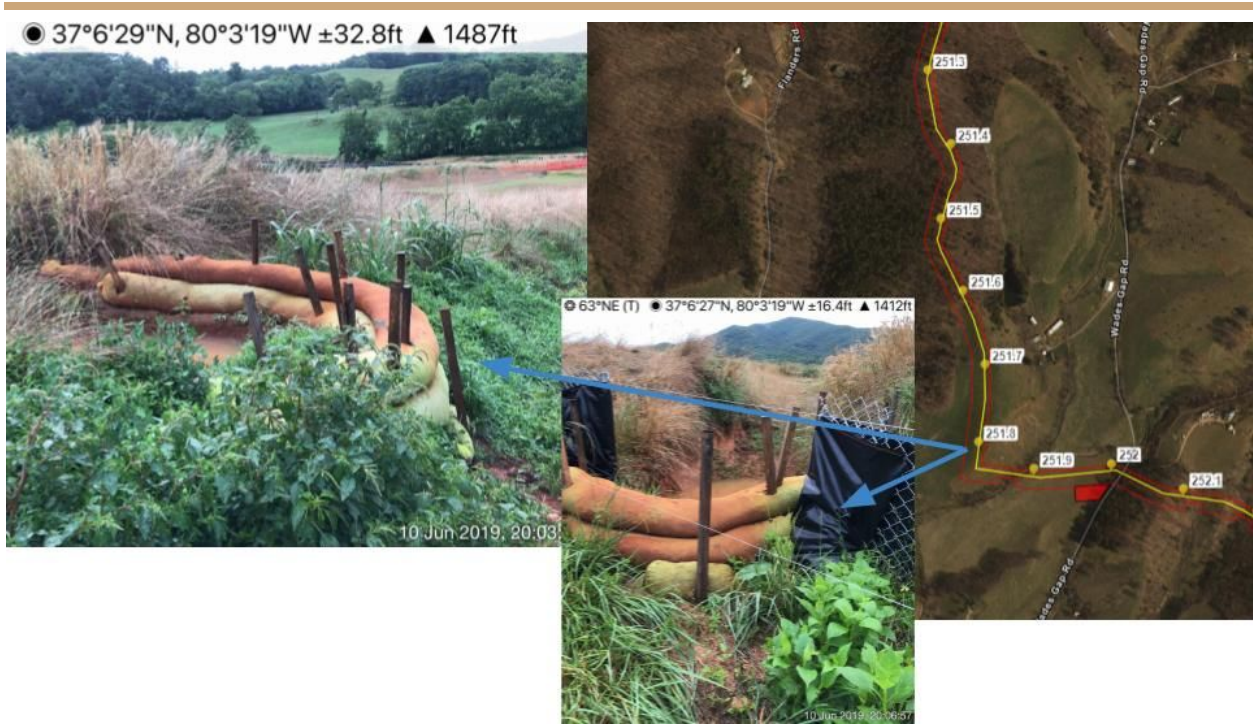
Figure 4: Filter socks overwhelmed by sediment near Wades Gap Road.

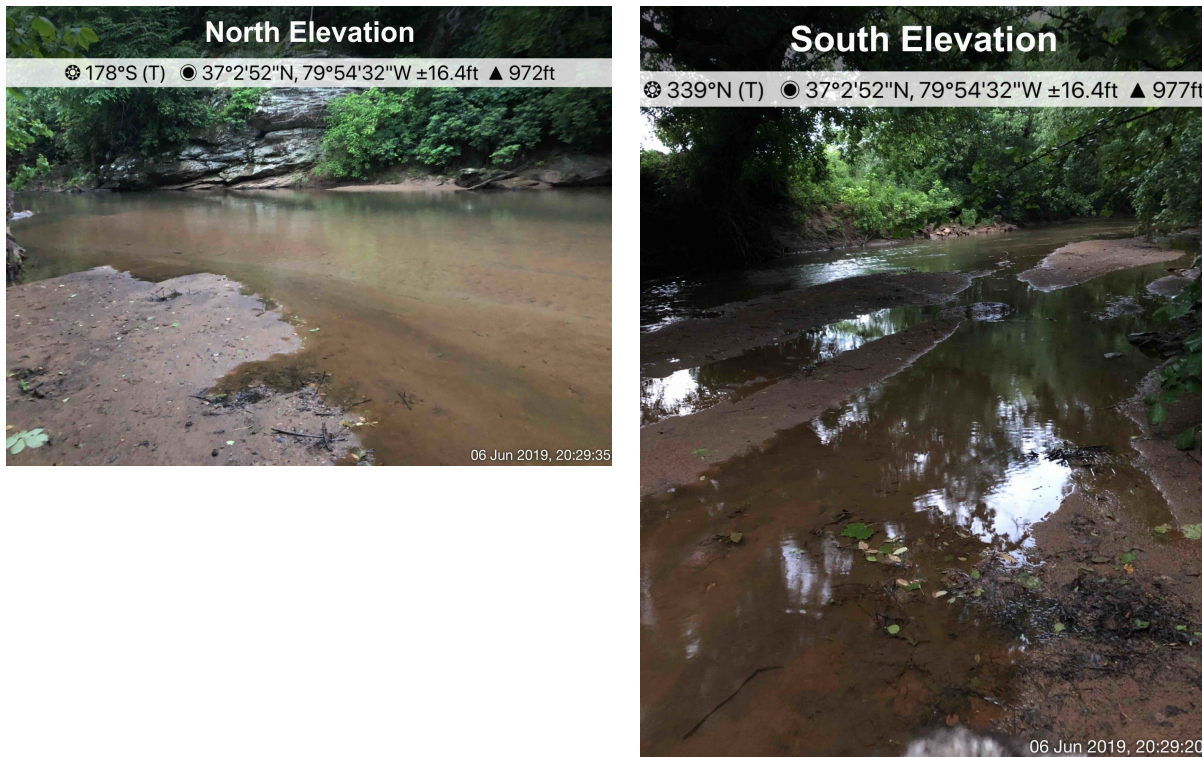
Dean and Dale Angle's farms are adjacent to Little Creek and the Blackwater River and have been heavily impacted by unsecured earth loss. The Angle farms have suffered severe sediment impacts since May 2018. The farm is below MVP construction sites on Little Creek at Cahas Mountain Road and below the convergence of Teel Creek, all heavily impacted by construction. Sediment flowing from the watershed above their farms combines with sediment from their property to silt in the waterways shown in the photos below .

Figure 5: Sedimentation at the convergence of Little Creek and Blackwater River.

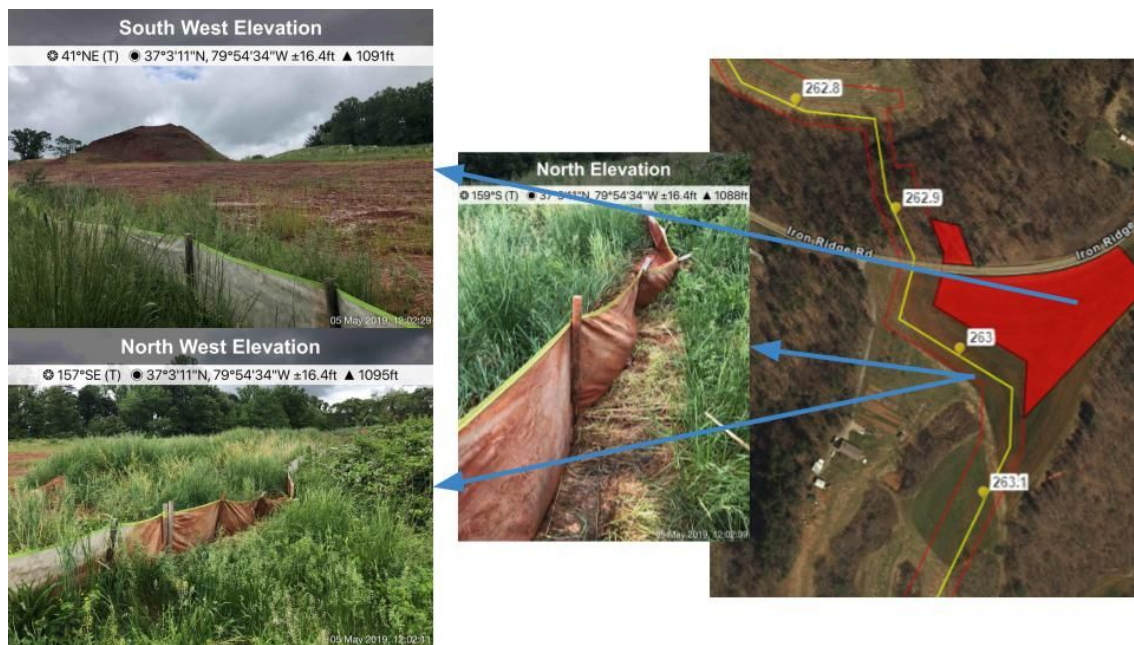
The area below in Franklin County has large areas that are bare of vegetation since last Fall 2018. Silt fence below the soil stockpile is in need of maintenance to prevent sediment from flowing off site.

Figure 6: Large stockpile, bare soil, and damaged silt fence on Angle property in Franklin county. (5/5/2019)

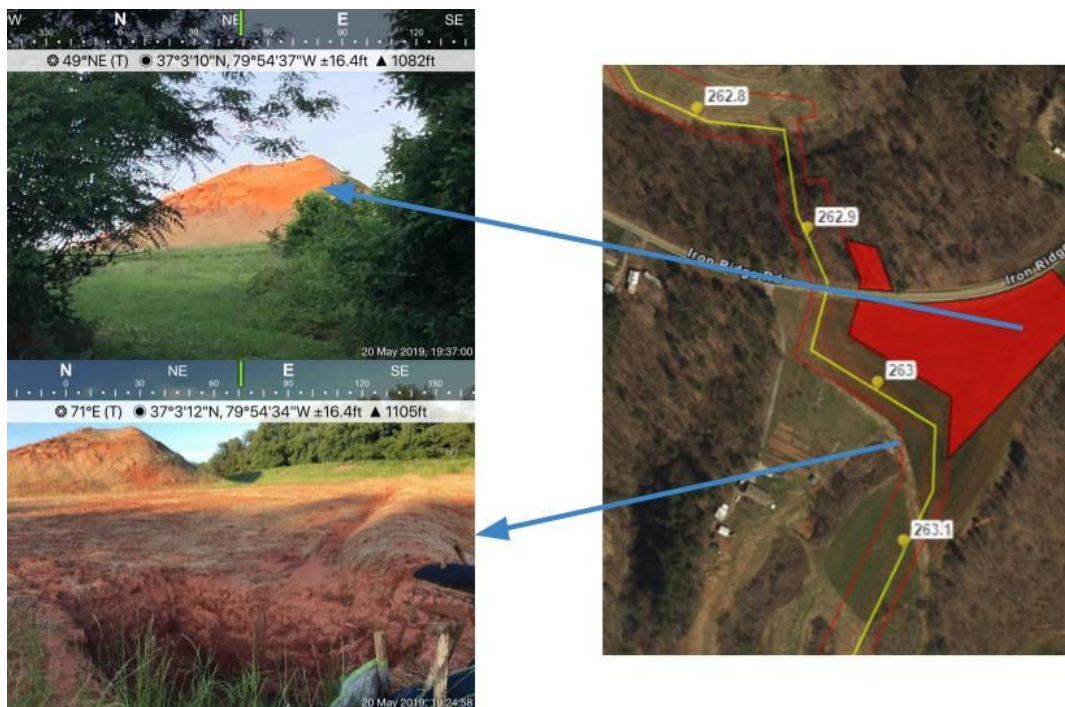
Figure 7: Bare soil on Angle property. (5/20/2019)

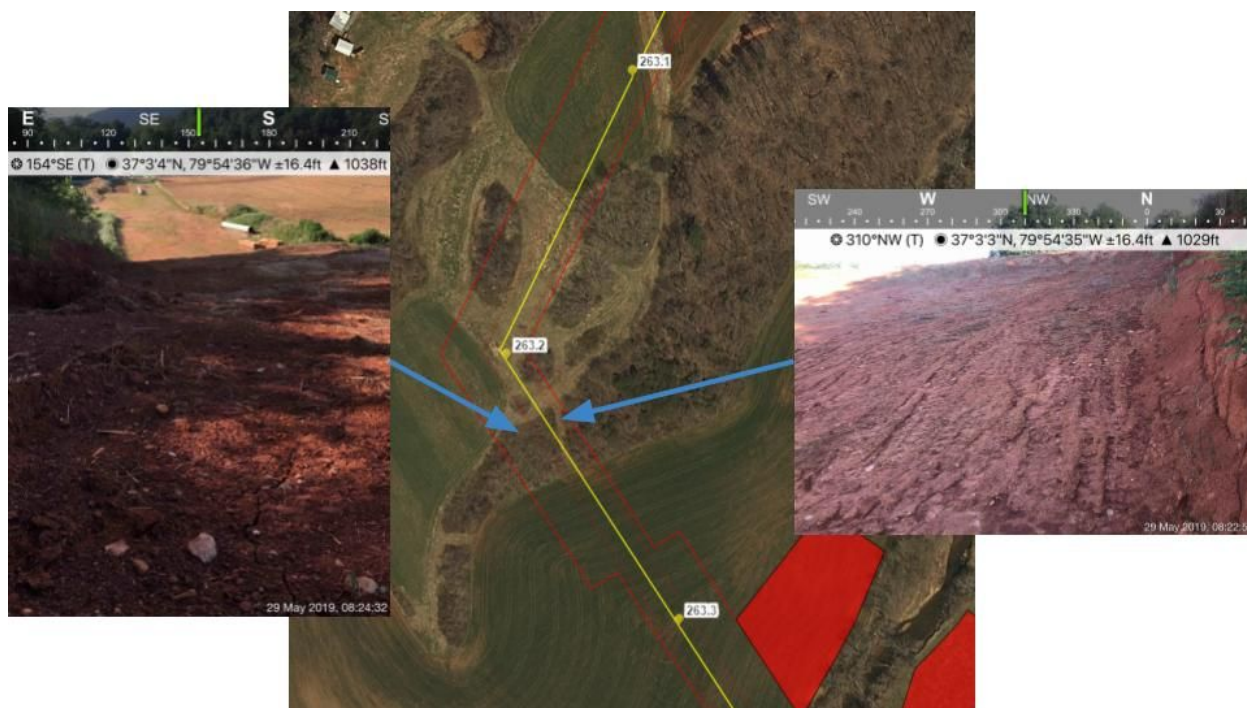
Figure 8: Locations on Angle farm showing bare soil. (5/29/2019)

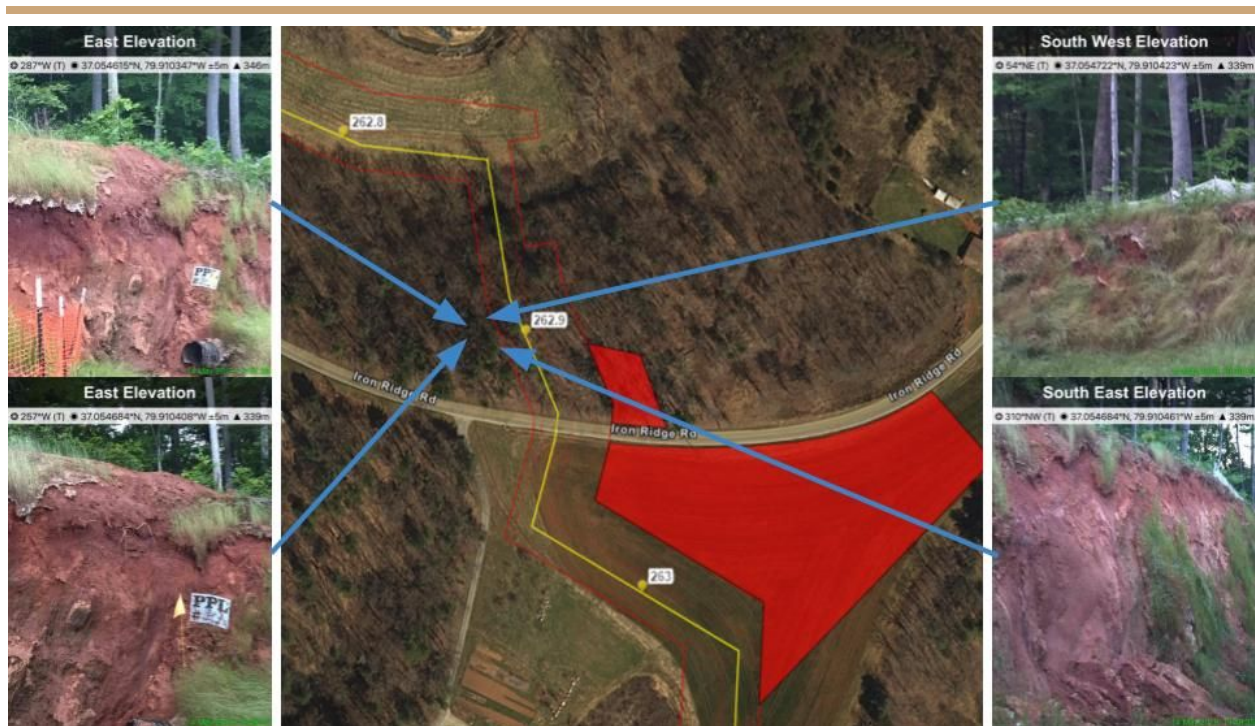
Figure 9: Buford property adjacent to Angle property on Iron Ridge Rd. (5/14/2019)

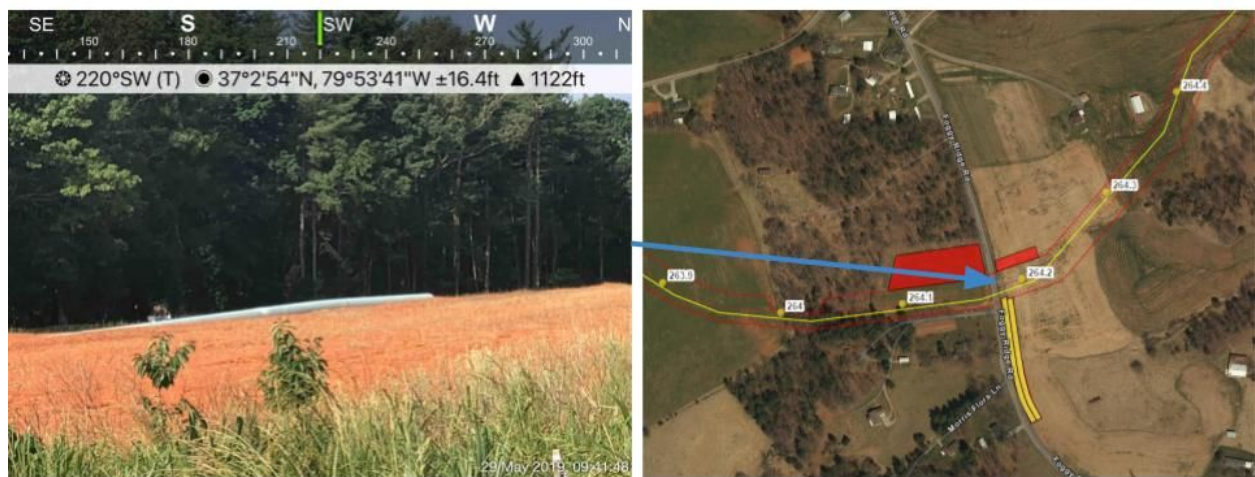
Figure 10: Bare soil near Foggy Ridge Road. (5/29/2019)

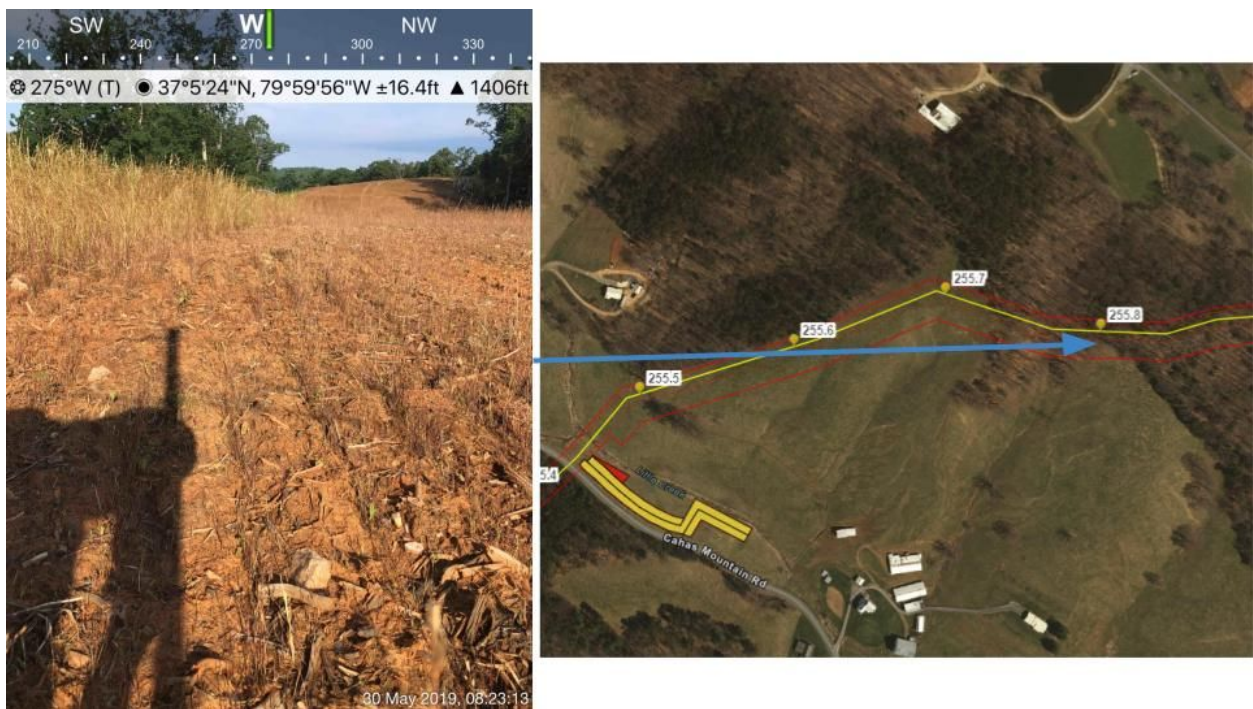
Figure 11: Bare soil near Cahas Mountain Road. (5/30/2019)

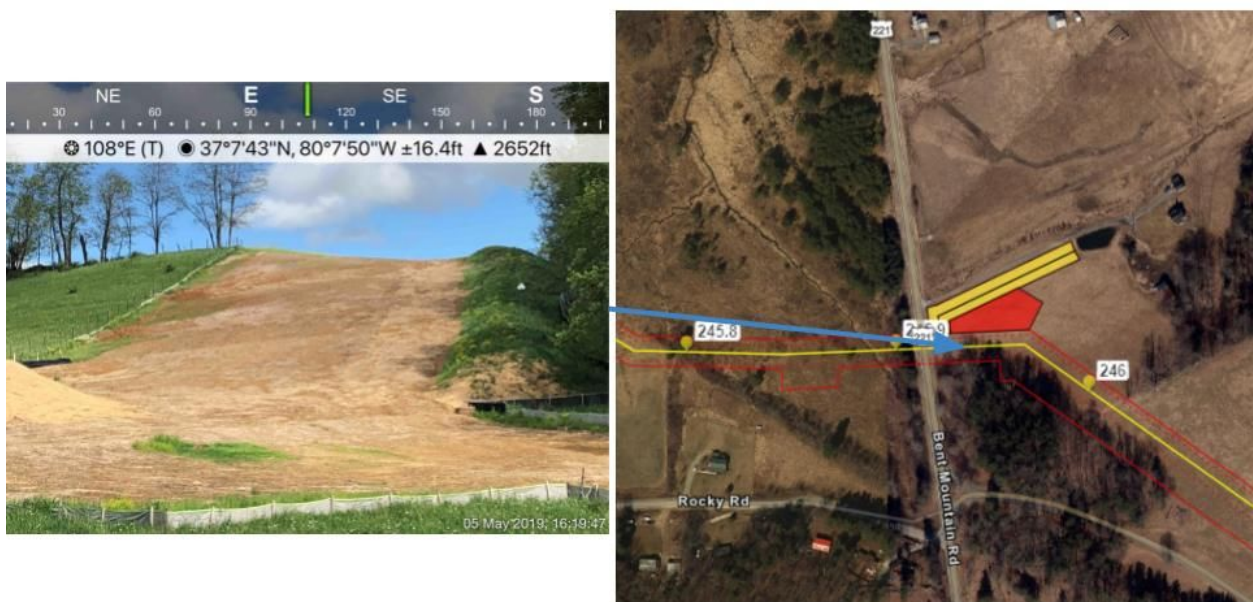
Figure 12: Slope adjacent to Route 221 North still not growing grass.

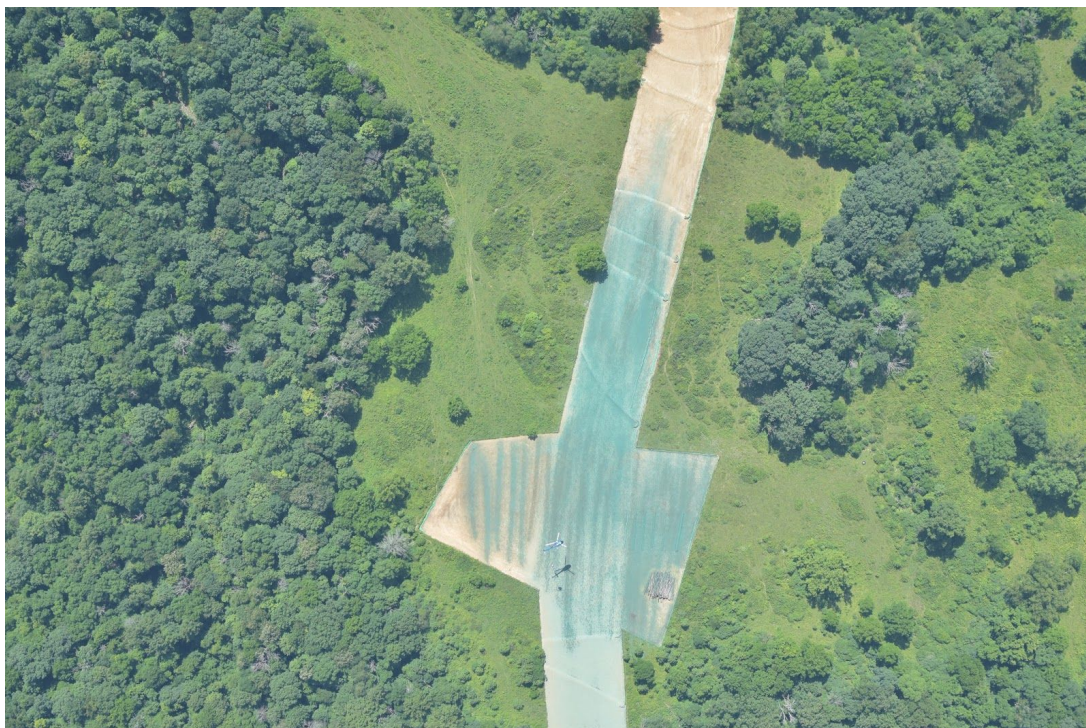
Temporary seeding by helicopter has not germinated in many areas. The soil has lain bare for months at a time and is hard packed due to exposure to the sun. The soil bed was not prepared for seeding per seeding requirements specified in the Virginia Erosion and Sediment Control Handbook. There are clay soils in Franklin County that are difficult to seed without adequate seedbed preparation.

The photo below shows an area that has remained bare for over six months.

Figure 13: Helicopter seeding the ROW with EarthGuard pellets June 24

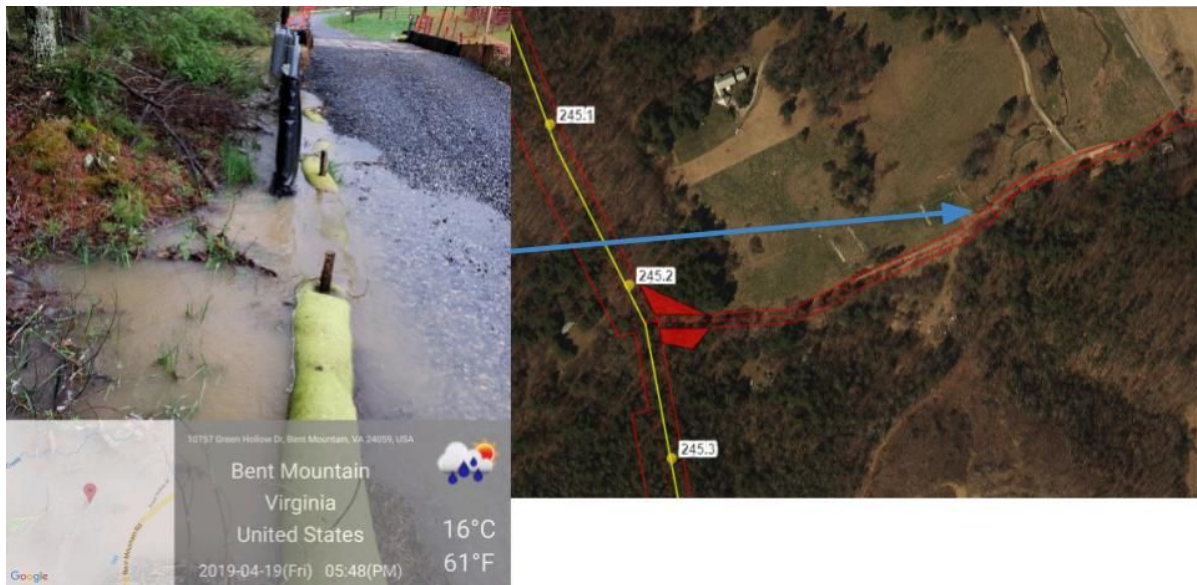
Bent Mountain's historic Green Hollow Drive is experiencing flooding on a regular basis during typical rainfall events. This is caused by a blocked culvert. Sediment flowing from the MVP constriction on sites at the Blue Ridge Parkway and the US 221 crossing carry sediment in the Mill Creek Watershed to this site. The sediment has accumulated at the culvert inlet — which is within the LOD of Green Hollow Drive as an access road — blocking flow and flooding areas upstream of culvert. The existing road is often underwater due to flooding. The timber mat bridge and silt fence are acting as a dam rather than controlling erosion or sedimentation on Green Hollow Drive. It is the responsibility of the contractor to remove debris and sediment clogging the culvert, which has not been done. MVP was made aware of flooding and sediment off the LOD at Green Hollow Drive in 2018.

Figure 14: Photo of flooding that occurs with most rain events along historic Green Hollow Drive in Roanoke County, near an MVP-constructed bridge.
