Mountain Valley Watch

December Report

2019

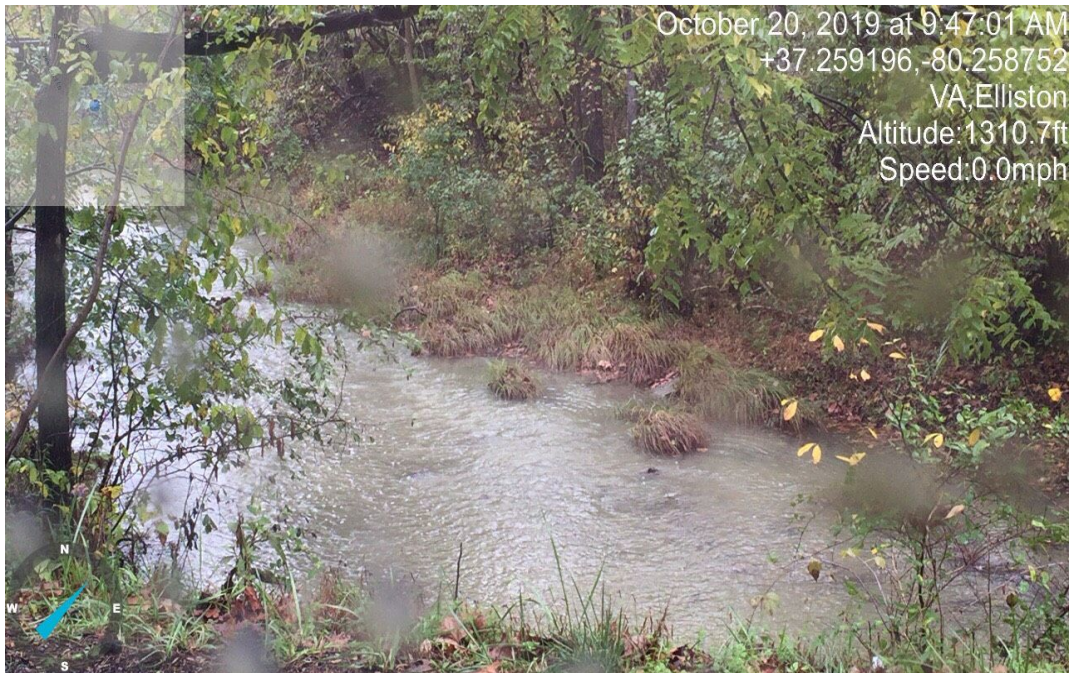
On October 20, 2019, Mountain Valley Watch volunteers reported severe turbidity at Bradshaw Creek in Montgomery County. Photos indicate the stream is clearer upstream from the MVP ROW and more turbid downstream.

Figure 1: Bradshaw Creek upstream of MVP ROW, October 20, 2019

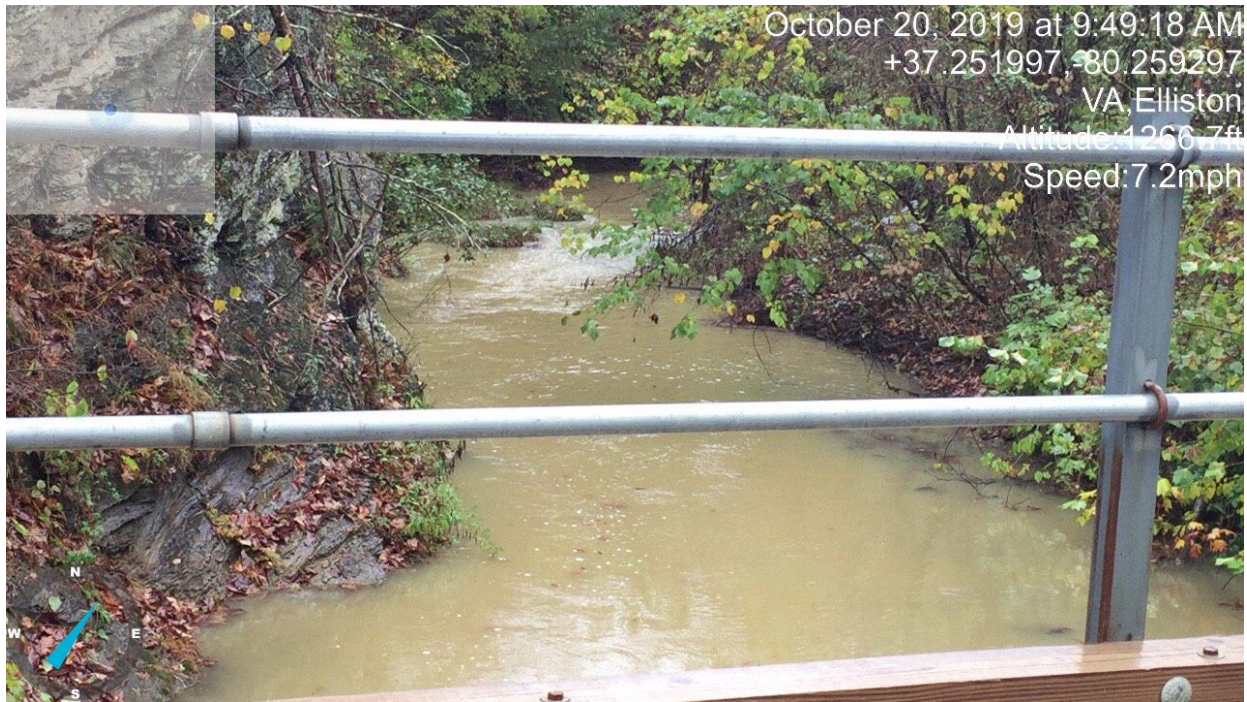
Figure 2: Bradshaw Creek at bridge downstream from MVP ROW, October 20, 2019.

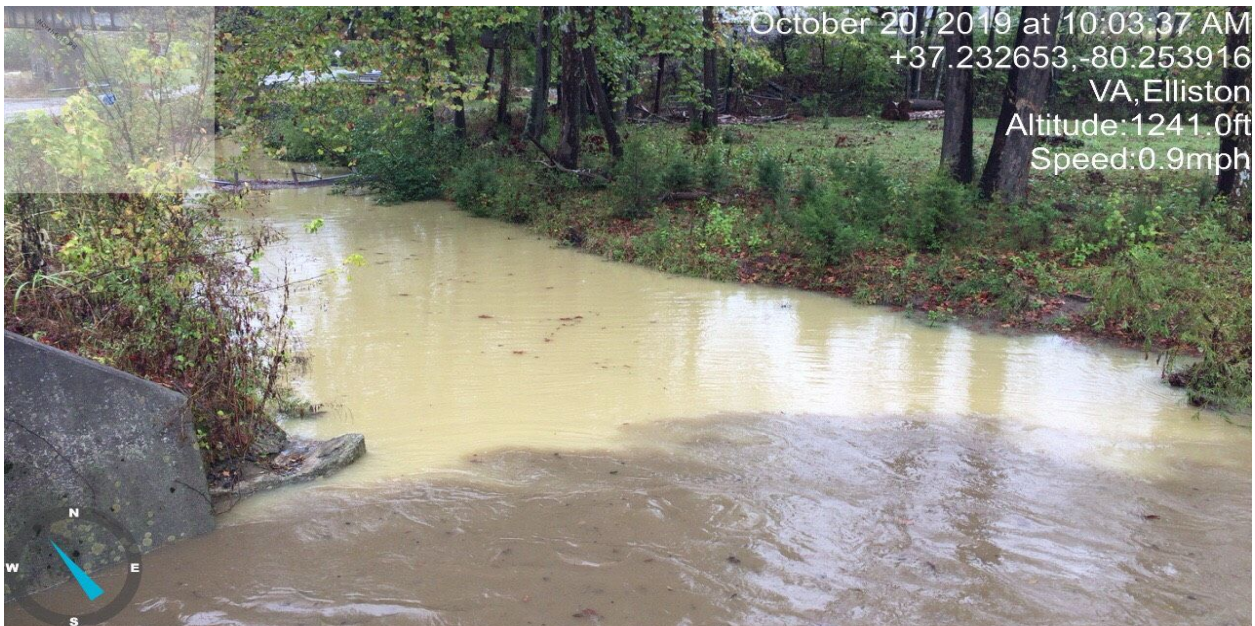
Figure 3: Sediment plume entering North Fork Roanoke River at confluence with Bradshaw Creek, October 20, 2019.

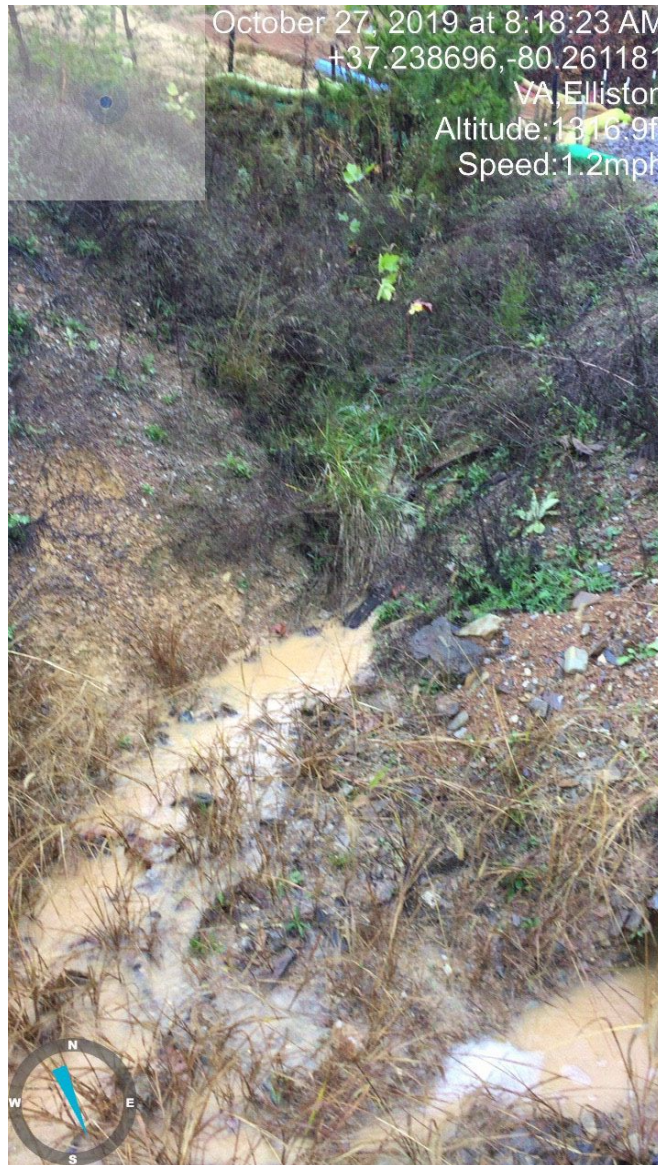
On October 27, 2019, *only one week later*, volunteers documented Bradshaw Creek polluted with sediment-laden runoff from the Mountain Valley Pipeline ROW. This is the second time sediment pollution occurred in one month. Sediment is flowing from graded areas into the North Fork Roanoke River, which is a habitat for the Roanoke Logperch, an endangered species named in the recently vacated Biological Opinion and Incidental Take Statement from the US Fish and Wildlife Service.

Figure 4: Sediment laden runoff flowing from MVP Right of Way.

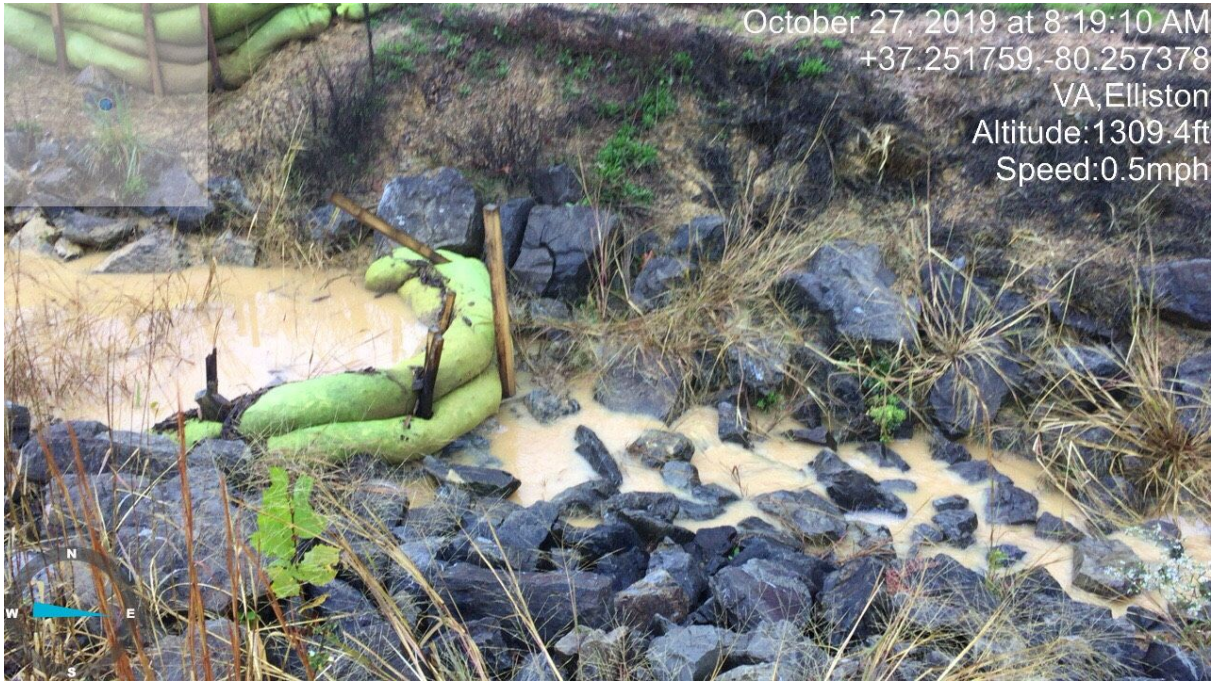
Figure 5: Silt socks overwhelmed by sediment laden runoff flowing off site

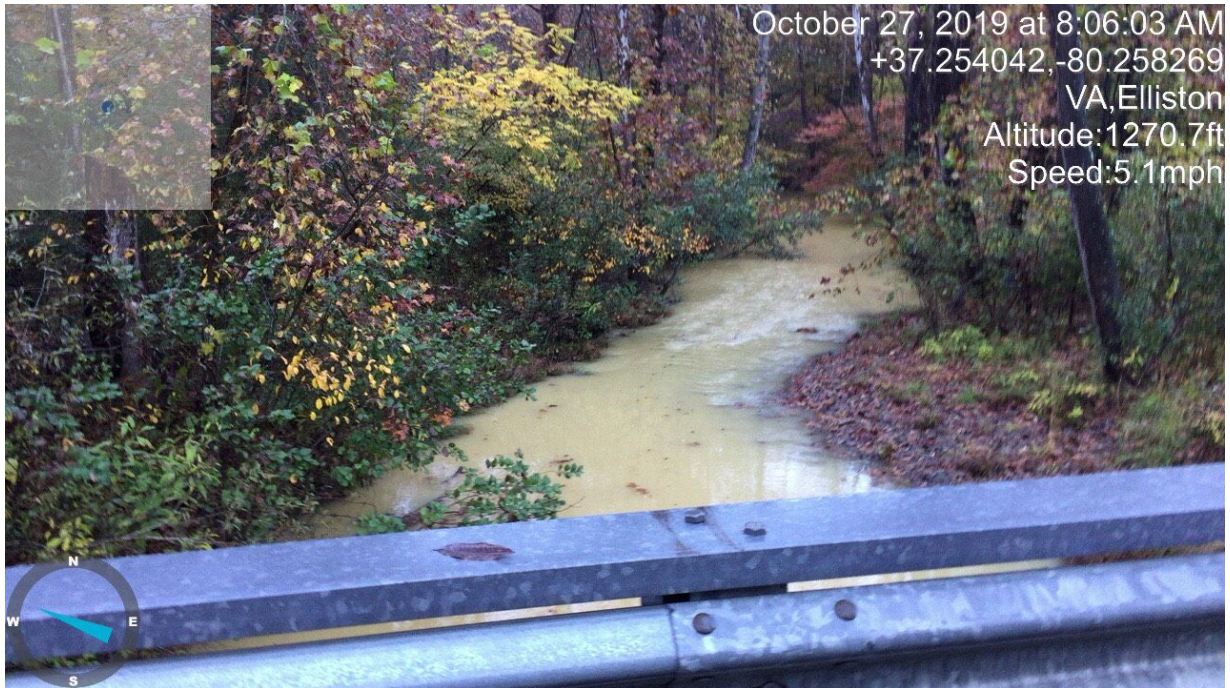
Figure 6: Bradshaw Creek flowing with sediment below MVP right-of-way

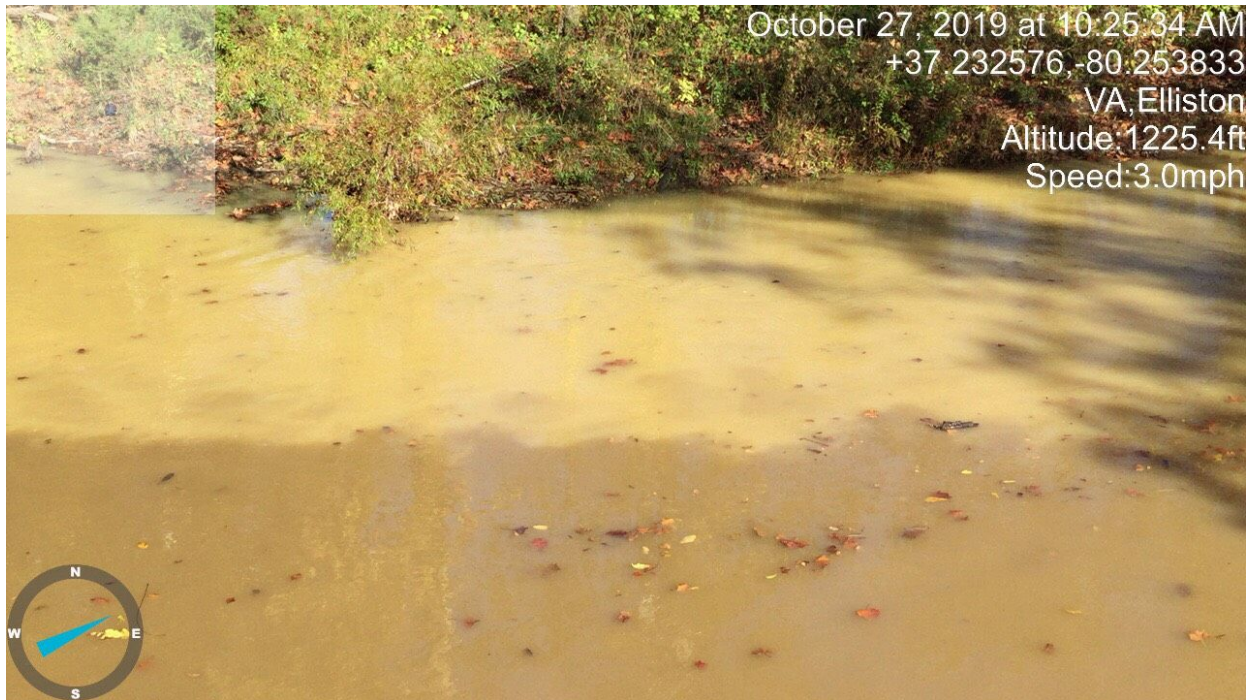
Figure 7: High levels of turbidity due to sediment in Bradshaw Creek below MVP ROW

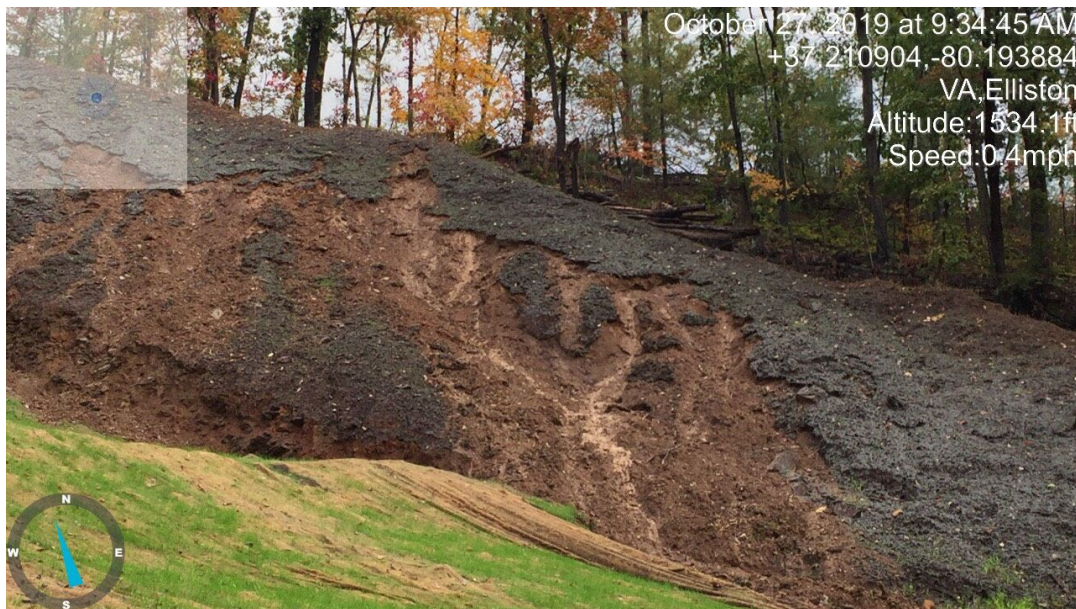
Ground photos taken near Elliston, VA show erosion gullies forming on unstabilized cut slopes disturbed by MVP construction.

Figure 8: Rill and gully erosion occurring on steep cut slopes

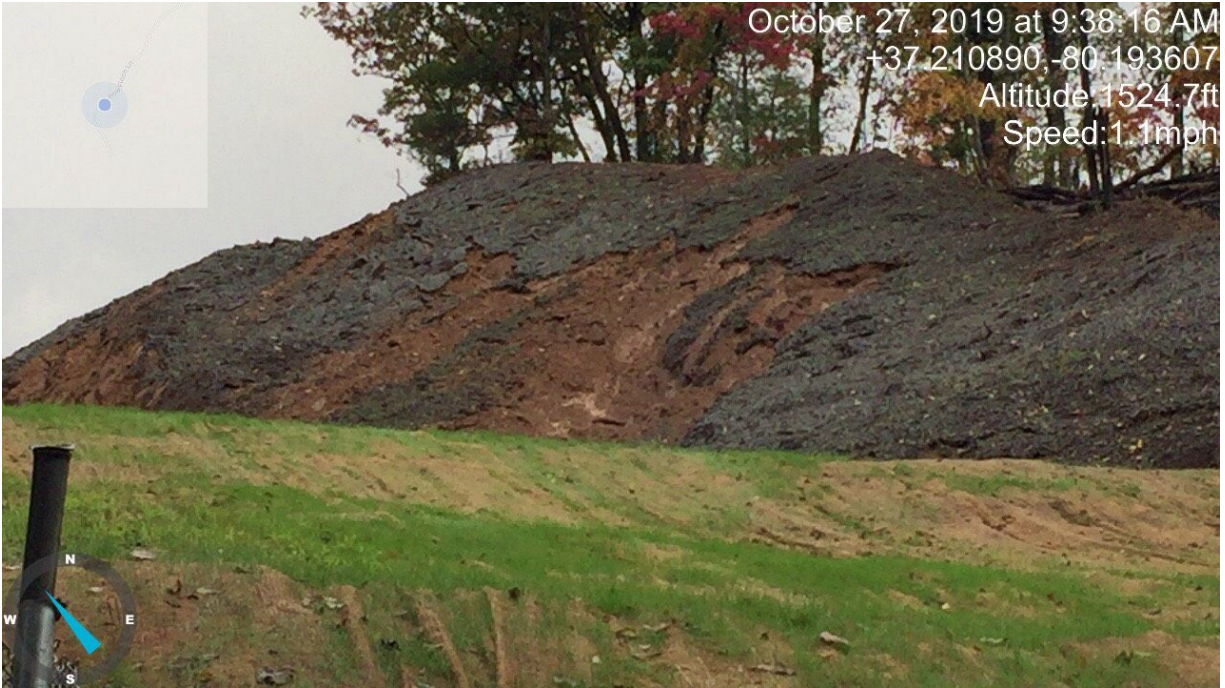
Figure 9: Bare cut slopes forming gullies due to rainfall impact erosion

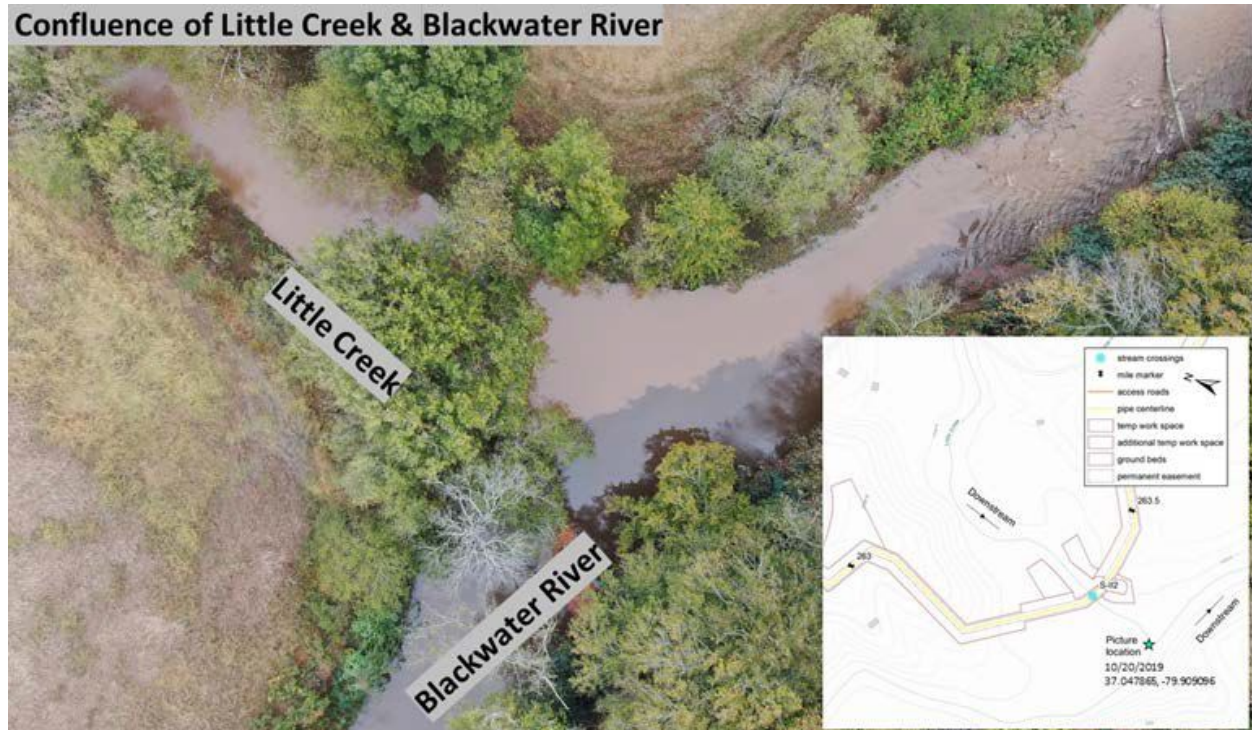
On October 20, 2019, volunteer drone pilots captured images of heavy sediment in Little Creek downstream of the MVP ROW converging with the clearer Blackwater River. Little Creek and the Blackwater River are considered “suitable habitat” for the Roanoke Logperch.

Figure 10: Aerial view of sediment plume at confluence of Little Creek and Blackwater River, October 20, 2019.

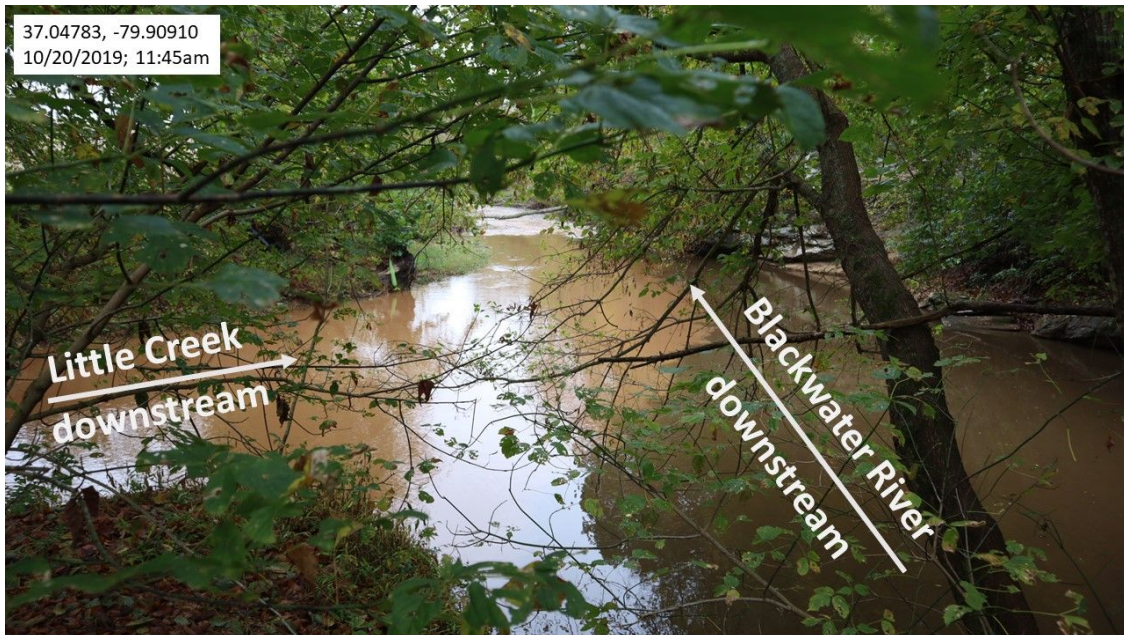
Figure 11: Ground view of sediment plume

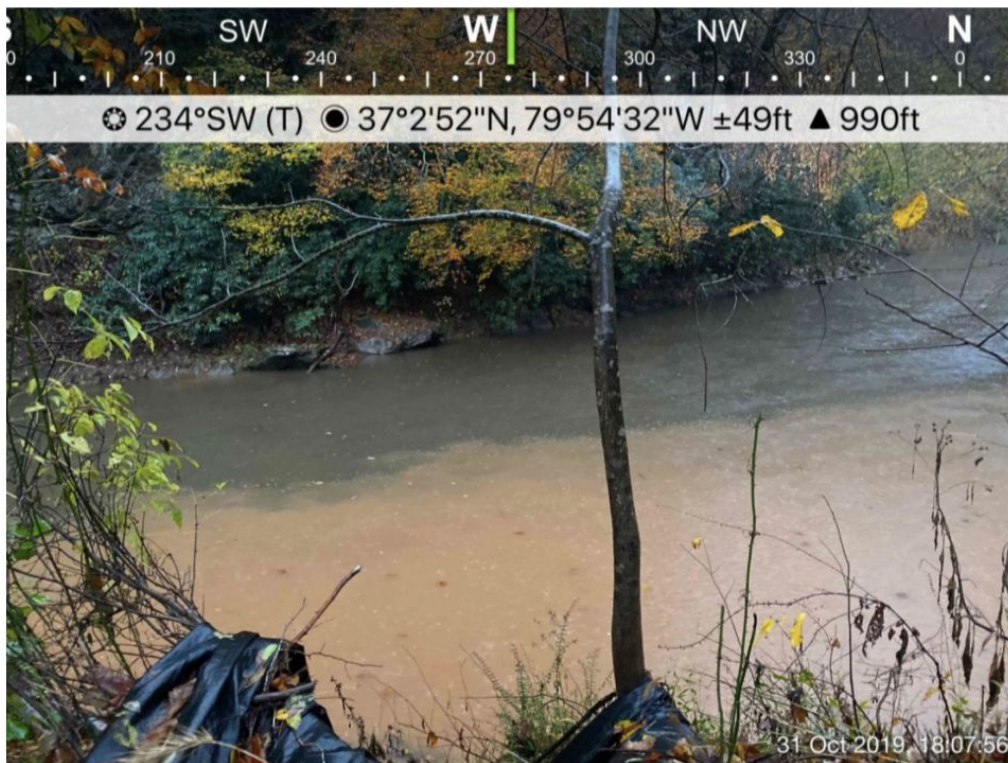
Figure 12: Sediment plume at the confluence of Little Creek and the Blackwater River was again observed October 31, 2019.

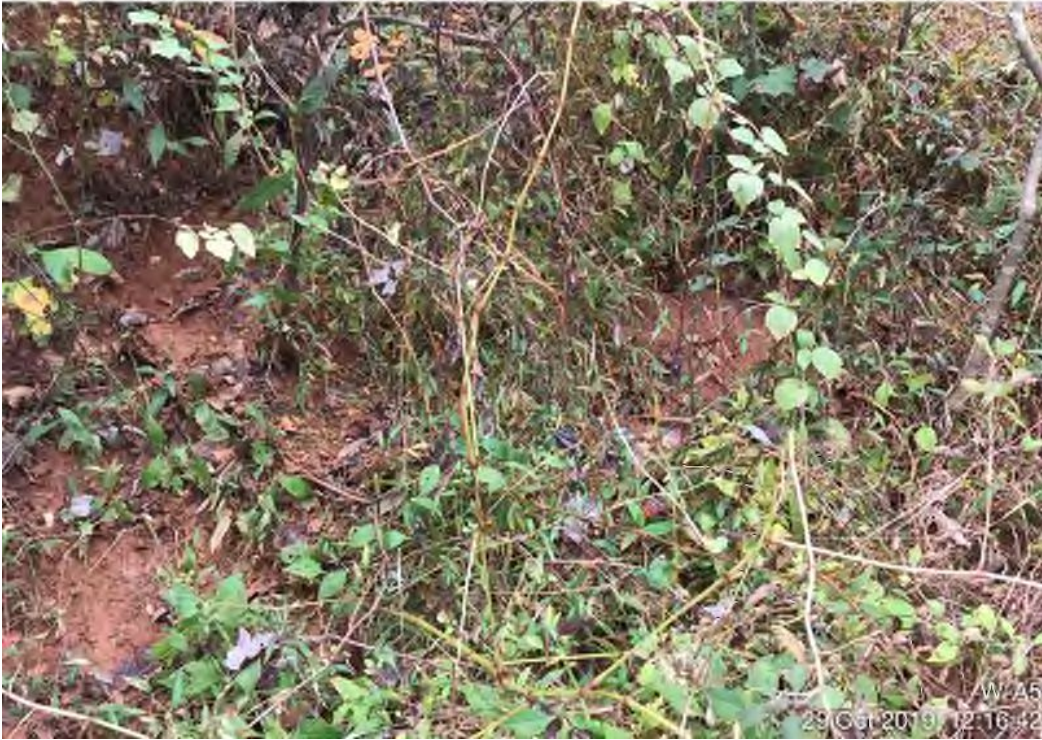
Wetland W-A5 Sediment off ROW impacting wetland W-A5 due to control failure and incorrect installation of upslope controls.

On page 7, the DEQ inspector photograph shows sediment flowing off ROW impacting wetland W-A5 due to erosion control device failures and incorrect installation of upslope controls. The MVP impacts numerous acres of wetlands along its route. The inaccessibility of the site makes it difficult for inspectors and volunteers to document and report upland wetland impacts. With the numerous wetlands crossed, and the reported wetland W-A5 shown in this report, it is difficult to determine the total impacts to wetlands along the route. How many other wetlands have been impacted by sediment flowing off the Right-of-way?

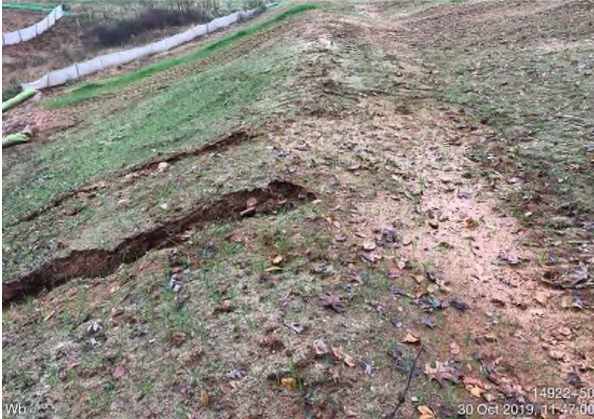
CFS end-treatment bypassed. Maintenance needed. Waterbar lower than CFS outlet.

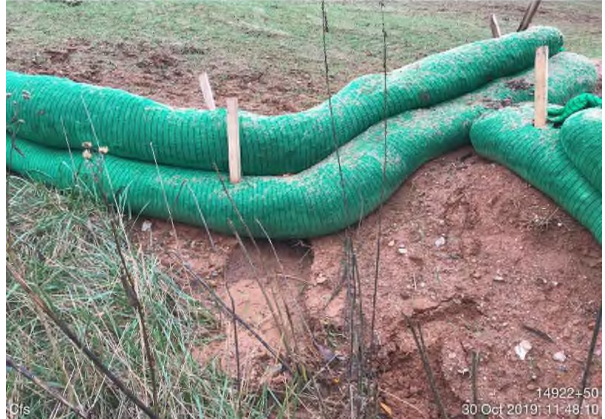
CFS end-treatment bypassed. Maintenance needed. Waterbar lower than CFS outlet.

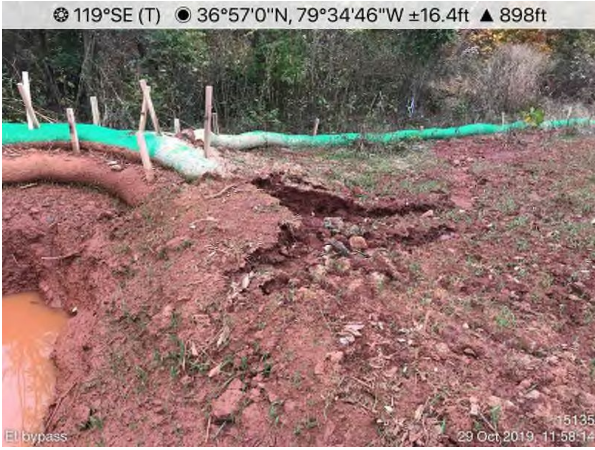
STA 15135+00 CFS end-treatment bypassed. Waterbar lower than CFS outlet.

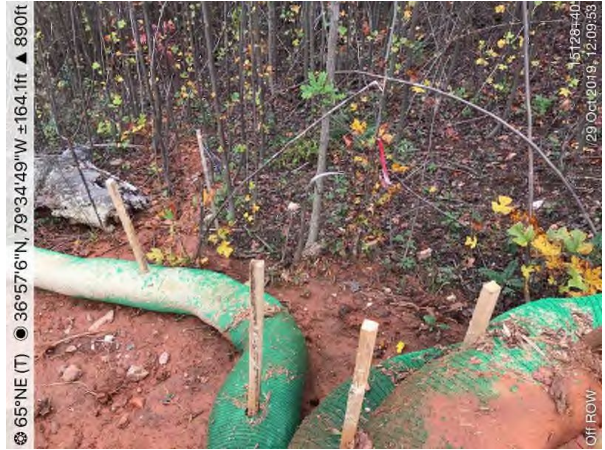
STA 15128+40 Sediment off ROW due to upslope control failure and incorrect installation of waterbar end treatments.

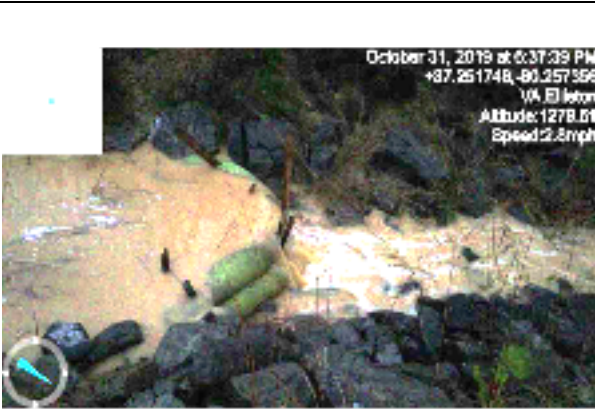
Filter socks overwhelmed by runoff. Drainage area too large for filter socks.

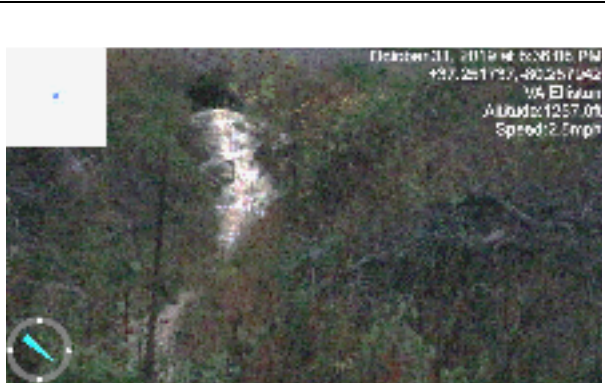
Sediment laden runoff flowing offsite.

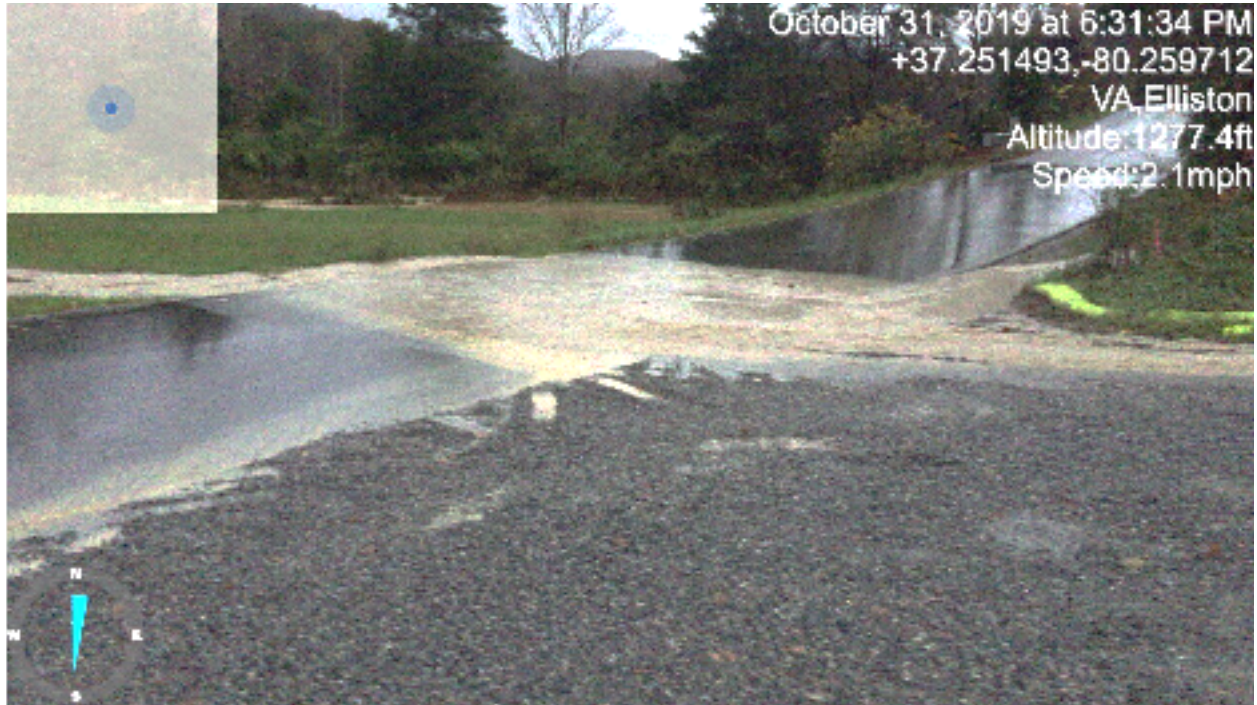
October 31, 2019: Sediment-laden water leaving MVP's right-of-way at Bradshaw Road.

Figure 13: Sediment-laden water leaving MVP's ROW, crossing Bradshaw Road, and entering Bradshaw Creek.

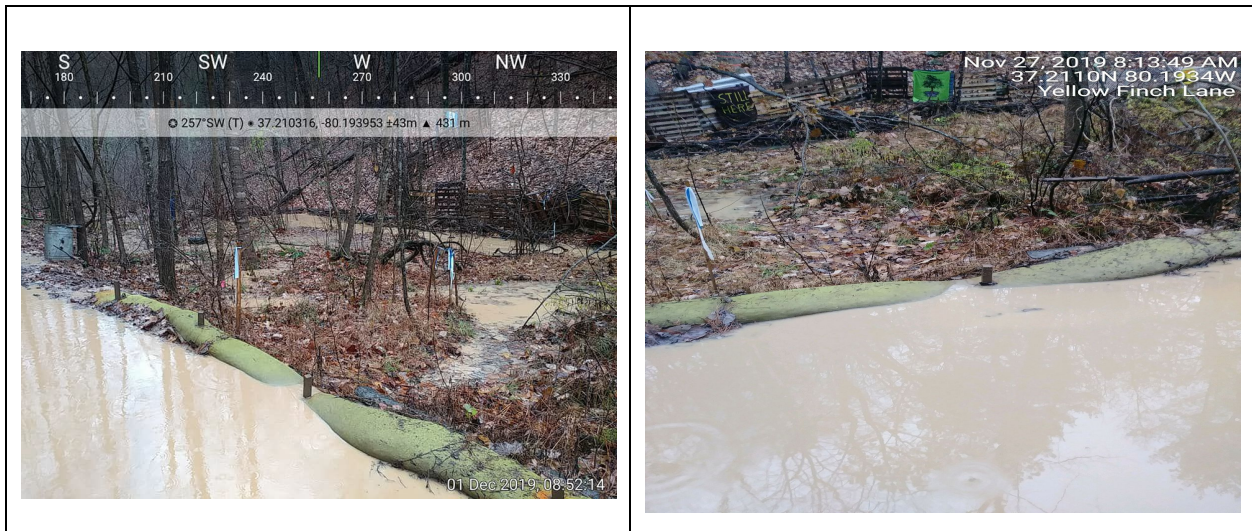
December 1, 2019: The unnamed tributary (background) running adjacent to Yellow Finch Lane (foreground) feeds into the Roanoke River, which is Roanoke logperch habitat. Filter sock overwhelmed by runoff. Sediment flowing offsite.
