Cave Report

May 2020

This report is intended to demonstrate the consequences of blasting in known karst areas in Giles County, Virginia and Monroe County, West Virginia. Mountain Valley Pipeline did not fully implement the measures in its Karst Mitigation Plan or General Blasting Plan outlined in Section 4 of the Final Environmental Impact Statement (FEIS). There are serious issues that require further evaluation to avoid potential pipeline rupture and contamination of groundwater. This is a highly unstable area in karst terrain.

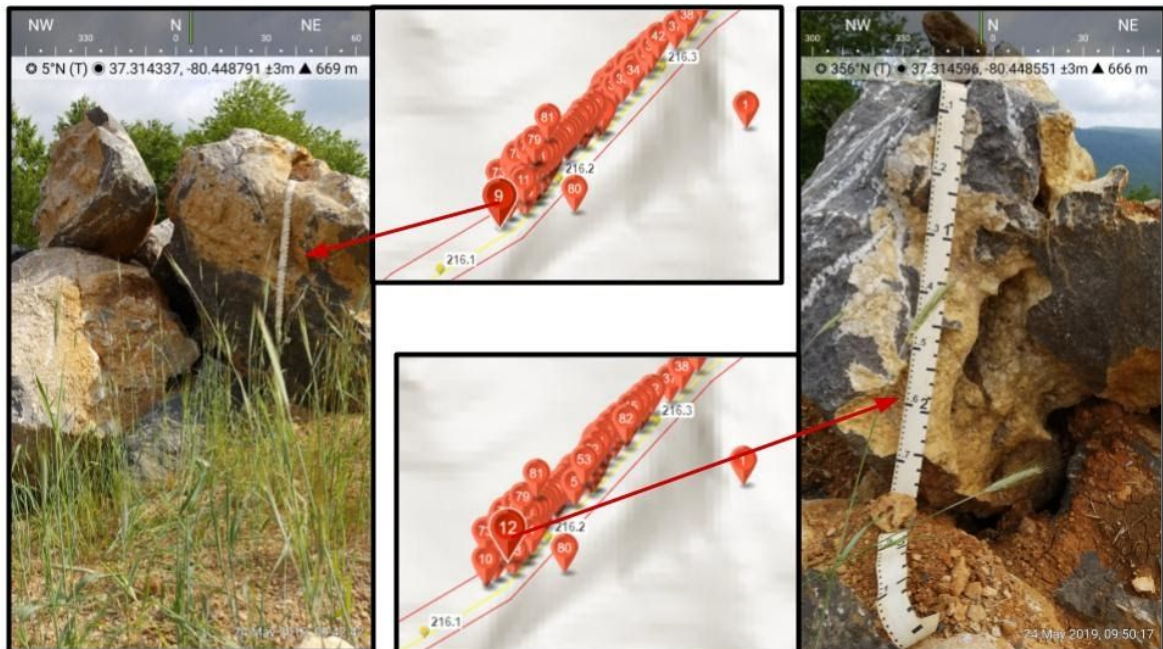
Figure 1A: Carbonate rock and karst features exposed along MVP ROW.

Exposed rock shown in the photos is limestone of high calcium carbonate content, and effervesces violently with contact to 10% Hydrochloric acid.

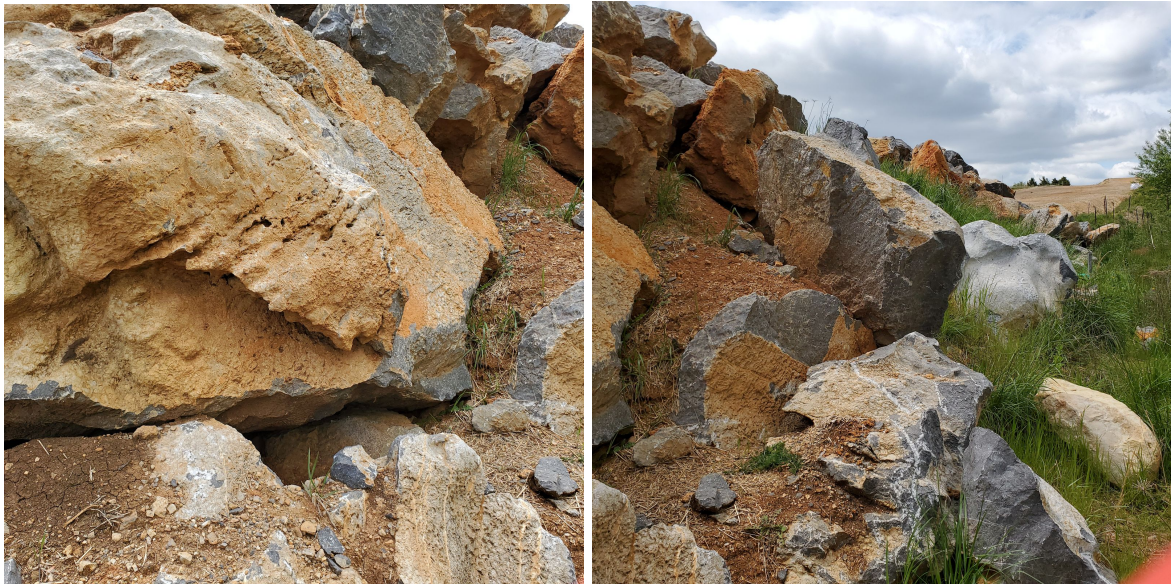
Figure 1B: Blasted limestone strewn along MVP ROW.

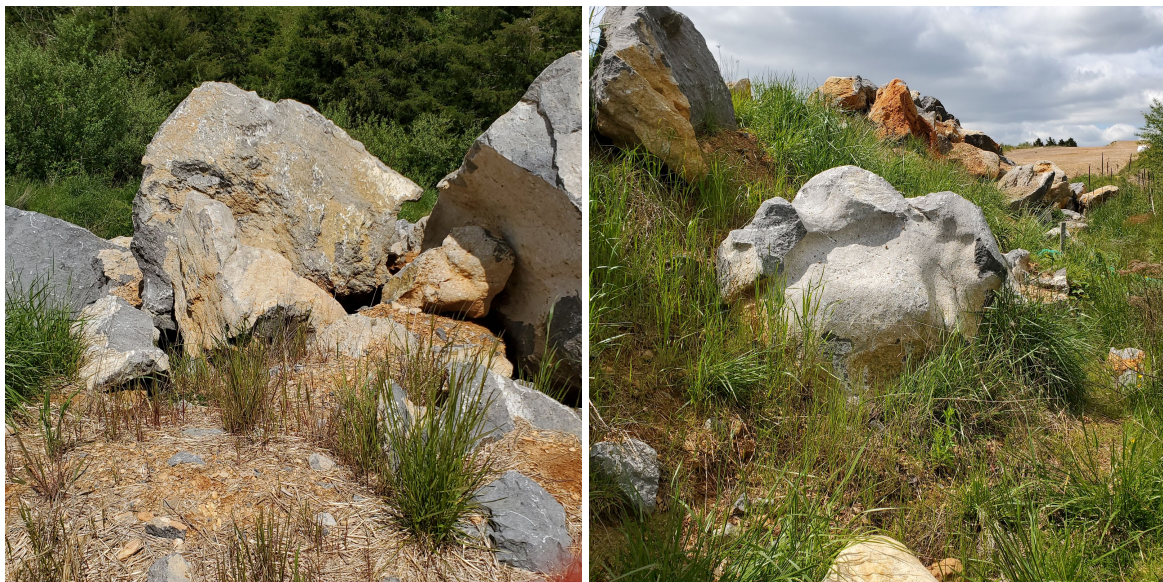
Figure 1C: More blasted limestone strewn along MVP ROW.

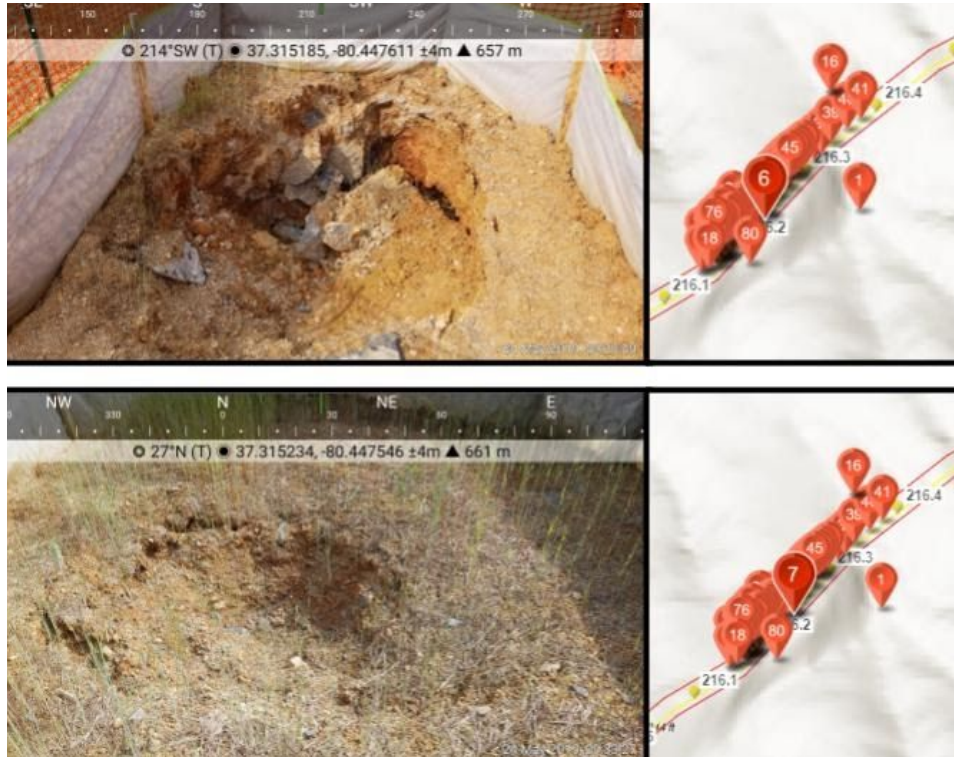
Figure 5: May 2019, two images showing areas of subsidence encircled in silt fence.

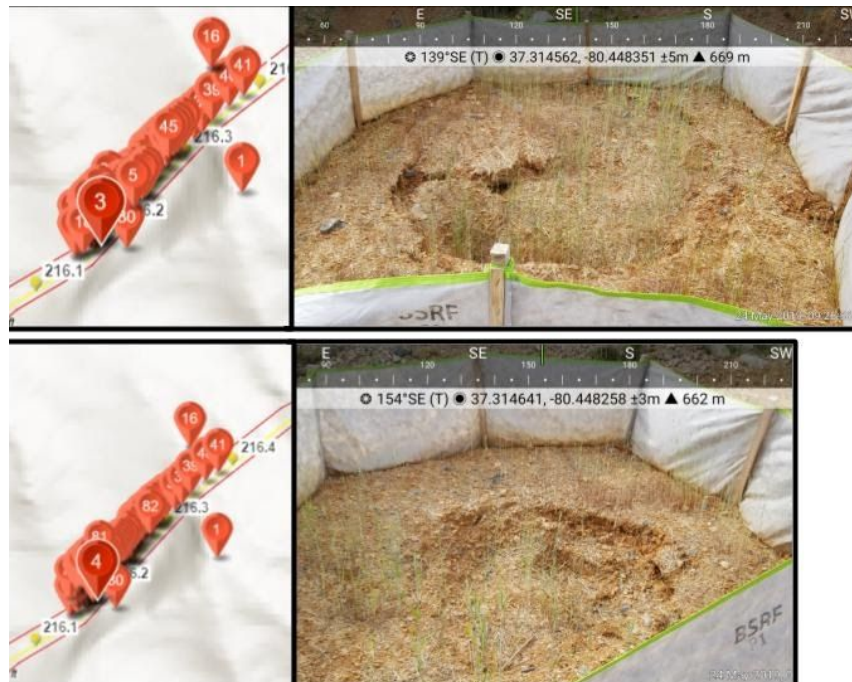
Figure 6: May 2019, two images showing more areas of subsidence enclosed in silt fence.

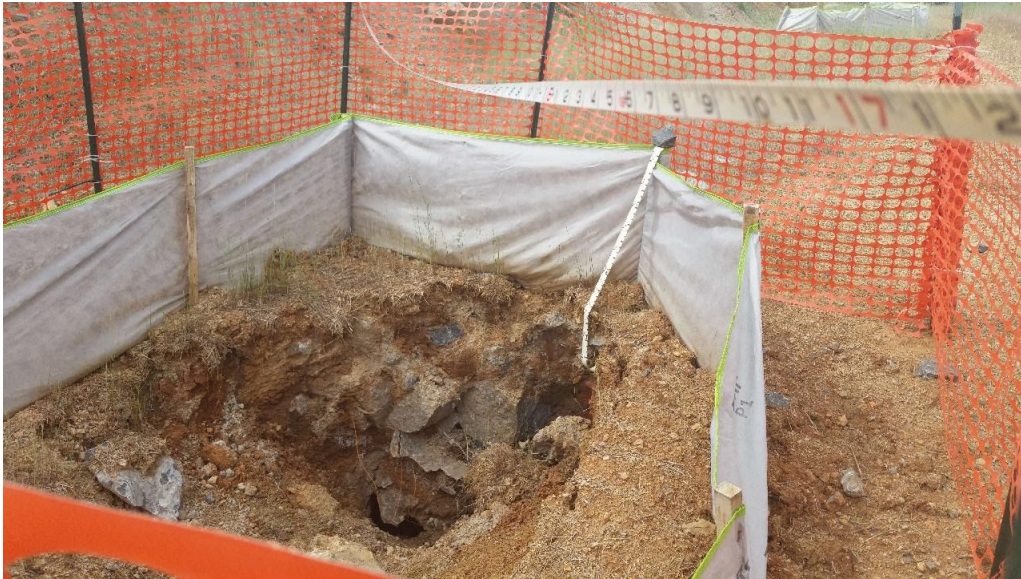
In June 2019, a month after images in Figures 5 and 6 were taken, photos taken during site visit show expanding areas of subsidence in Figures 7 and 8. These photos were taken at the same locations as Figures 5 and 6.

Figure 7: June 2019 site visit shows expanding subsidence in the same location shown in Figure 5.

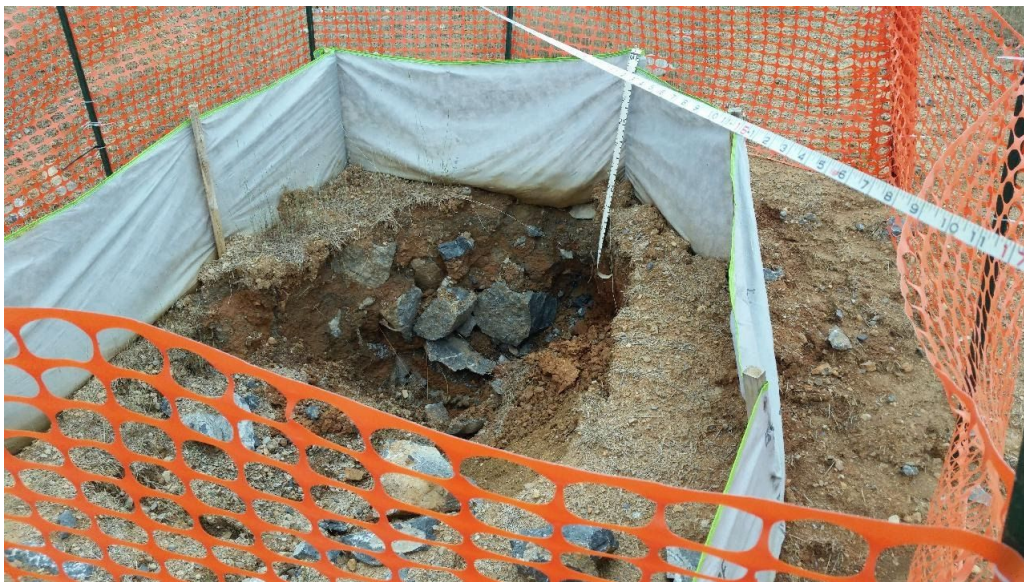
Figure 8: June 2019 site visit shows expanding subsidence.

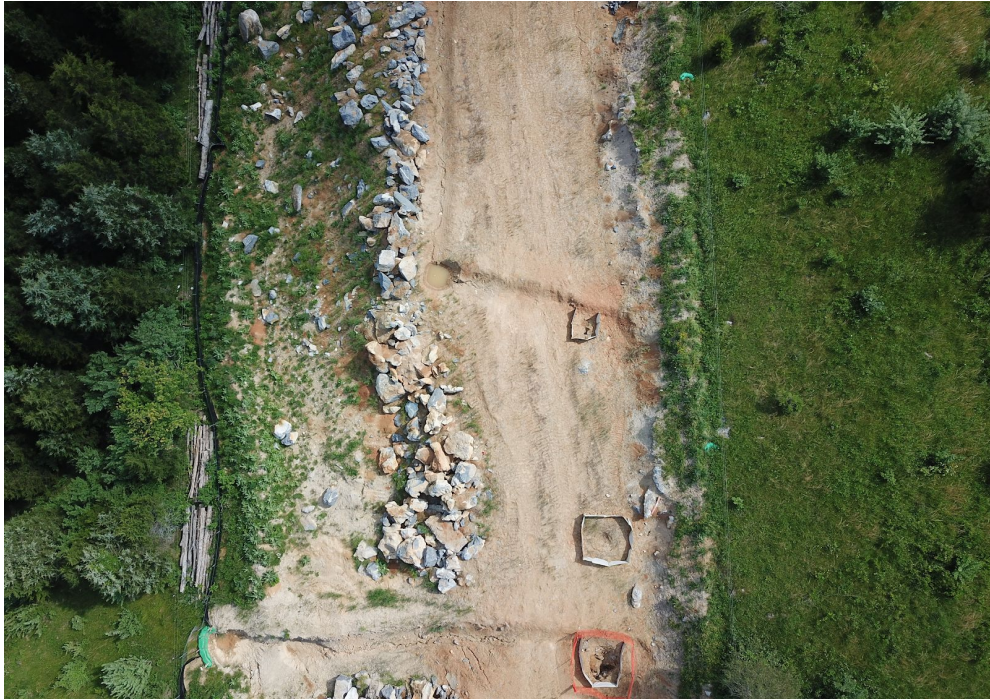
Figure 9: Drone flight photos showing locations of three sinkholes encircled with safety fence in June 2019.

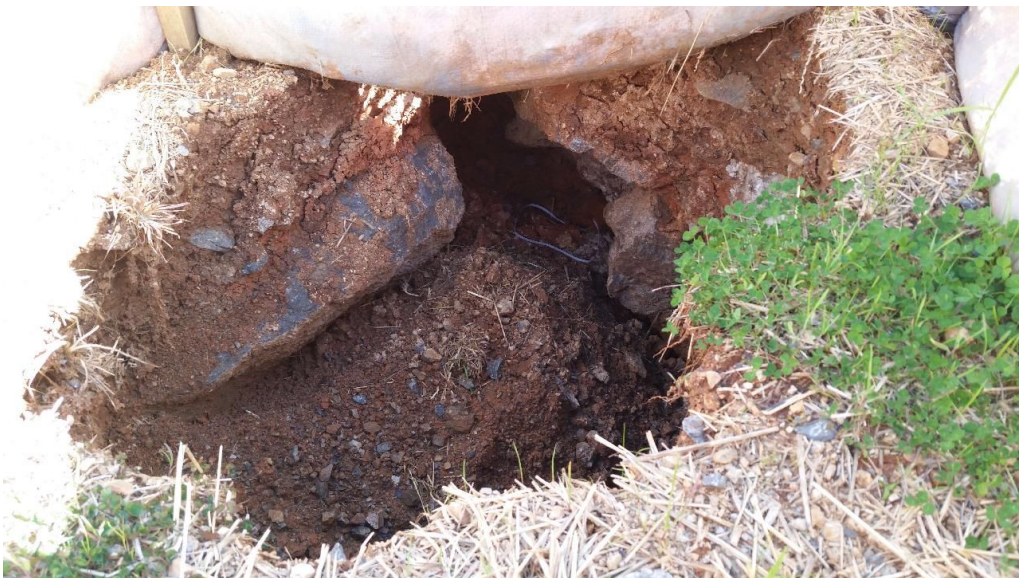
Figure 10: New sinkhole forming in right-of-way on top of the pipeline in the same area shown in Figure 9. Photo taken April 2020.

This is a poor assessment of the existing geology of this area. Since 2019, four additional sinkholes have appeared in a line with the previously identified sinkholes. The depth of the sinkholes have increased. A new sinkhole shown in Figure 10 to 14 is not measurable by conventional measuring devices due to the depths. This is a known karst area. The ridgeline is like swiss cheese with numerous subterranean cavities. There is extensive evidence of karst features in this area which jeopardizes the structural integrity of the MVP.

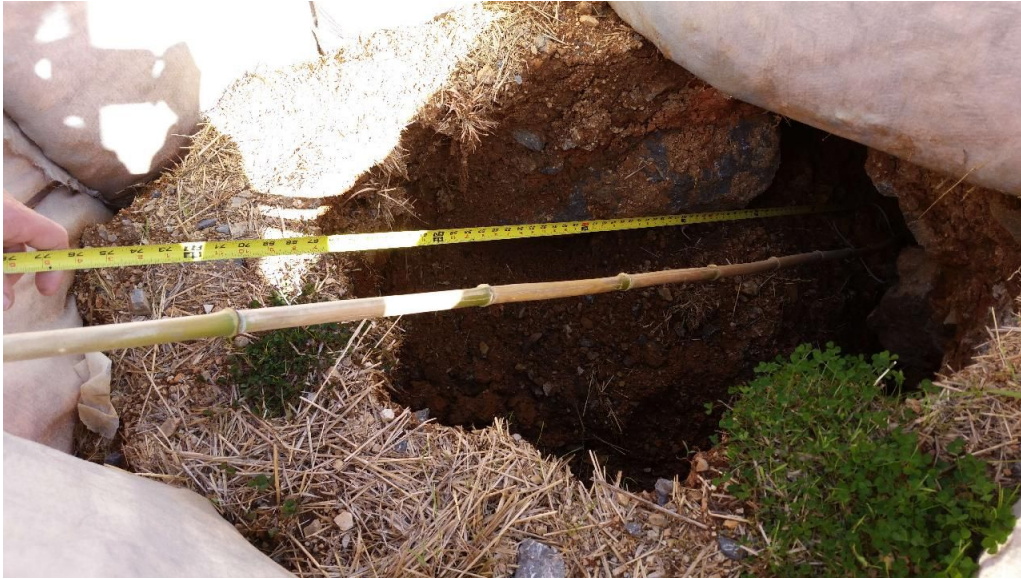
Figure 11: Measurements show the depth of the sinkhole is over 6 feet.

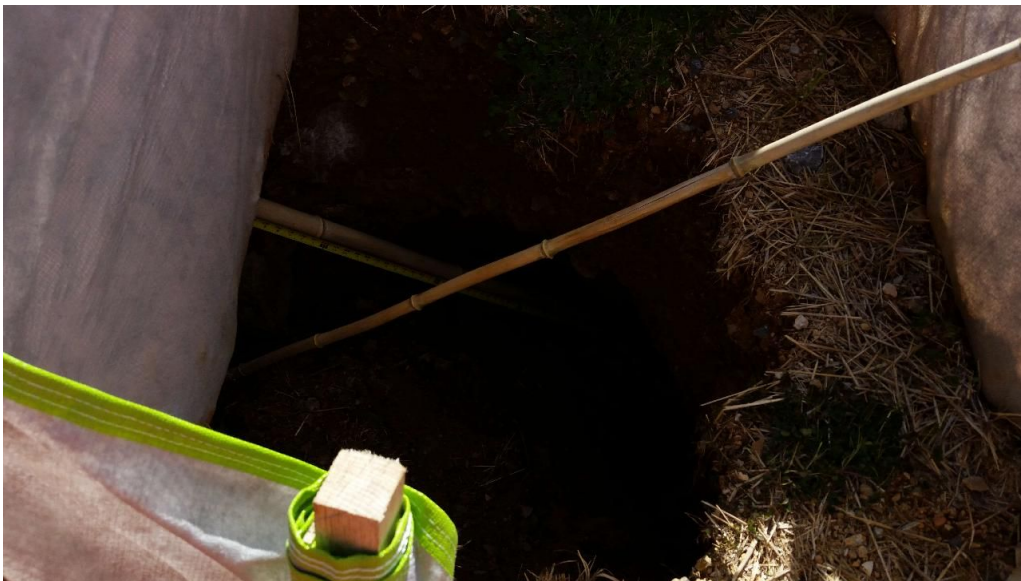
Figure 12: Bottom of the new sinkhole is not visible from the surface.

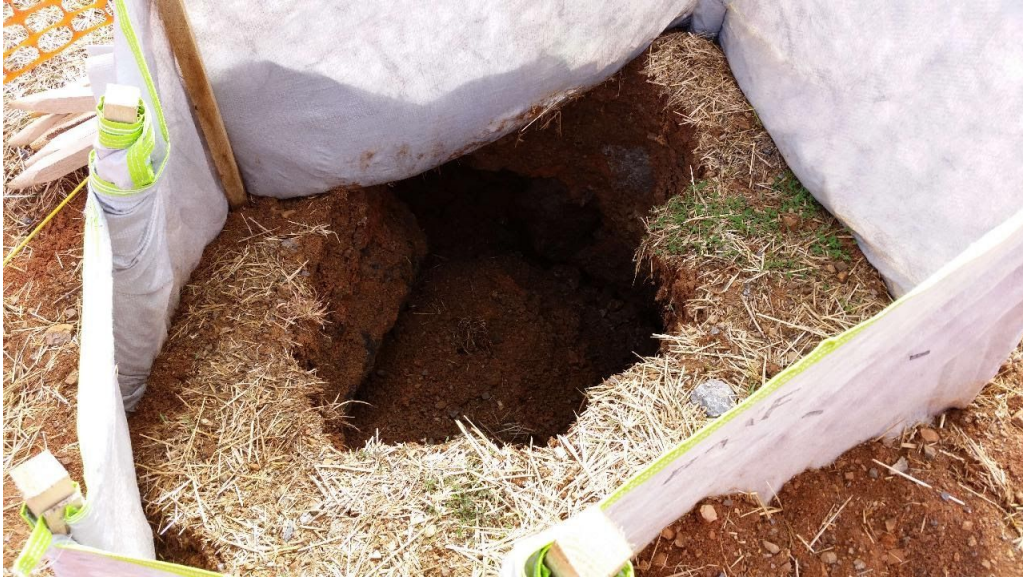
Figure 13: Photo of sinkhole enclosed by silt fence and safety fence.

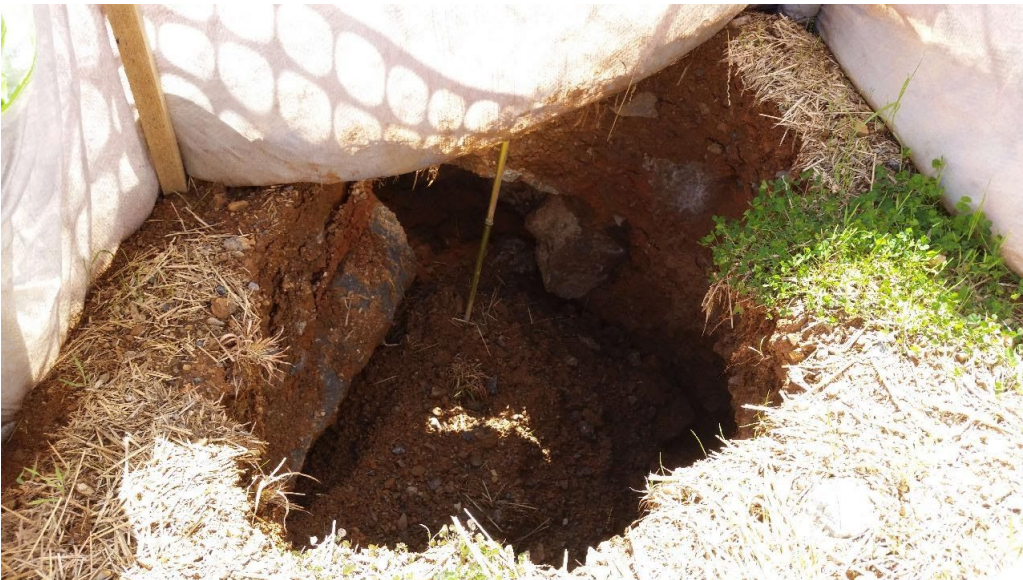
Figure 14: Sinkhole extends into subsurface voids.

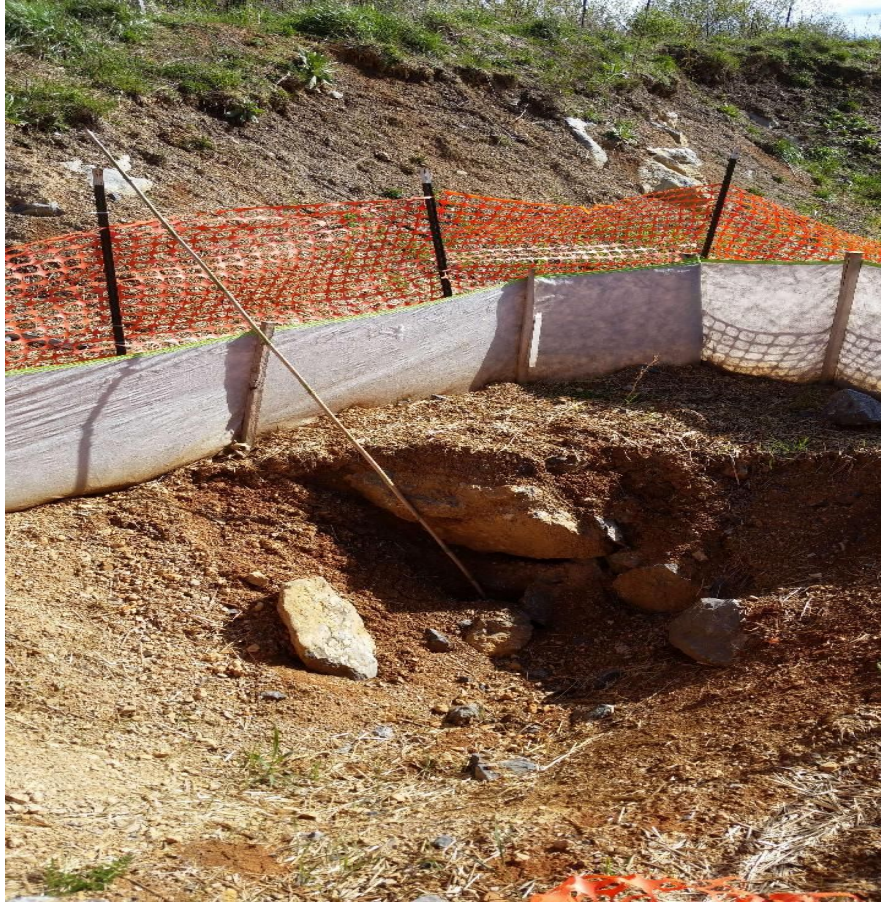
Figure 15: Photo shows sinkhole is continuing to expand.

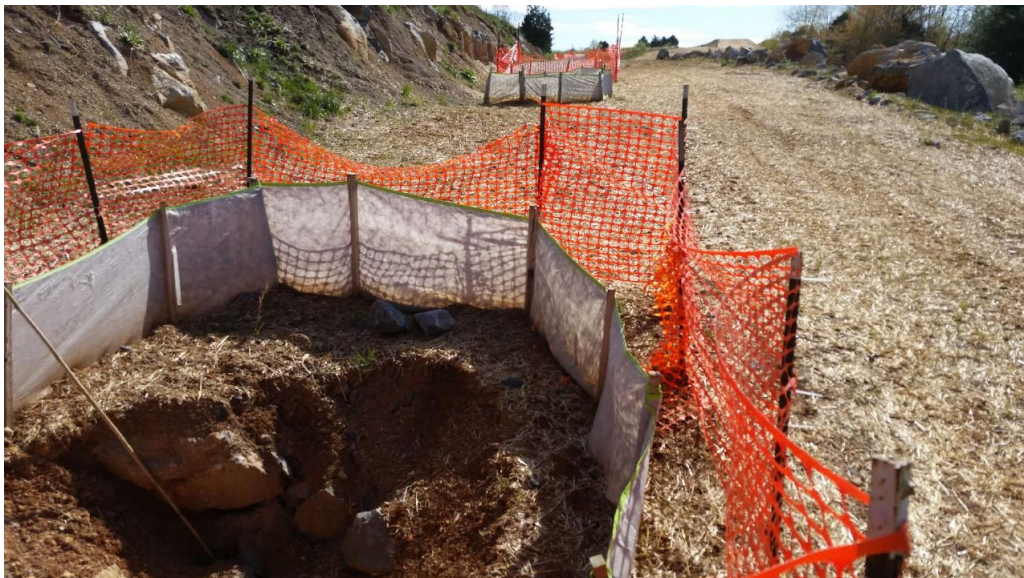
Figure 16: This photo shows locations of four sinkholes within right-of-way. These sinkholes are located adjacent to or over top of the pipeline.

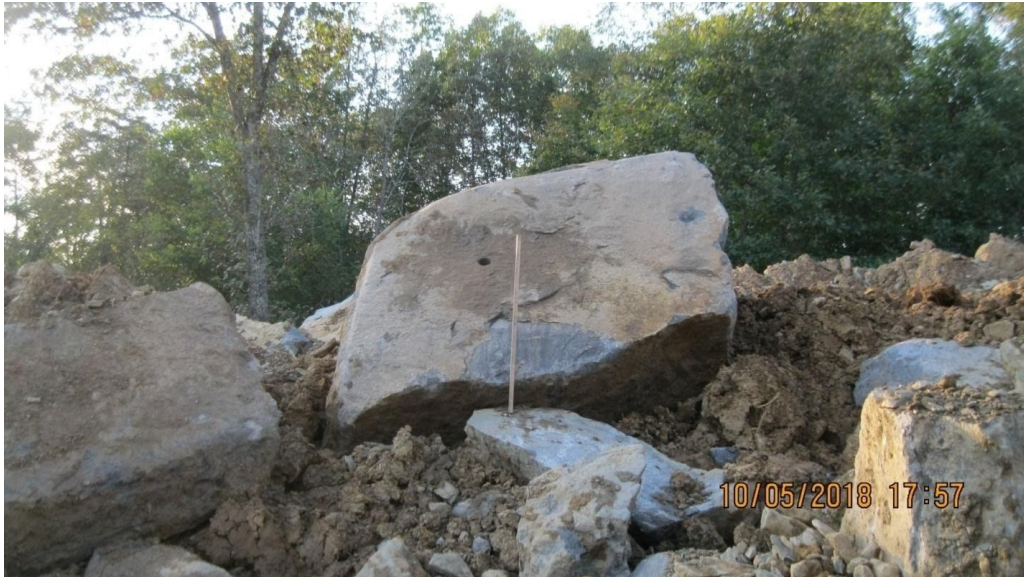
Figure 17: Large carbonate boulder blasted from trench.

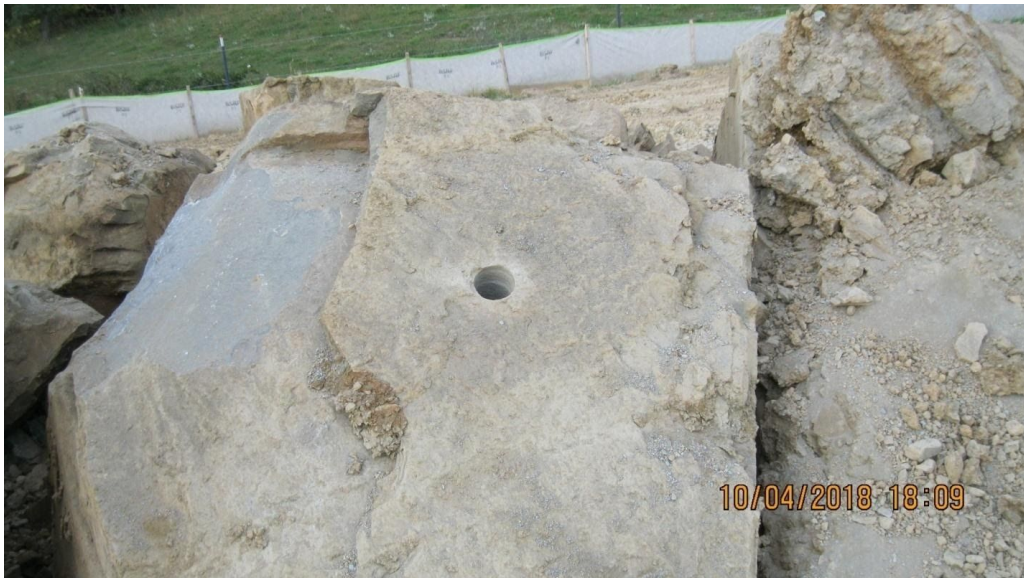
Figure 18: Limestone slab with drill hole showing.

Procedures outlined in the General Blasting Plan were not followed as demonstrated by drilling of blast holes exceeding eight feet in depth. Heavy charges were used to remove rock and overburden in the pipeline right-of-way. Ten to twenty feet of overburden and rock were removed from the ridge top. Blasted rock from the roof of underground

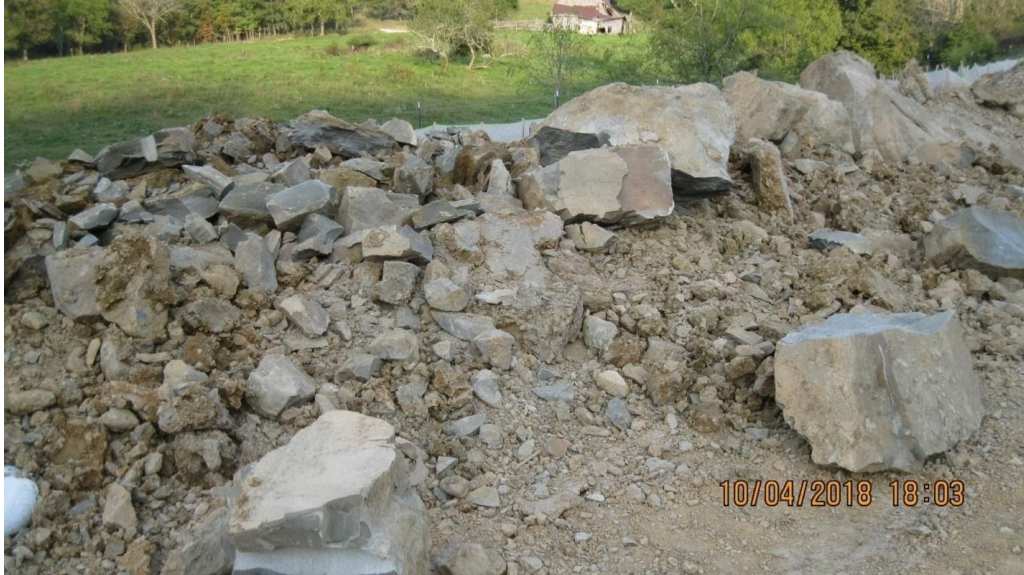
Figure 19: Limestone boulders and rock strewn along right-of-way.

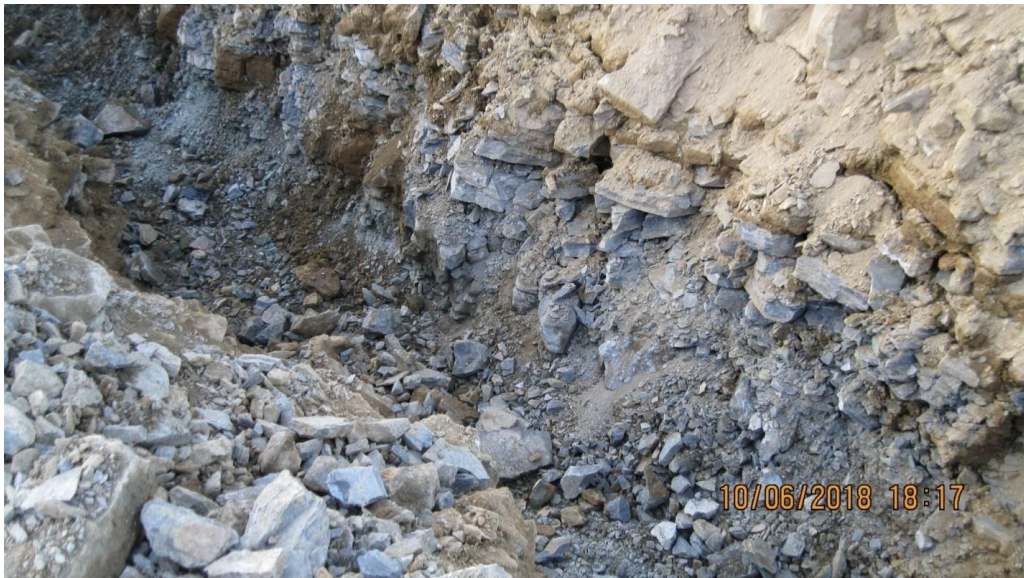
Figure 20: Layers of limestone shown in blasted trench.
