From: Mountain Valley Watch (MVW)
Kirk A Bowers, PE

To: Virginia Department of Environmental Quality
1111 East Main St., Suite 1400
Richmond, VA 23219

SUBJ: Mountain Valley Pipeline aerial photo review

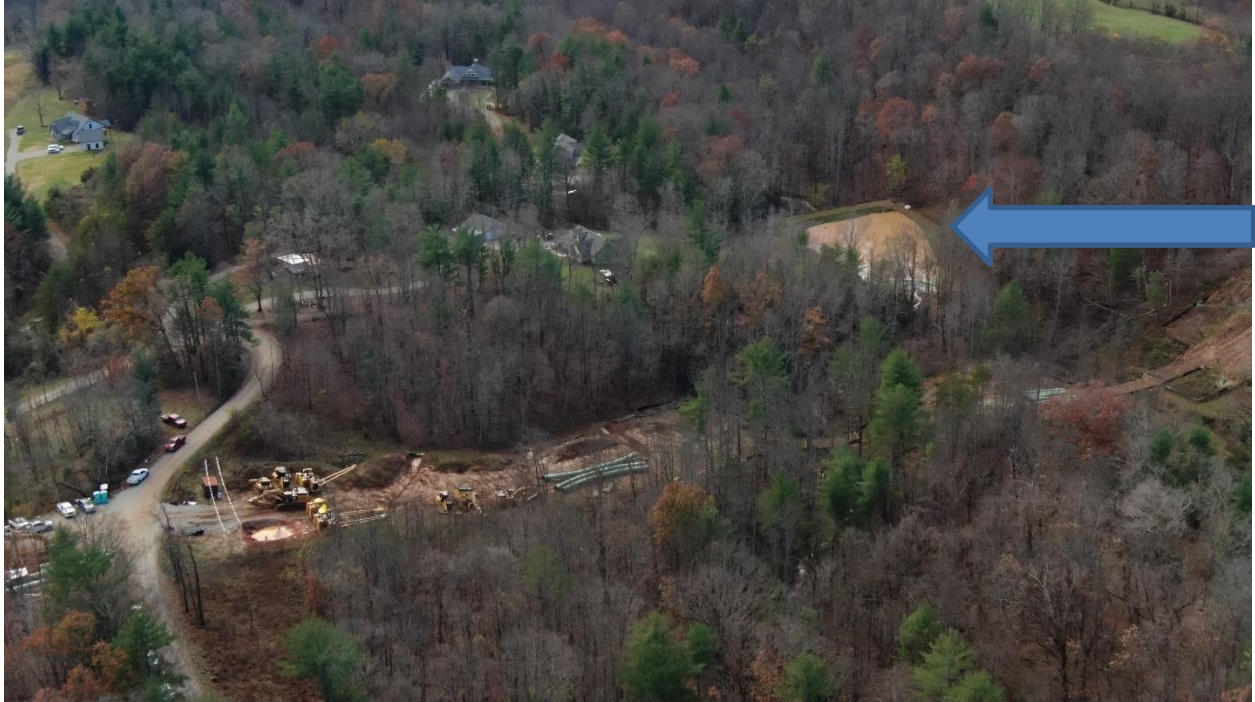
November 13, 2020 Franklin County, Pond below ROW full of sediment.

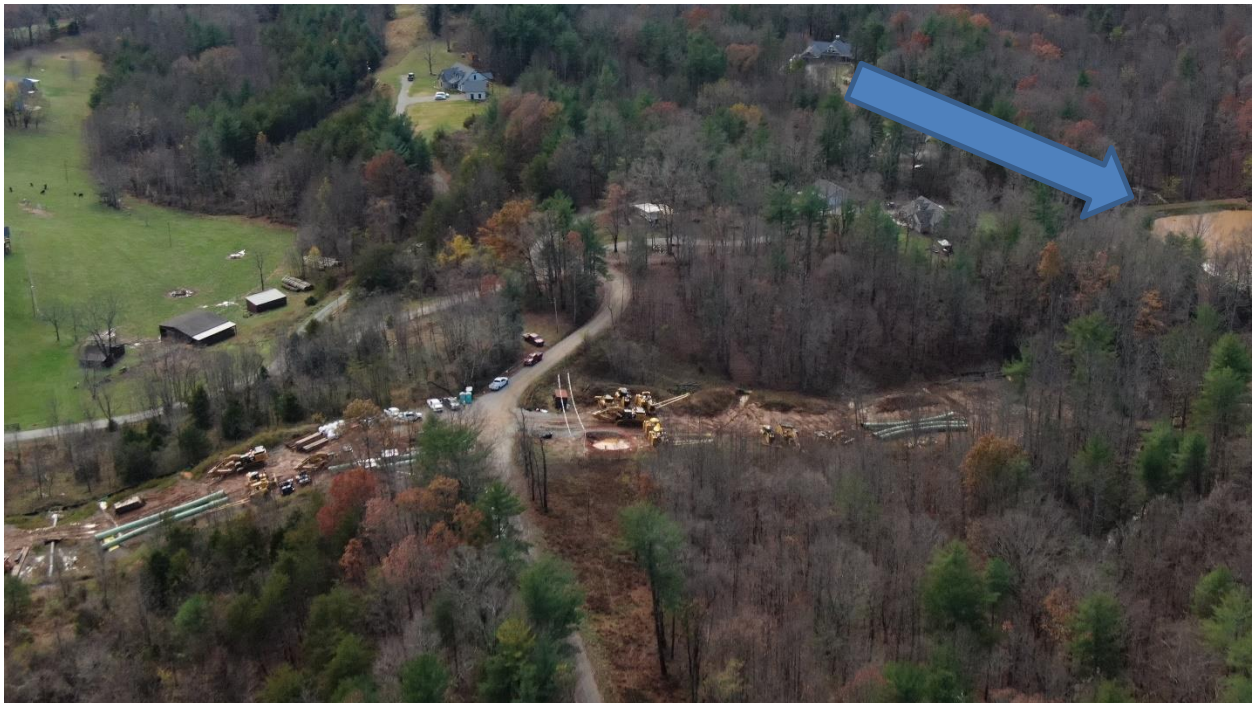
November 13, 2020 Franklin County, Pond below ROW full of sediment.

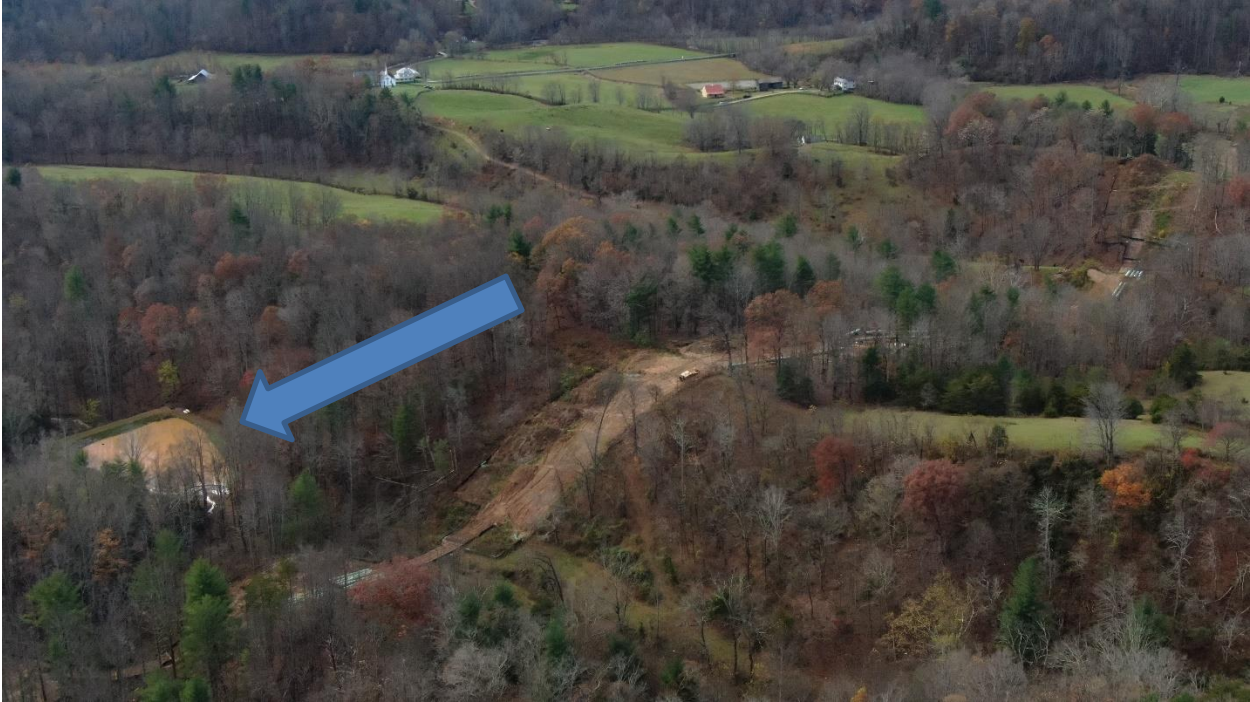
November 13, 2020 Franklin County, Pond below ROW full of sediment.

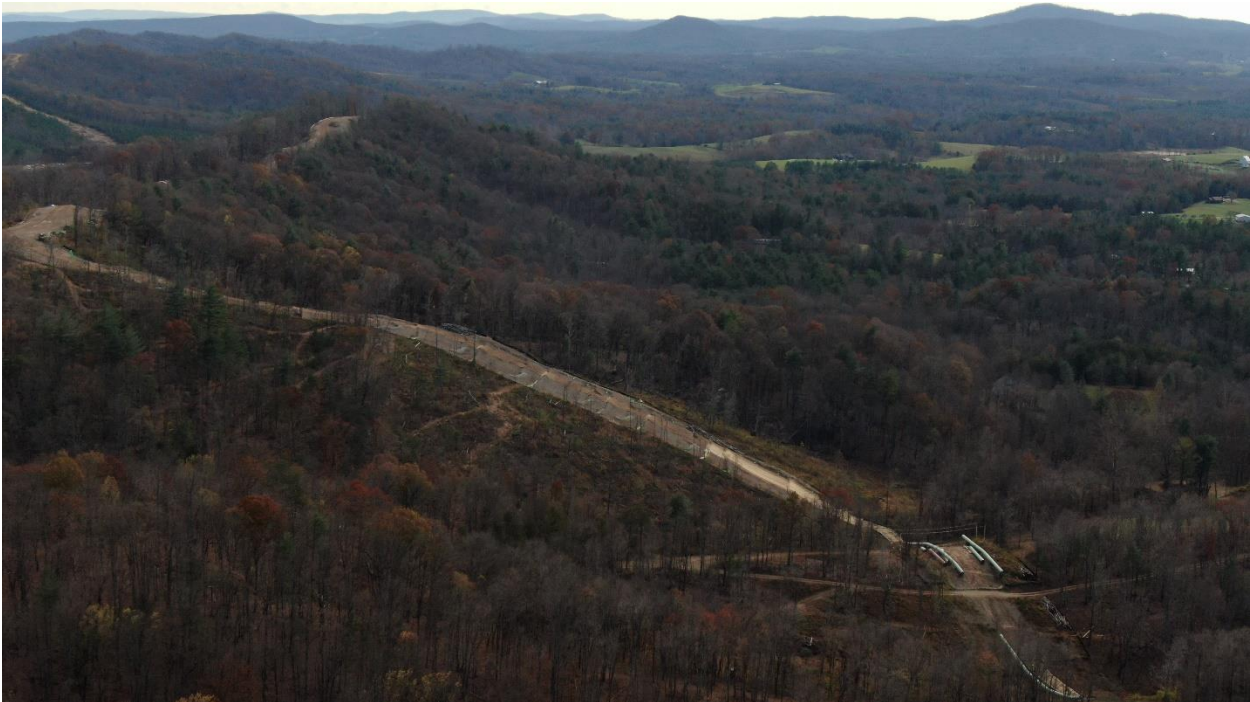
November 13, 2020 Franklin County. Bare areas shown. Jute mesh blanket applied to area eroding at bottom of slope.

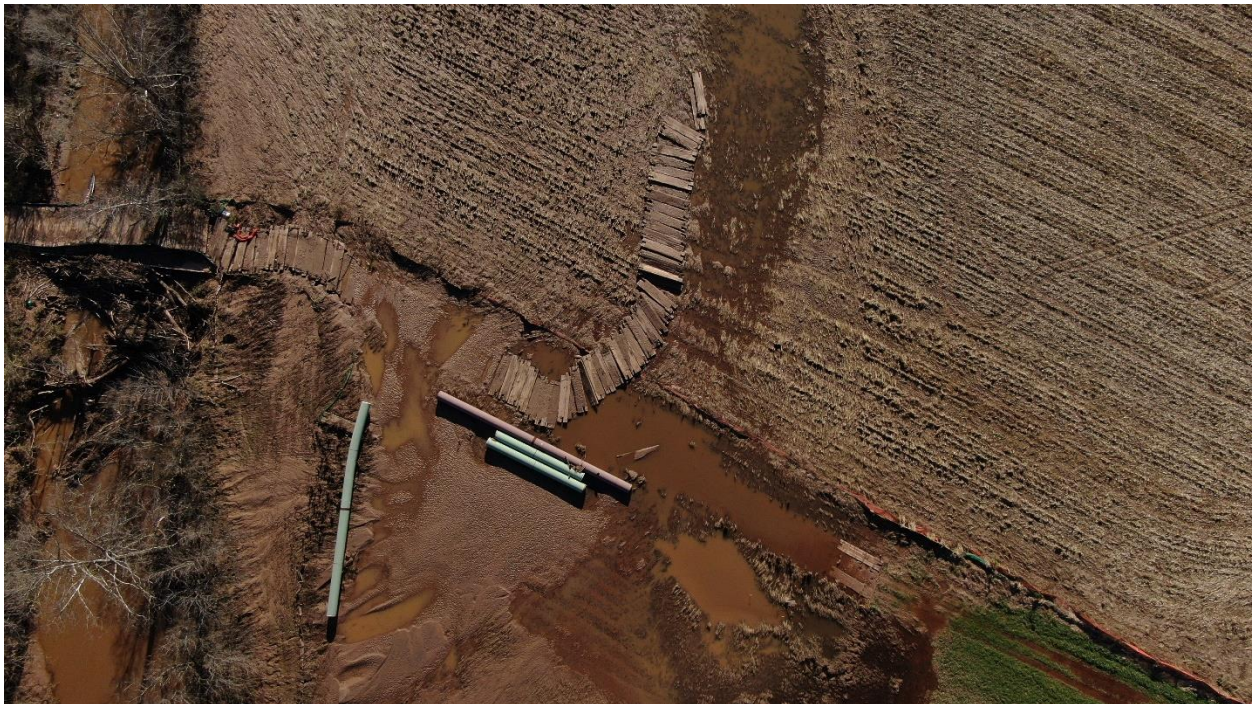
November 13, 2020 Franklin County drone flight shows stream crossing with timber mats displaced by flooding. The stream is brown with sediment flowing from surrounding fields and the MVP right-of-way.

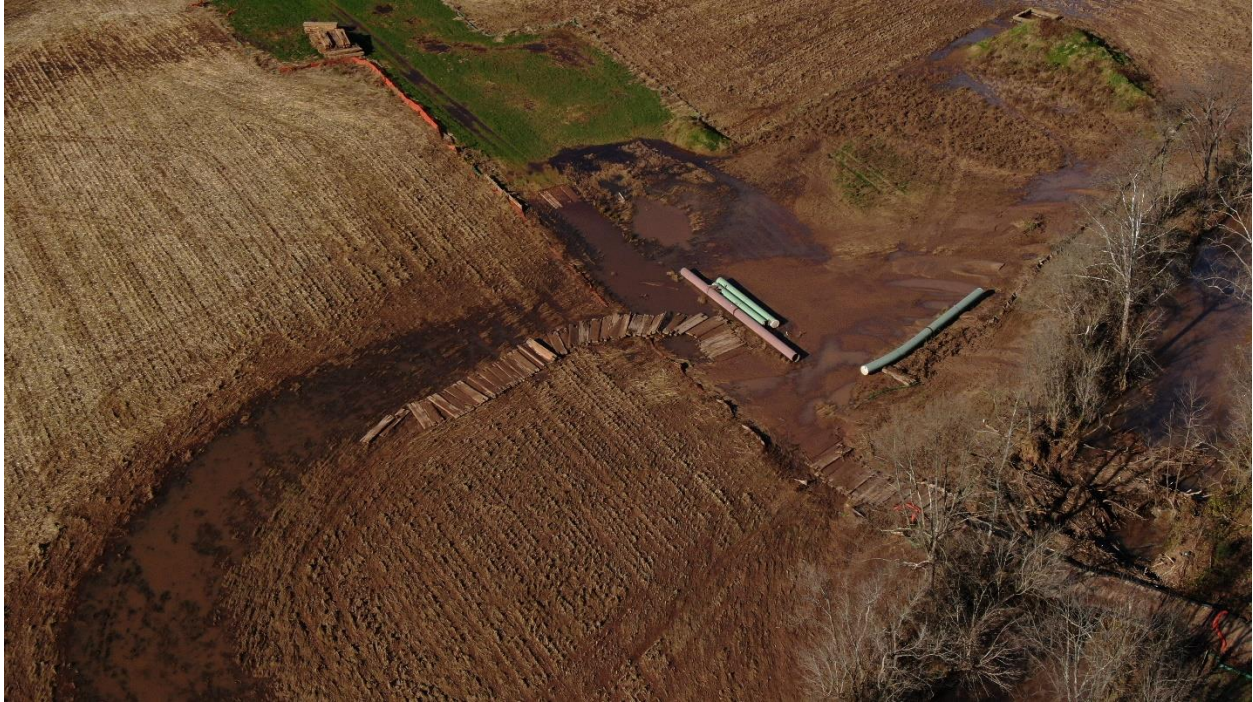
November 13, 2020 Franklin County drone flight shows bridge washout and sediment flowing into stream.

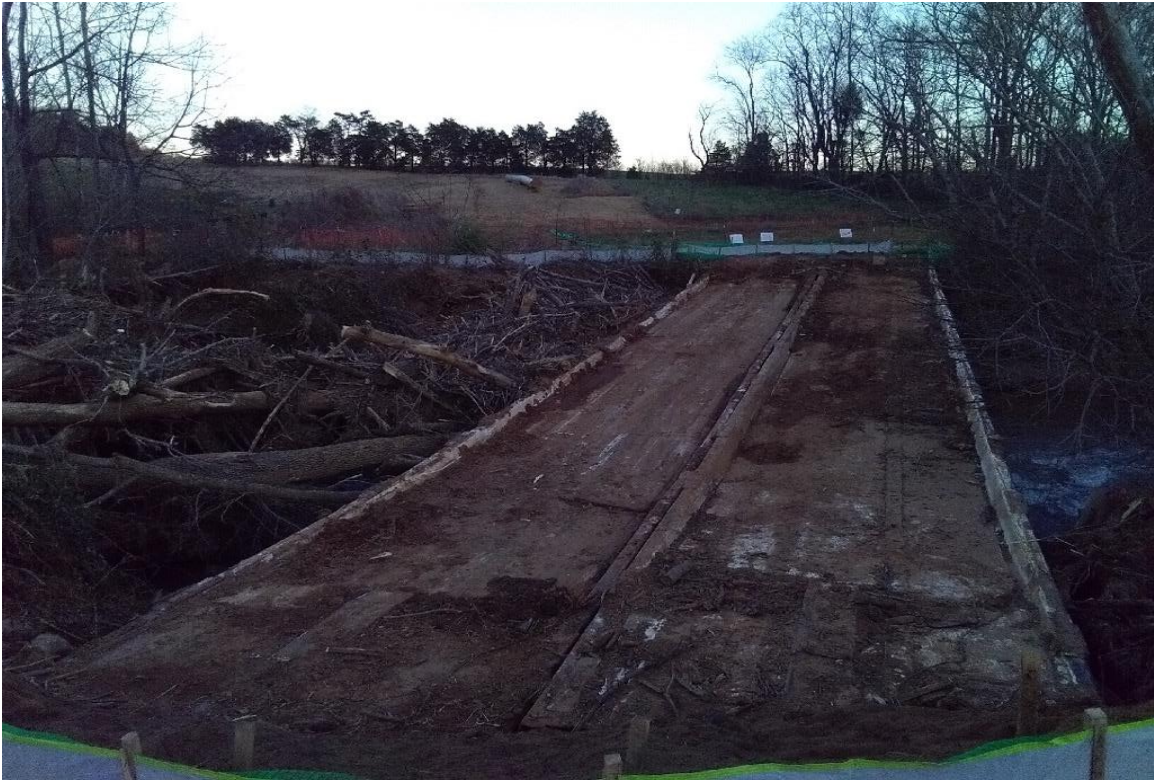
November 13, 2020 Franklin County ground photo shows debris stuck under MVP bridge crossing.

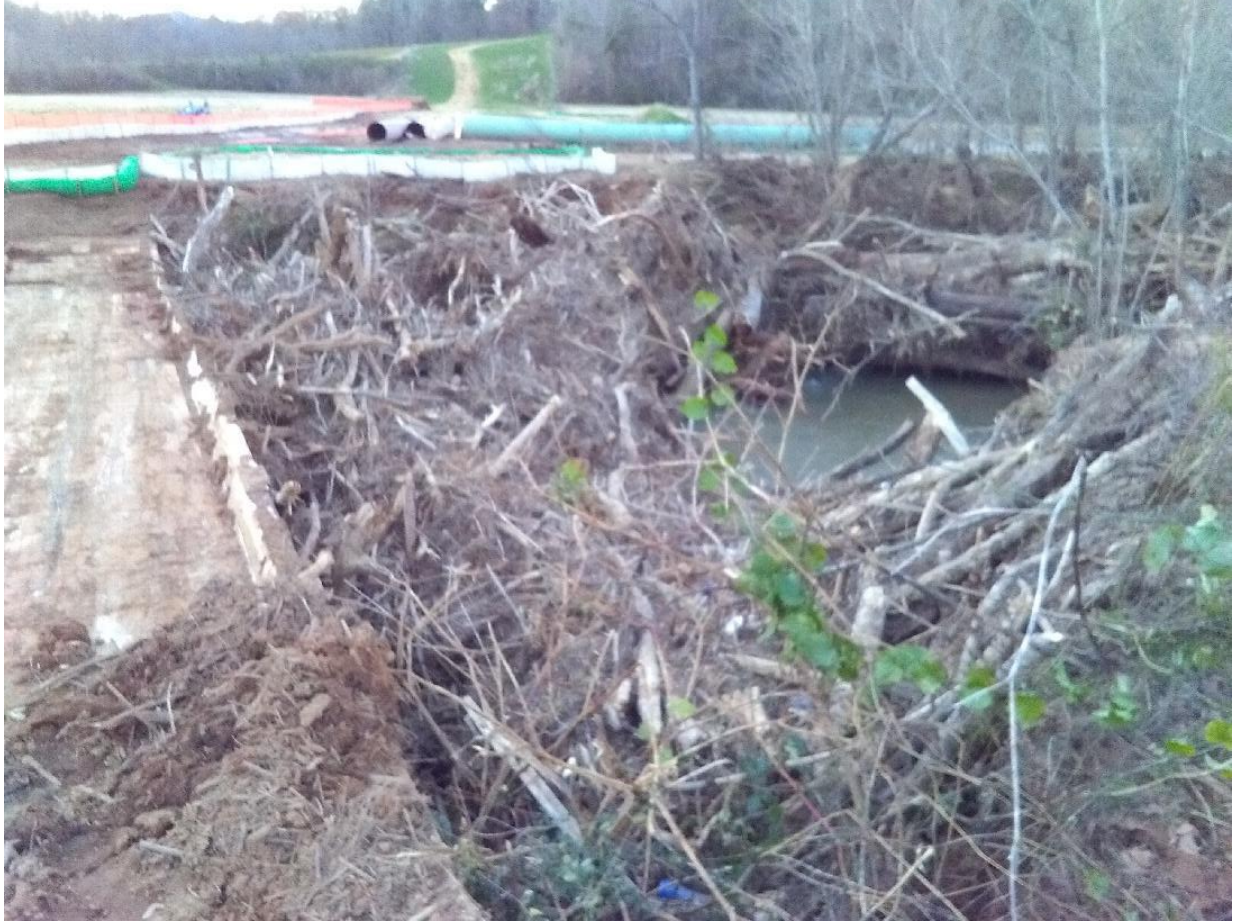
November 13, 2020 Franklin County ground photo shows debris obstructing flow of stream.

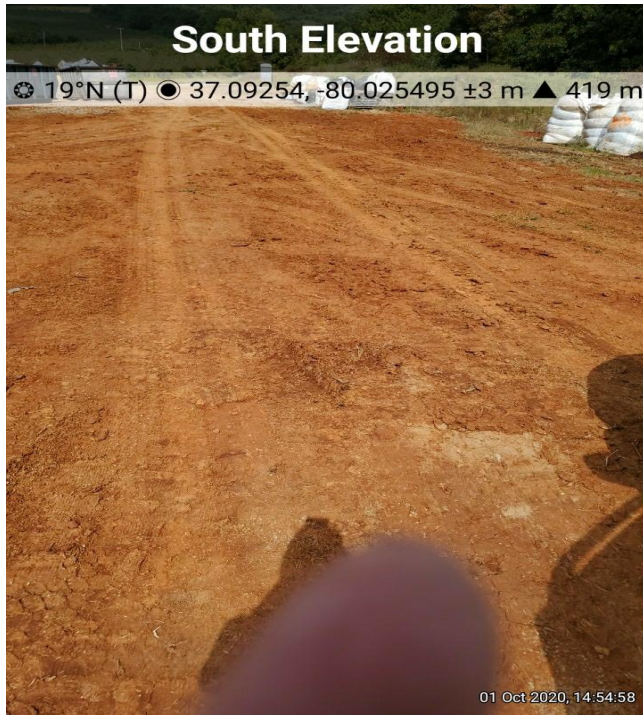
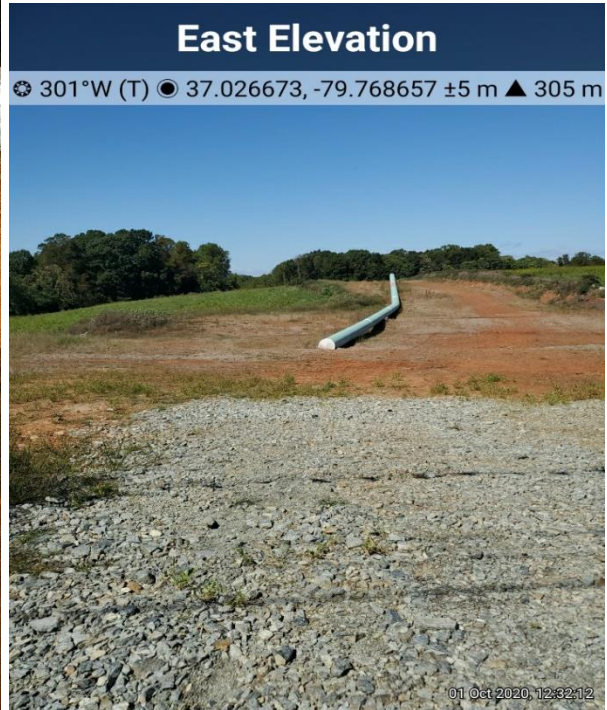
Photos taken October 1, 2020 at two MVP road crossings in southern Franklin County. There is no grass or straw showing at these locations.

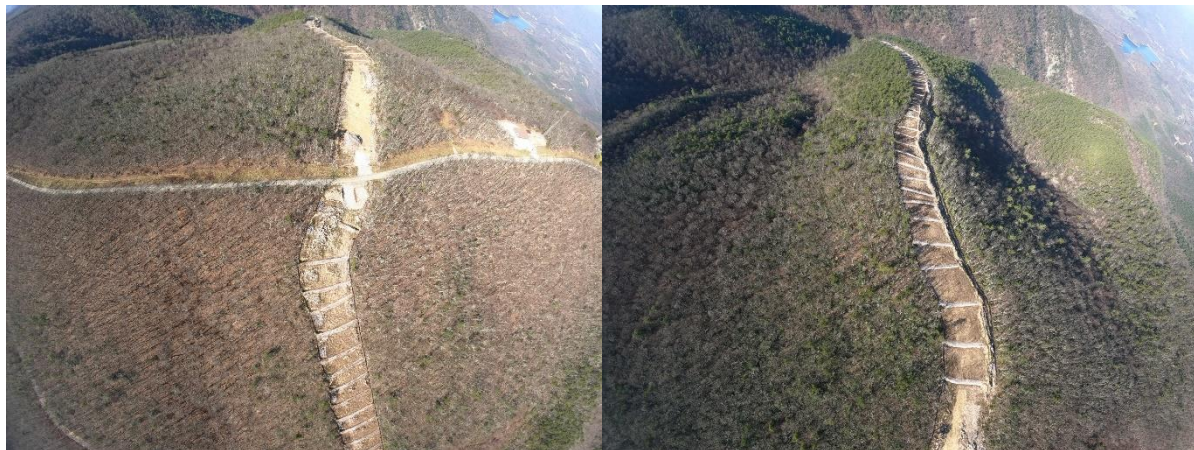
November 21 flight photos at top of Poor Mountain in Roanoke County shows little vegetative cover. Jute mesh blankets were placed months ago, but show little sign of grass growing.

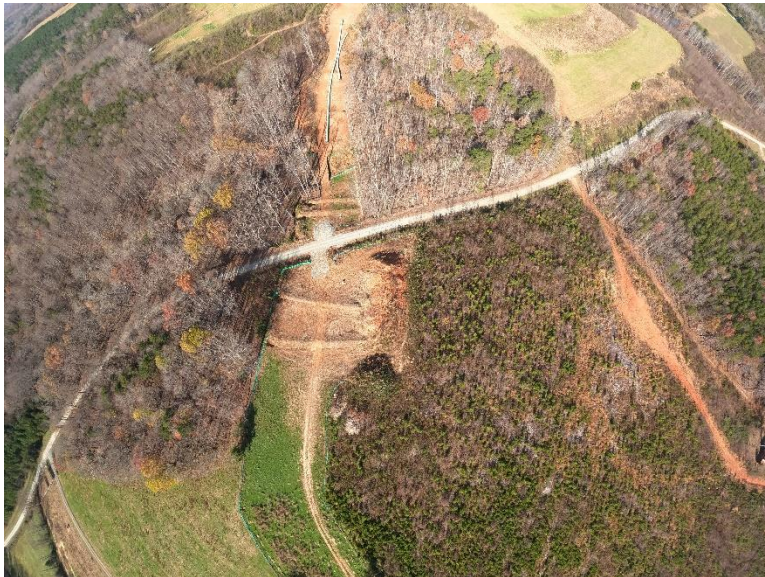
Milepost 286.6 shows bare areas and areas with vegetated cover. There is a stark contrast between the two areas.

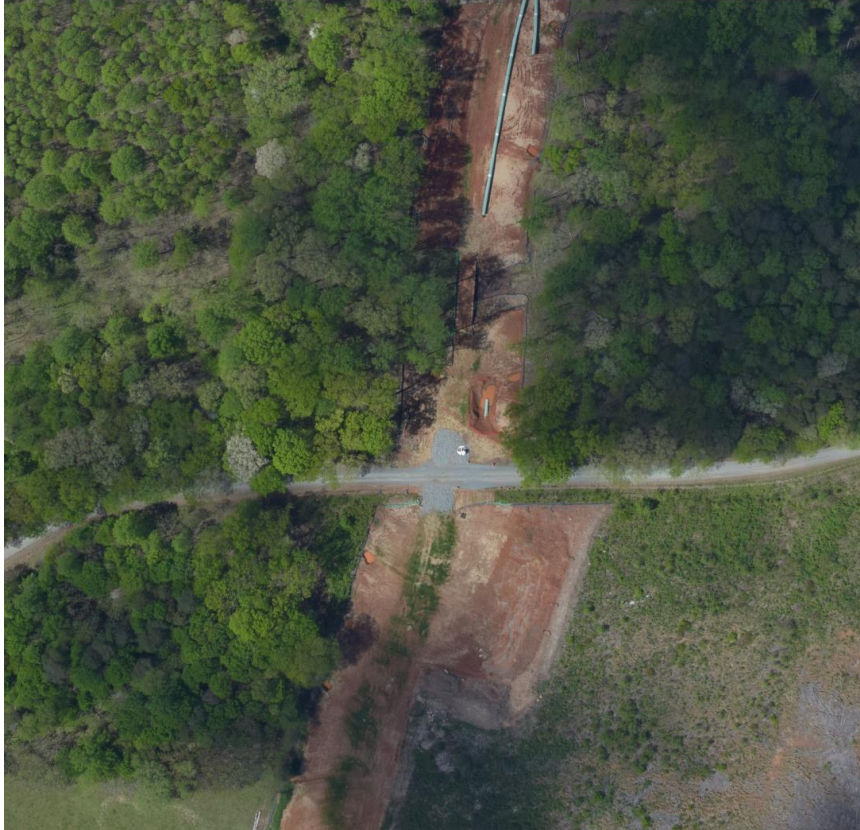
April 21, 2019 flight at Milepost 286.6 shows bare areas and areas with vegetated cover. There is little to no change in cover in over 18 months. The pipes laying in the ROW are still present.

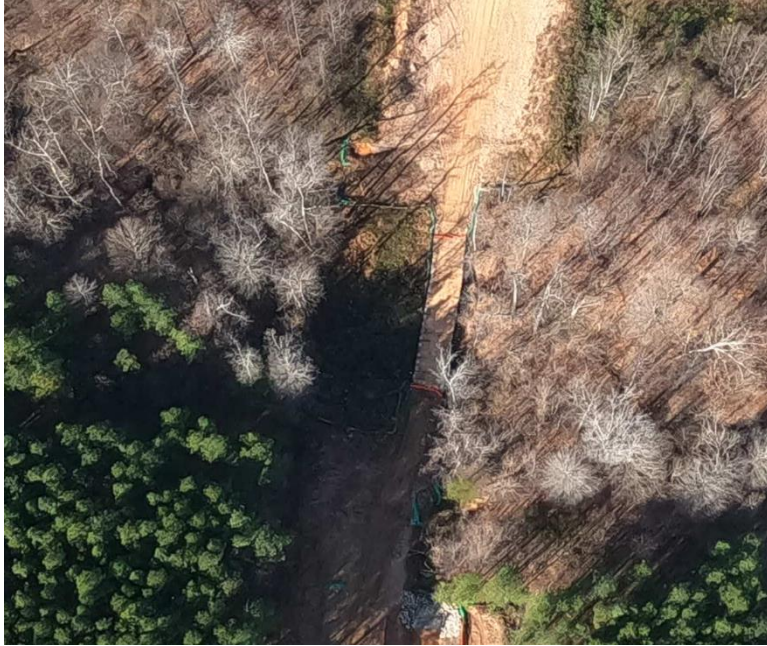
Milepost 294.8 shows evidence of sediment overflowing silt fences and filter socks

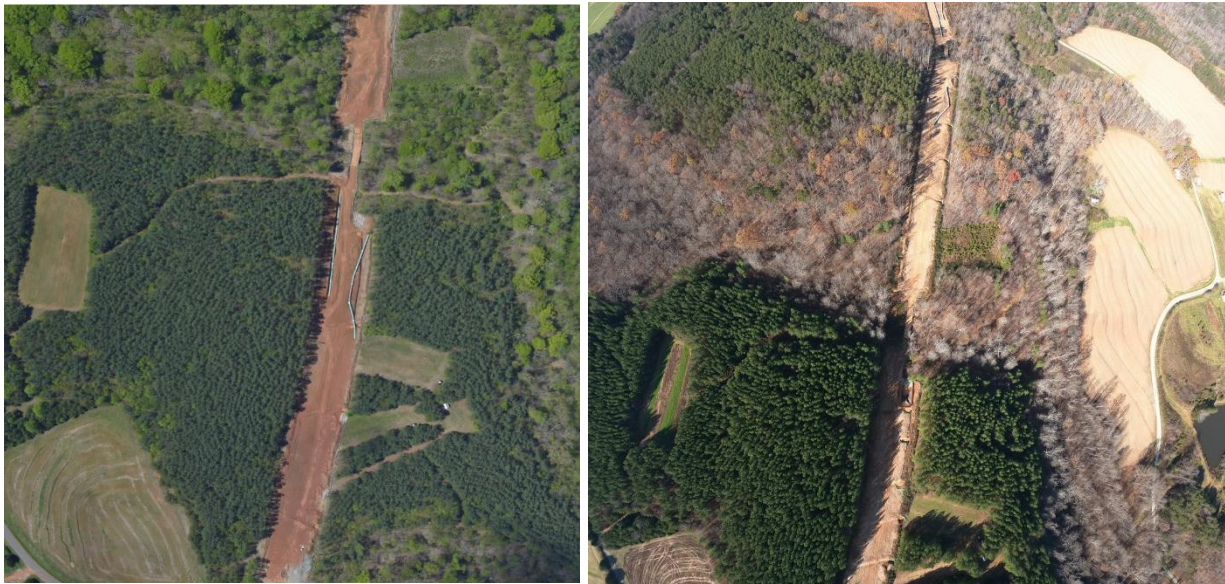
Milepost 294.8: Photo on the left was taken on April 21, 2019. Photo on the right was taken on November 21, 2020. Both photos show bare, uncovered areas with little vegetation. There is dead grass in parts of the photo taken in 2020, which does not meet vegetative cover requirements.

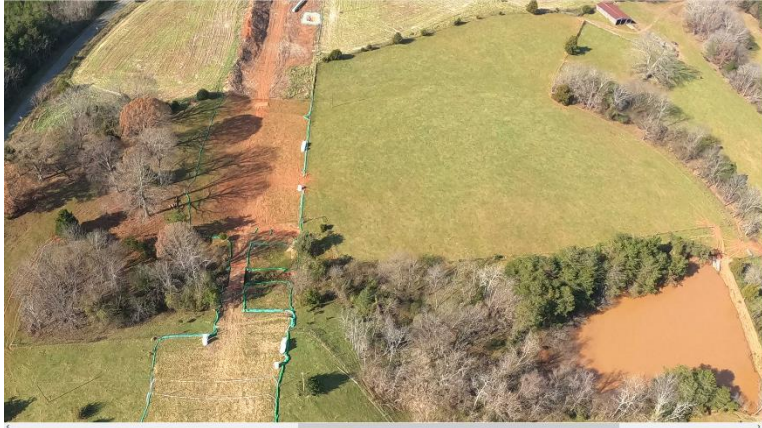
Milepost 283.8 shows pond discolored by sediment. Bare soil shown with gaps in filter socks flowing off ROW.

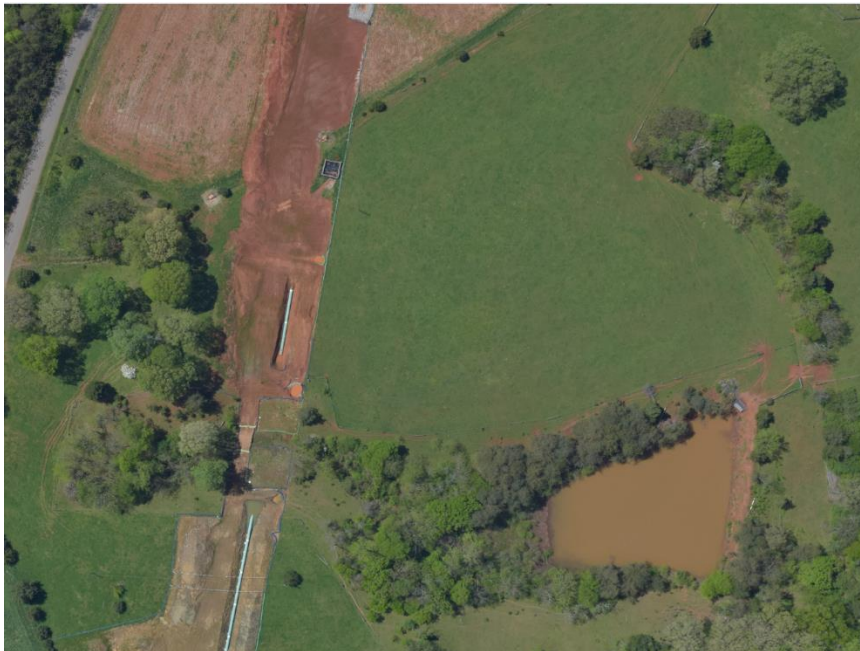
Milepost 283.8: This photo was taken during a flight on April 21, 2019. It shows the same location as the previous photo with bare areas in the ROW above the farm pond.

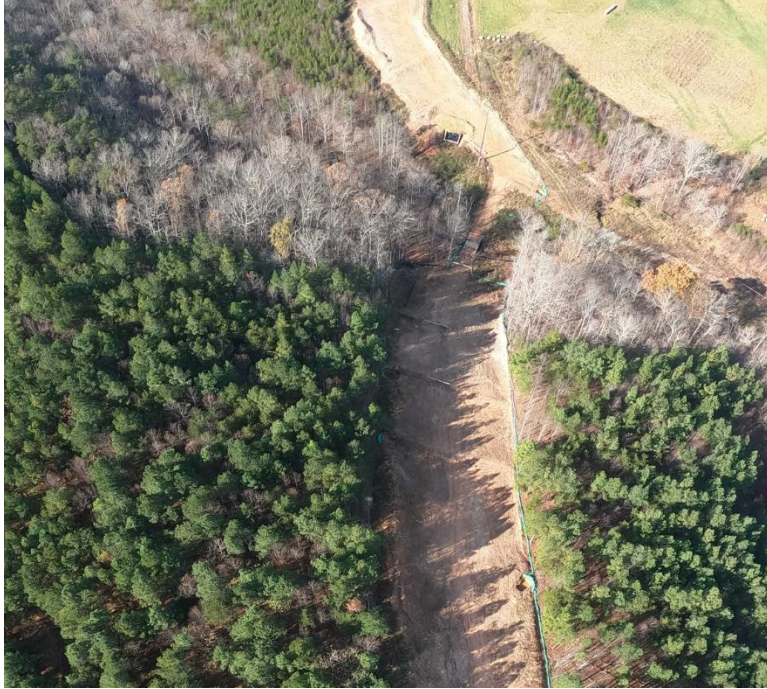
Milepost 283 above Parrott Branch shows areas that are bare or lack vegetative cover.

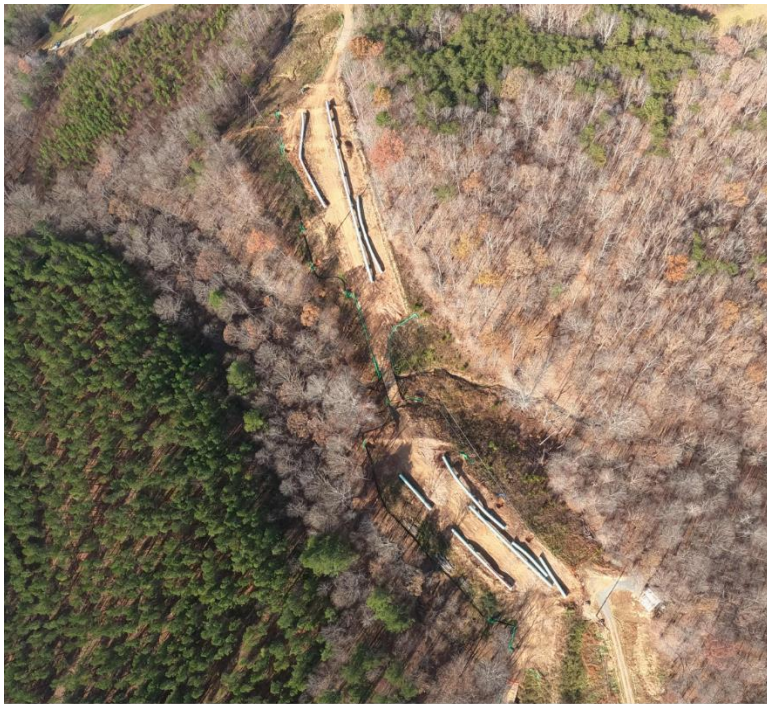
Milepost 279.9 shows bare areas adjacent to Little Jacks Creek.

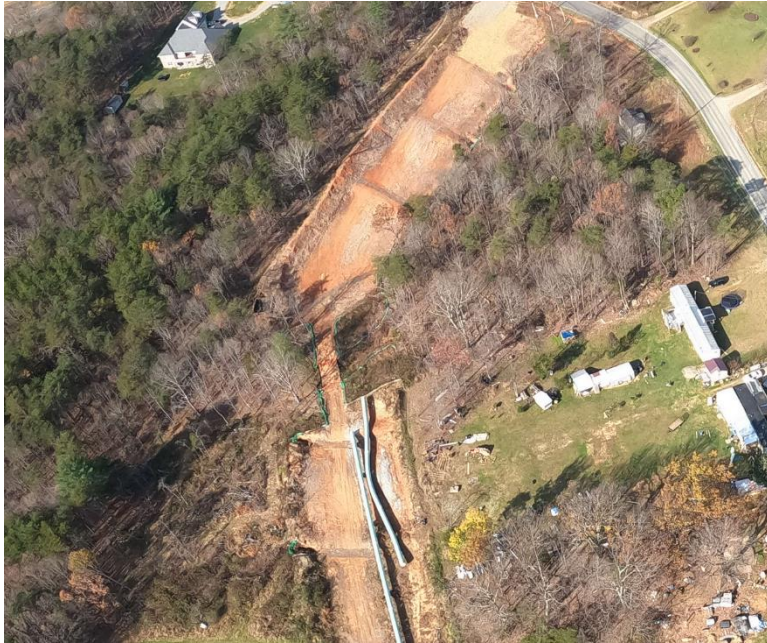
Milepost 271.3 below Golden View Road shows several bare areas with sparse or dead vegetation.

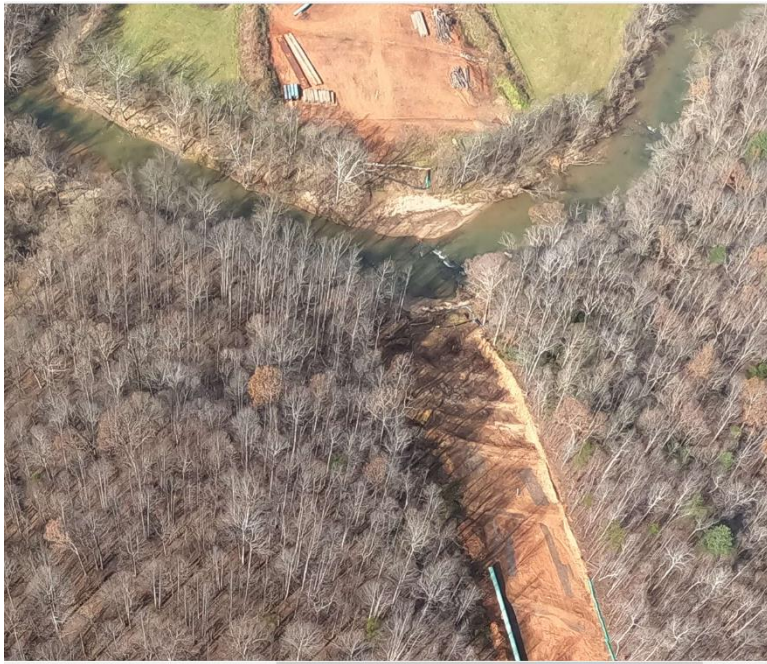
Milepost 269.8 shows a large graded area with little vegetation on both sides of the Blackwater River crossing.

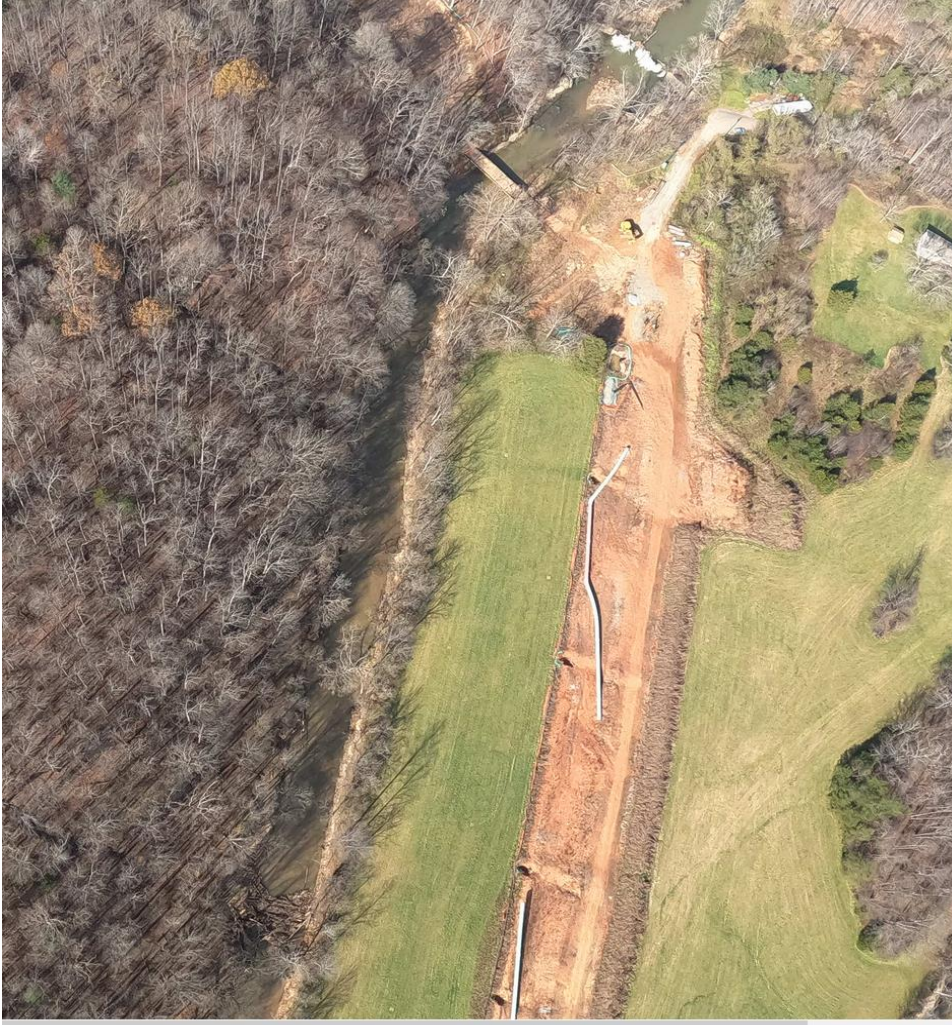
Milepost 269.5, Magodee Creek crossing, shows sediment lining bank of creek below MVP crossing. Debris jam shown in creek at bottom of photo.

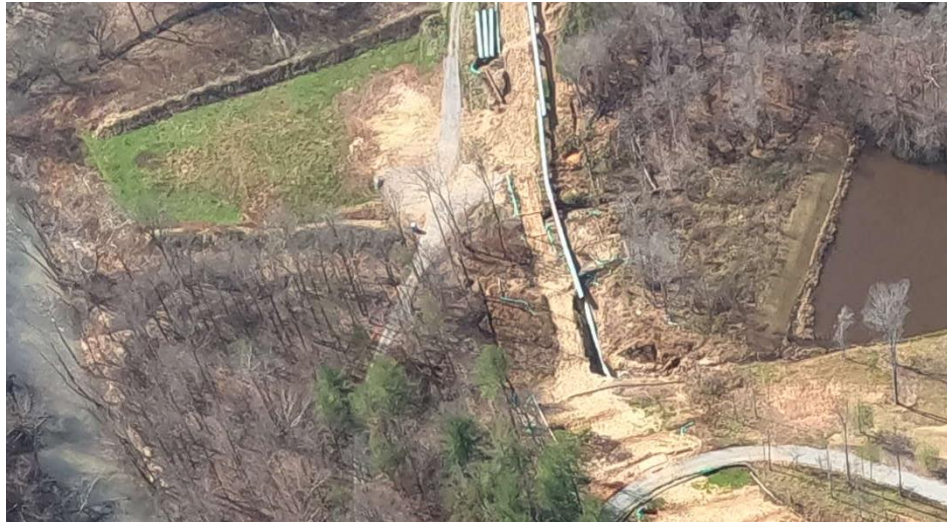
Milepost 265.1 shows pipe strung across wetlands and stream crossing. The photo shows the pipe in a trench below the principle spillway of a large farm pond. Runoff from pond spillway is eroding a channel above the pipeline.

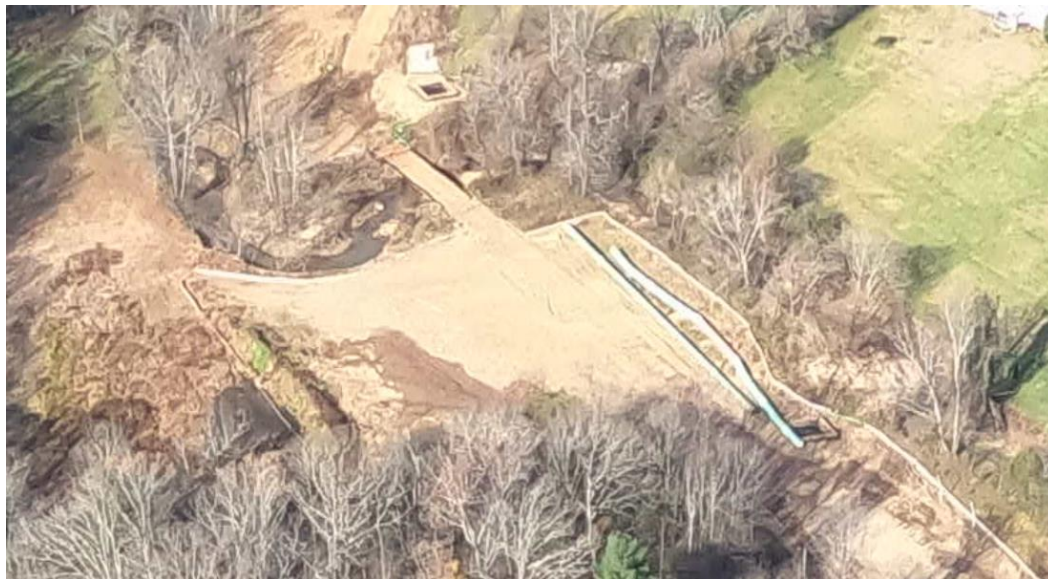
Milepost 260.3 shows bare areas with water pooling and flowing across bare areas next to Teels Creek crossing.

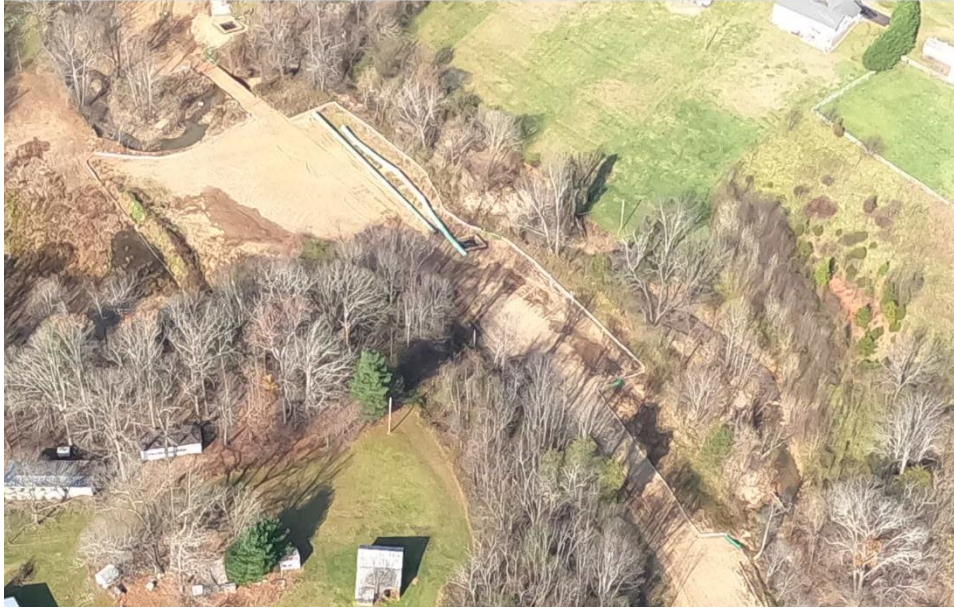
Another shot of Milepost 260.3 at Teels Creek. The LOD of the cleared area is too close to stream. Photo shows LOD at top of bank of Teels Creek.

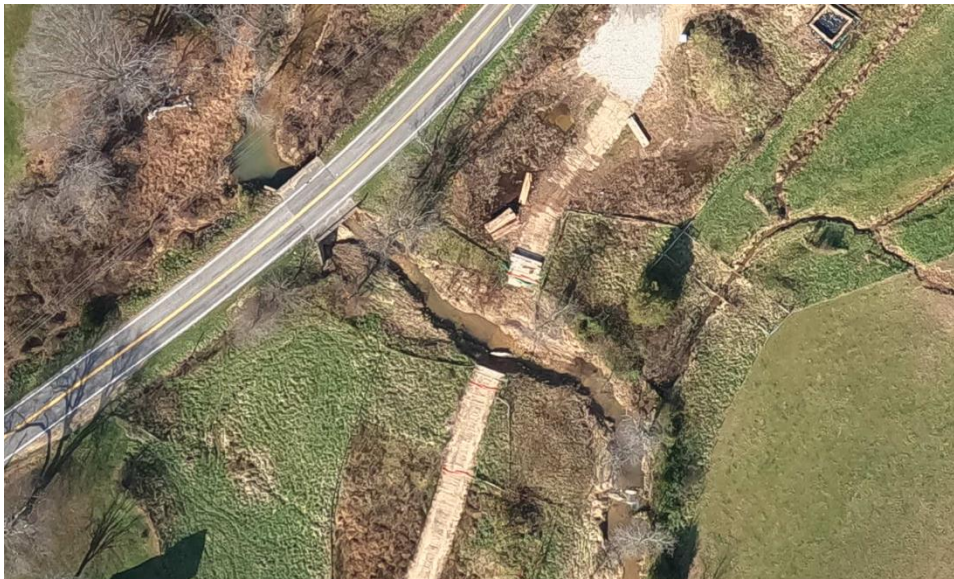
Temporary bridge washed out at Teels Cr. Xing next to Grassy Hill Road, Franklin County, VA.

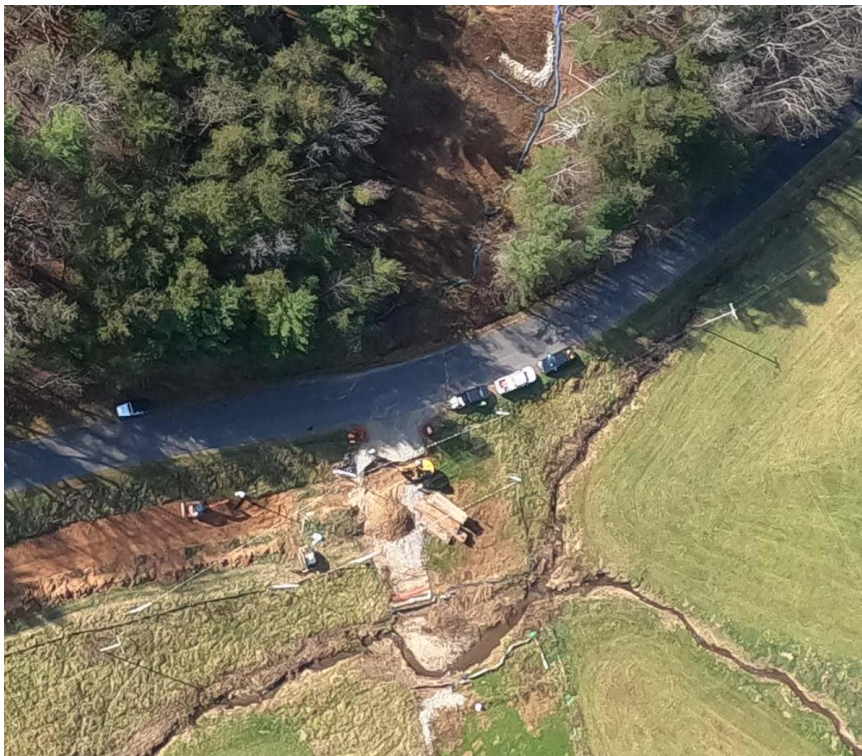
Milepost 255.4, Cahas Mountain Road, shows recent activity to grade slope above road. Dozer is leveling dirt below the road above Little Creek. Stream crossing was washed away by recent storms.

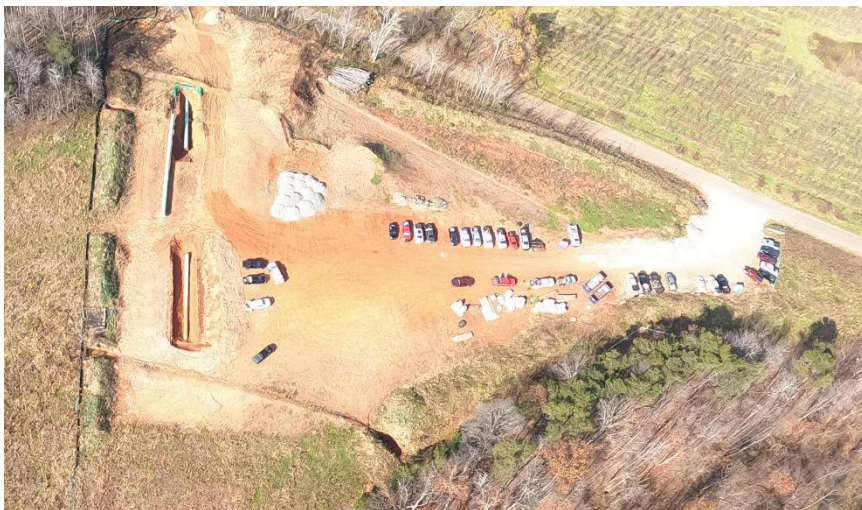
Milepost 253.6: large equipment yard with one sediment trap shown in lower edge of cleared area. Was the trap designed for the site? Does the drainage area exceed the limits for a sediment trap? This area has lain bare for over 6 months.

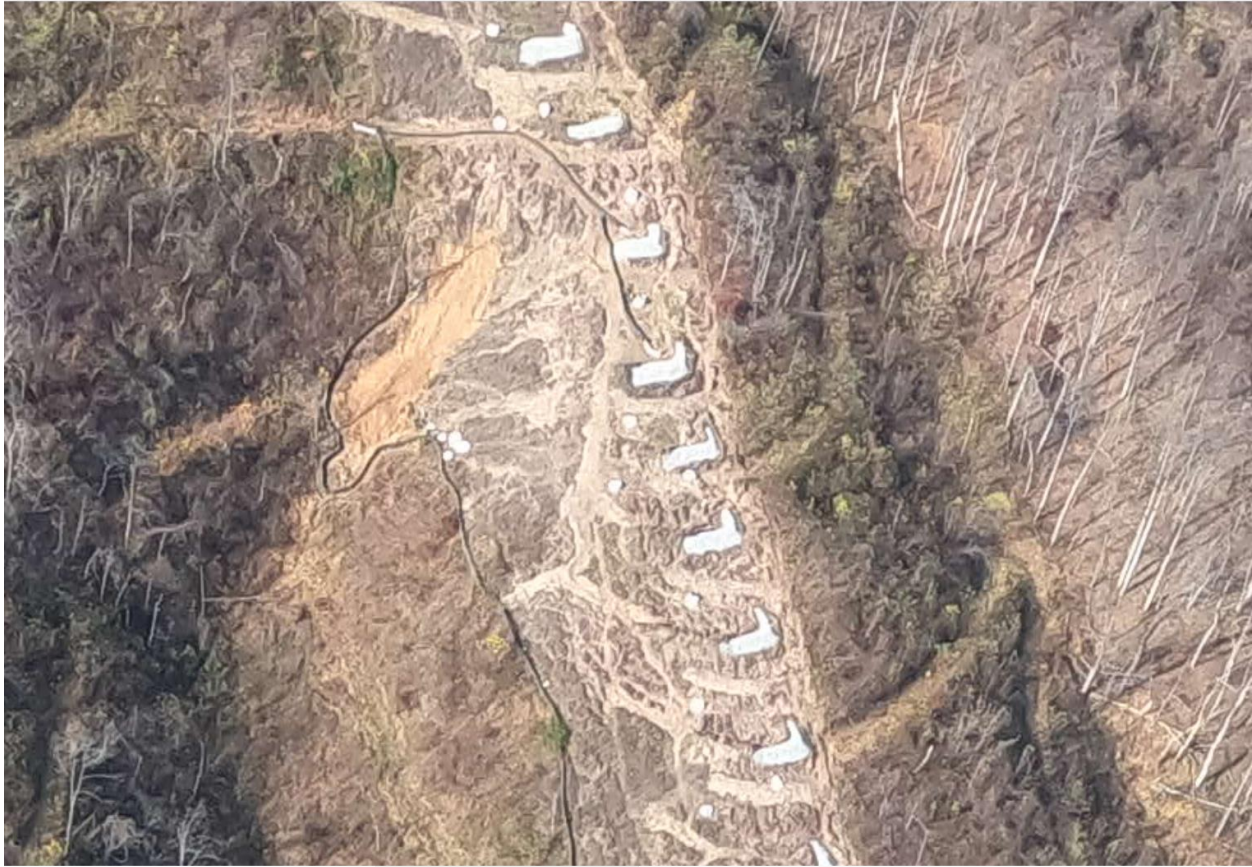
Large slip area shown in photo near milepost 250.8.
