FROM: Kirk A Bowers, PE
Mountain Valley Watch

DATE: February 16, 2021

SUBJ: Mountain Valley Pipeline Slip report analysis, milepost 57.2-57.3

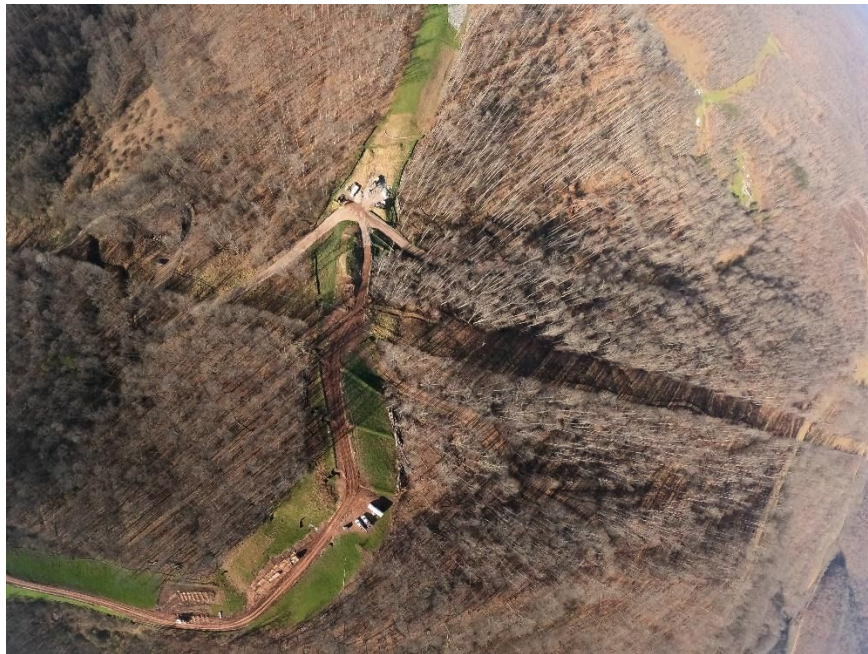
4/8/2020: Spread B MP 56.7

The Lead Environmental Inspector notified the Compliance Monitor that crews verified that the installed pipe shifted due to the movement of the slips in at least three locations south of Brush Run Road. The Lead Environmental Inspector said that survey crews marked where the pipe was installed and other crews used line locators and potholing to determine the current location of the pipe. Mountain Valley is still determining a course of action to correct the movement.

December 2020 flight photo of milepost 56.7 slip location

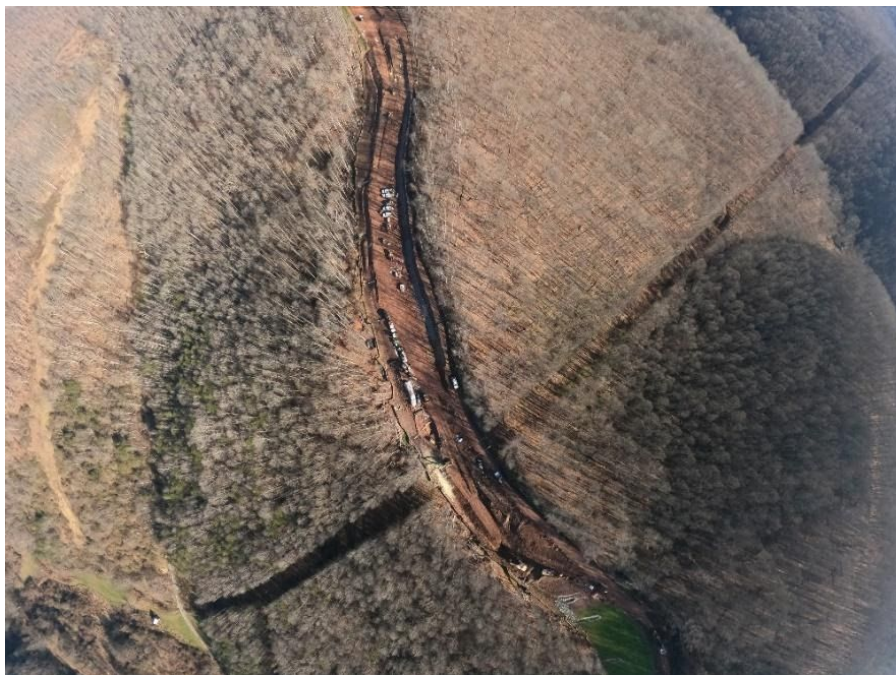
Variance Request B-59

Mountain Valley Pipeline LLC requests a variance to add MVP-ATWS-1676, MVP-ATWS-1677, and MVP-ATWS-1678 for slip remediation and the installation of rock drains (slip MBP-B-060). The rock drains will be permanent and above ground. This variance has a net increase of 0.07 acre of LOD from the original permit. The current vegetative cover of the variance area is deciduous forest and scrub-shrub. However, no tree clearing will be required as part of the slip remediation and drain installation.

The photo below is from a December aerial flight over the MVP that records continued construction/remediation activity in the ROW at MP 57.2.

December 2020 flight photo of milepost 57.2 slip location

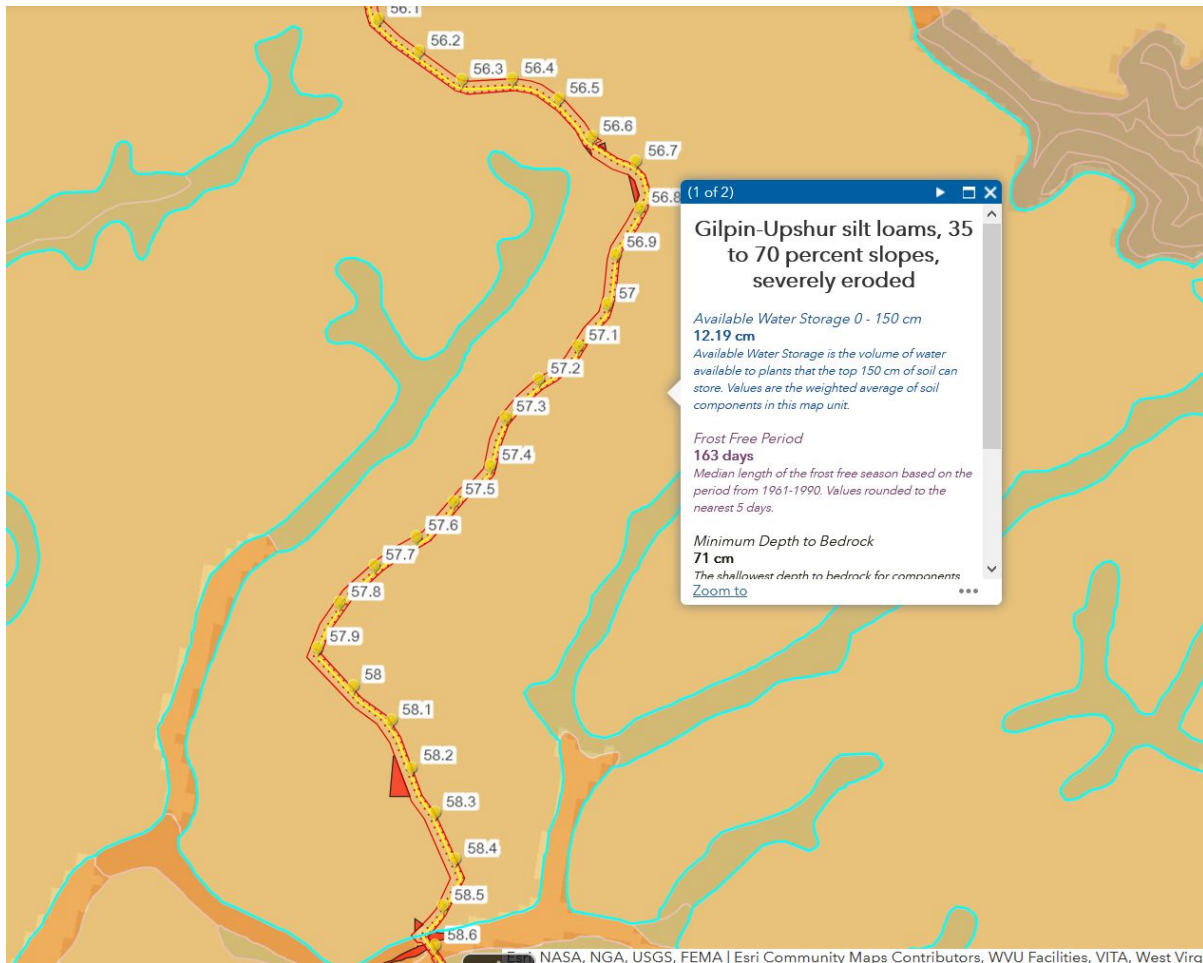
Soils map for section of MVP at Milepost 57.2

The Gilpin series consists of moderately deep, well drained soils formed in residuum derived from shale, siltstone, and sandstone. The Gilpin soils are on ridgetops, benches, and hillsides throughout the survey area. Slope ranges from 8 to 70 percent. The Upshur series consists of deep, well drained soils formed in material weathered from siltstone and shale. The Upshur soils are on ridgetops, benches, and side slopes throughout the survey area. Slopes range from 8 to 35 percent.

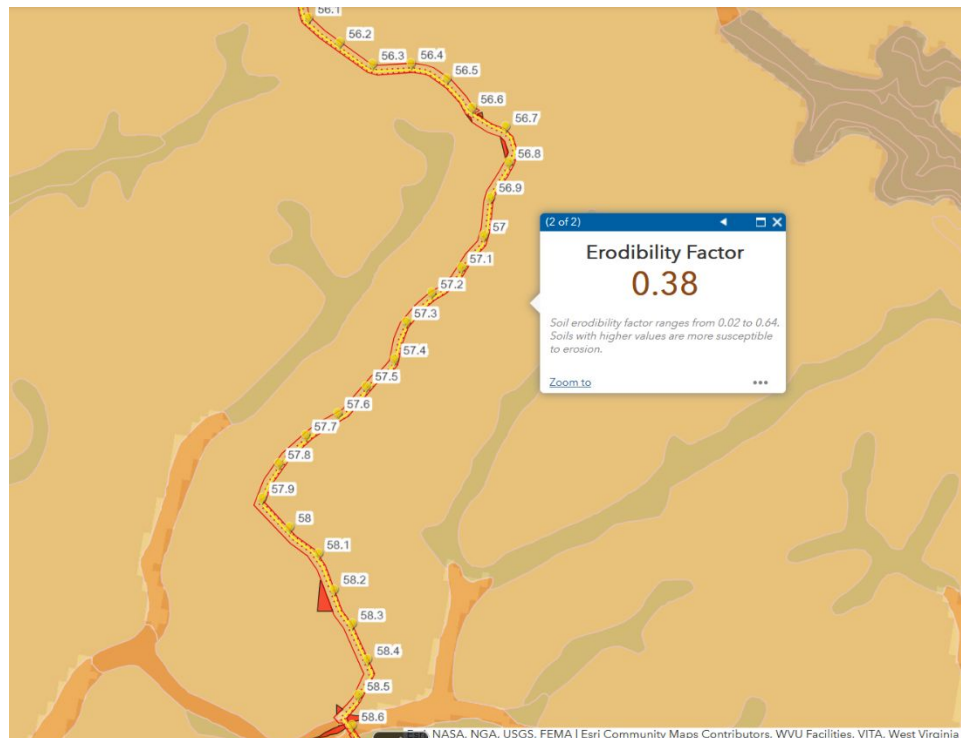
Dominant soil Erodibility Factor, $K_f = 0.38$

Chapter 6, VA Erosion and Sediment Control Handbook, p. IV-44 (shown below) includes an explanation of the Erodibility factor and lists three groups of erosion hazard. **K_f factors above 0.36 are documented high risk No Build Zones.**

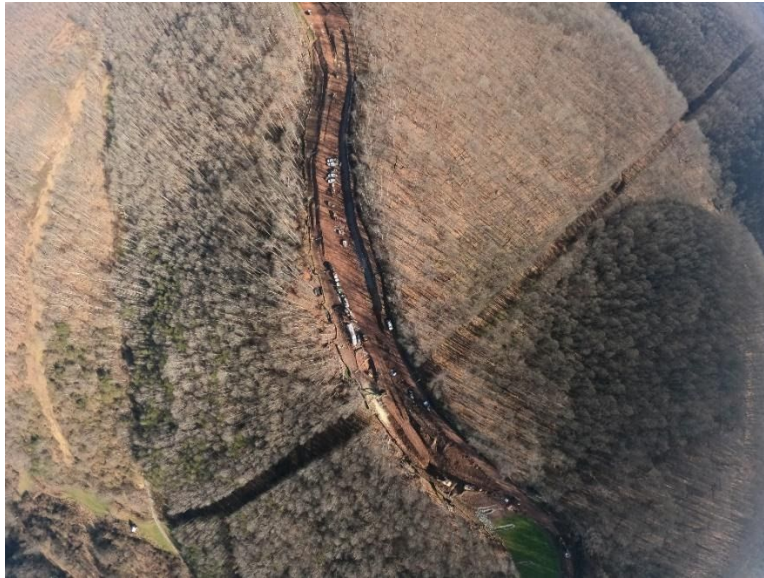
The photo below is from a recent aerial flight over the MVP that records construction in the ROW. The photo is in the area of recent landslides. What appears like a "construction site" in the photo below of MP 57.2 is a remediation effort for the location where the installed pipeline shifted early LAST year and was not adequately stabilized.

December 2020 Milepost 57.2

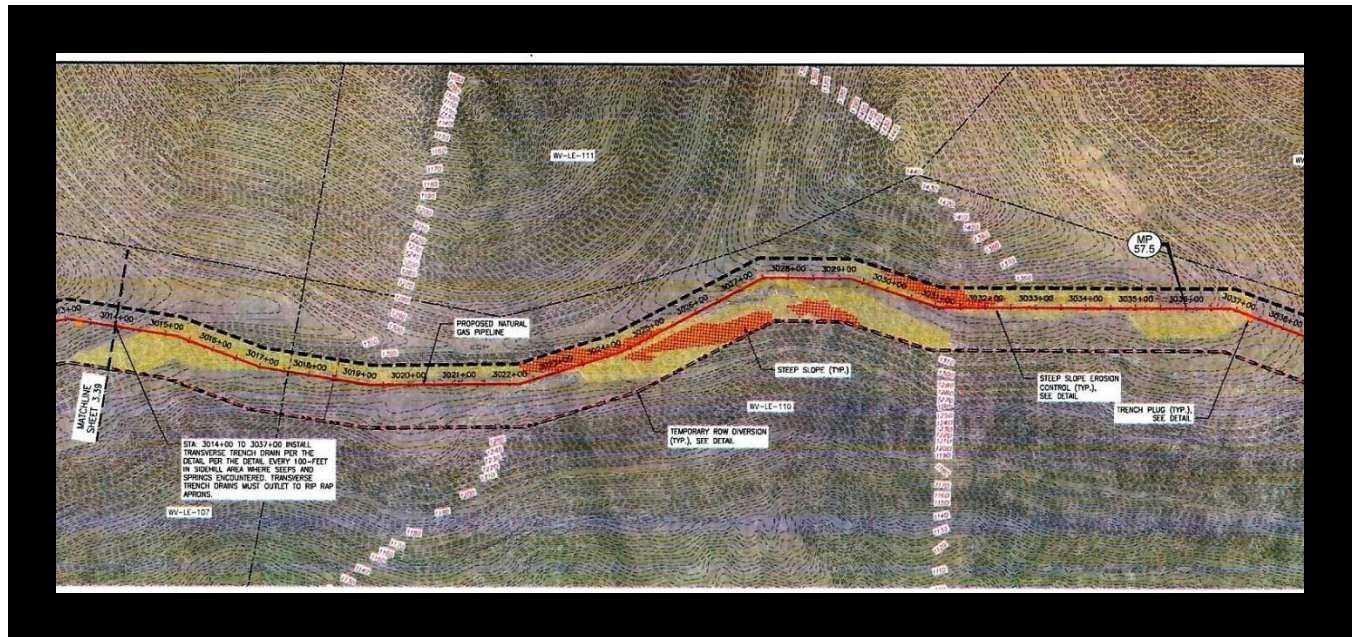
Construction plan sheet 3.40 showing location of landslide

The ridgeline elevation shown on the MVP construction plan sheet 3.40 shows a large difference in elevation on the side of a steep mountain slope. There is up to 80 feet of elevation difference shown on the construction plan. The soils in this area are extremely sensitive to erodibility as indicated by a K_r , erodibility factor, of 0.38. This is a high slip hazard area and construction was not recommended or suitable at this location.

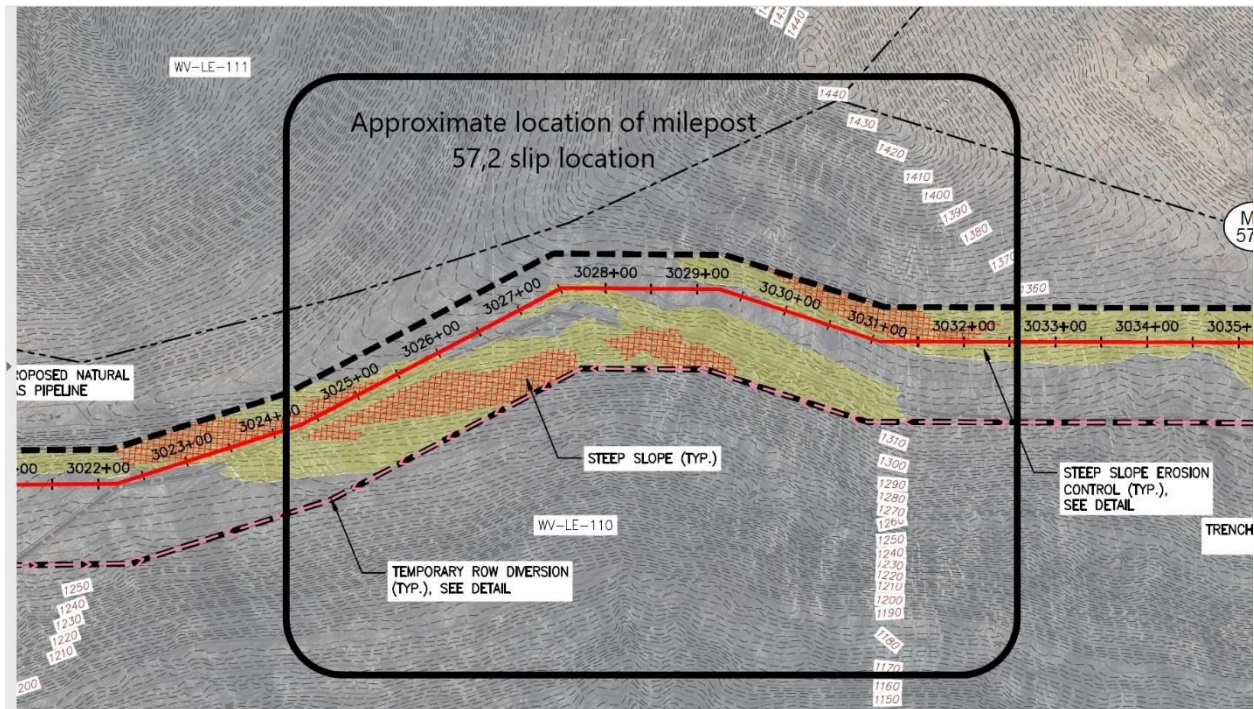
Enlarged view of plan sheet showing slope and elevation of existing ground.

The pipeline at milepost 57.2 is located on the side of a mountain. Elevation differences above the pipeline centerline are dependent on location. The lowest elevation difference is 8 feet at Station 3026+00. The highest elevation difference is 80 feet at Station 3030+00.

Higher elevation differentials on the slope of a mountainside creates a large mass of overburden which produces a downward force on the existing pipeline and displaced soils. The slopes below the pipeline are steep and provide little stability for sliding soils.

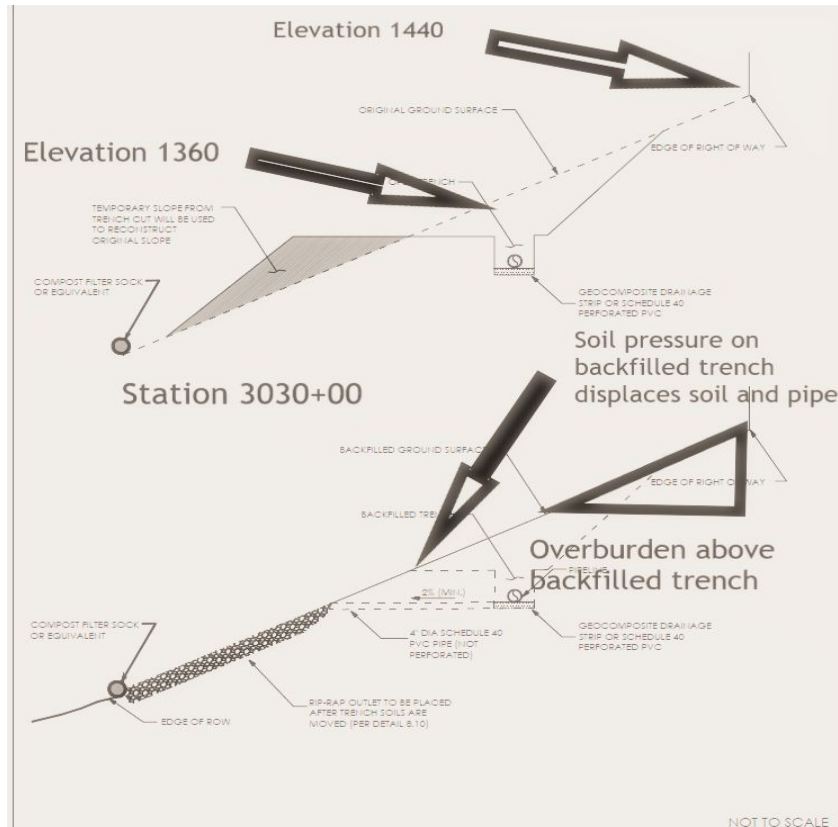
Trench construction profile at Station 3030+00

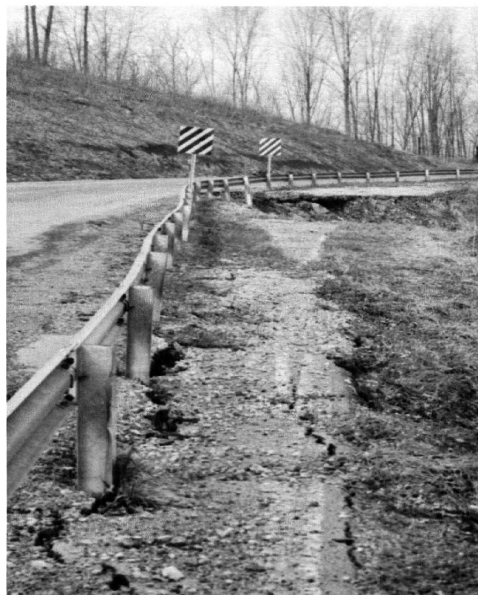
Lewis County, WV
Road damage caused by slippage in an area with Gilpin-Upshur silt loam,
35 to 70 percent slope⁴
