February 3, 2021

SUBJ: Mountain Valley Pipeline Stabilization  
Webster County, WV.

We are submitting documentation of slips and lack of stabilization in the right-of-way of the Mountain Valley Pipeline.

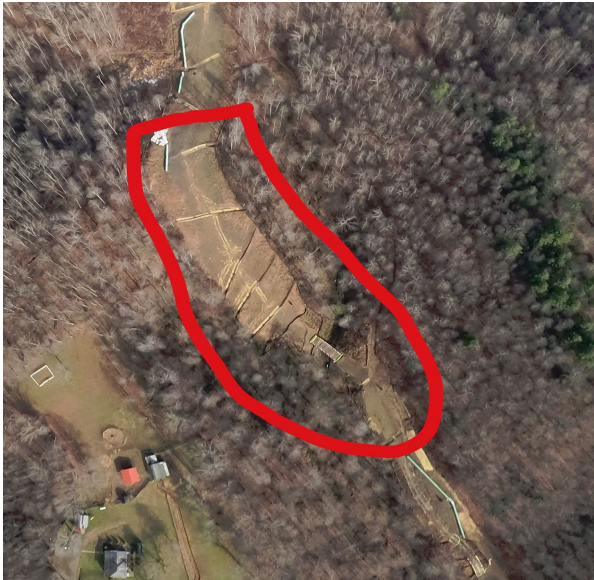
**Milepost 109.5** [G0023800.jpg](#)  
The Steep Slope above stream crossing has little vegetation. Waterbars are in need of stabilization and maintenance.

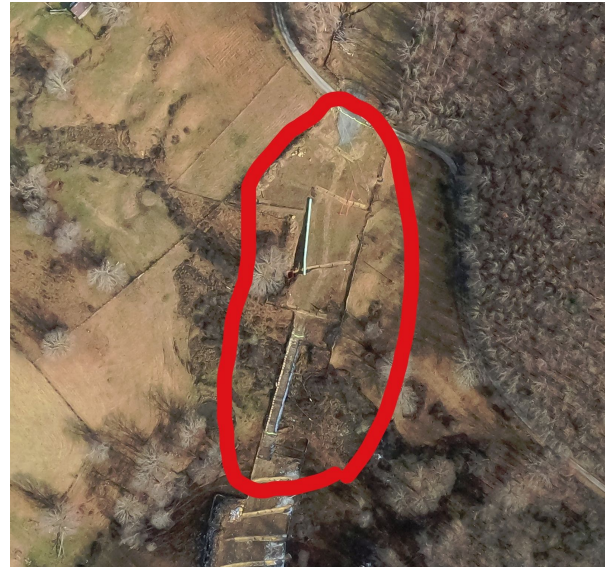
**Milepost 106.4** [G0023856.jpg](#)  
Area on the slope above wetlands crossing is bare and needs vegetative stabilization.

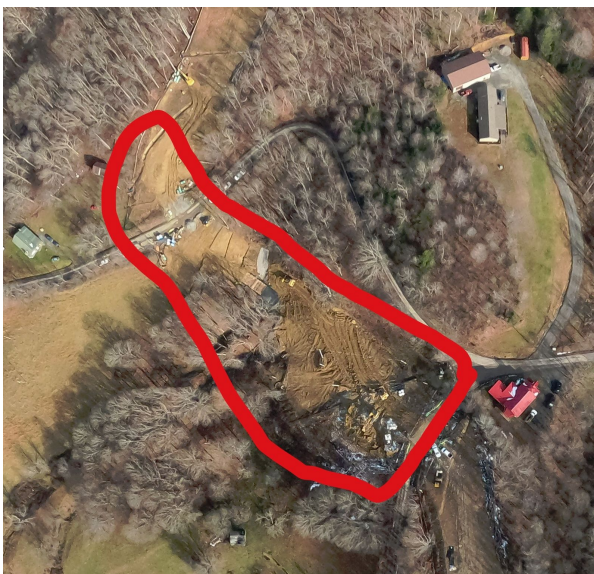
**Milepost 106.1** [G0023860.jpg](#)  
Bare areas above stream crossing need stabilization. The photo shows a dozer pushing dirt into the stream crossing. The bridge for the crossing appears to have collapsed.

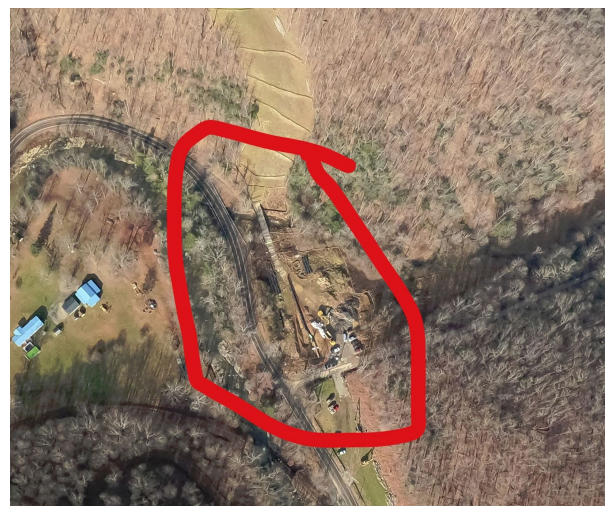
**Milepost 98.7** [G0023997.jpg](#)  
Large area with little vegetation on both sides of stream crossing. Work area perimeter control is too close to the edge of the live stream. Inspection requested.

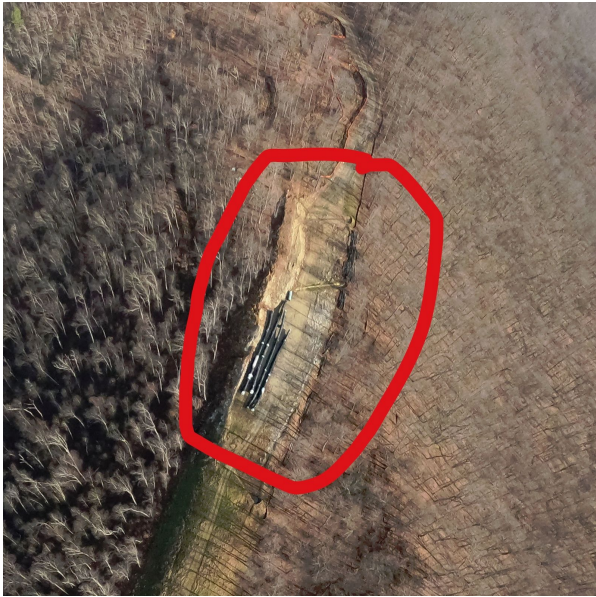
**Milepost 95.6** [G0024052.jpg](#)  
Bare area with pipe lying on ground, Very little vegetation in ROW. Seeding required.

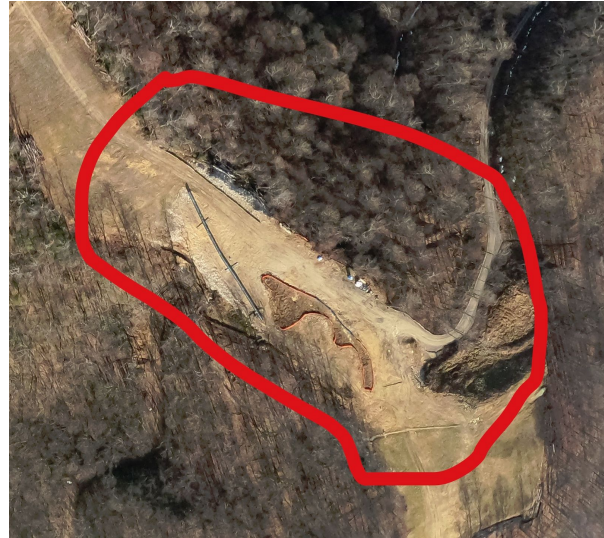
**Milepost 95.4** [G0024059.jpg](#)  
Large bare area at intersection with access road. Seeding required. There appears to be a slip above the road intersection. Possible sediment flowing off site.

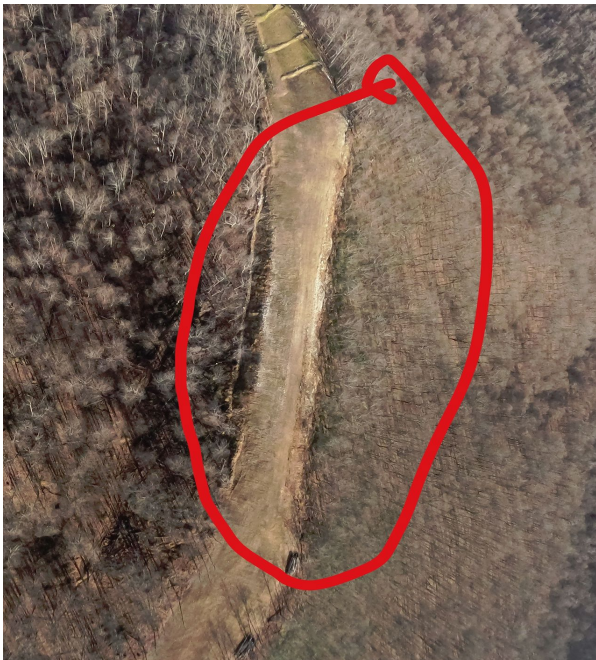
**Milepost 94.6** [G0024071.jpg](#)  
Remote location at the top of the ridge has sparse vegetation. Perimeter erosion controls are not visible. Inspection requested.

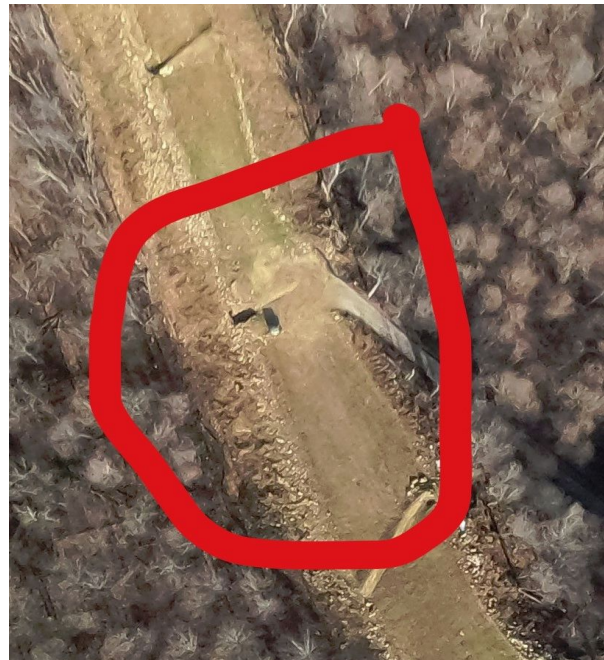
**Milepost 94.3** [G0024075.jpg](#)  
Small area at low point/access road with sparse vegetation. Additional seeding necessary at this location.

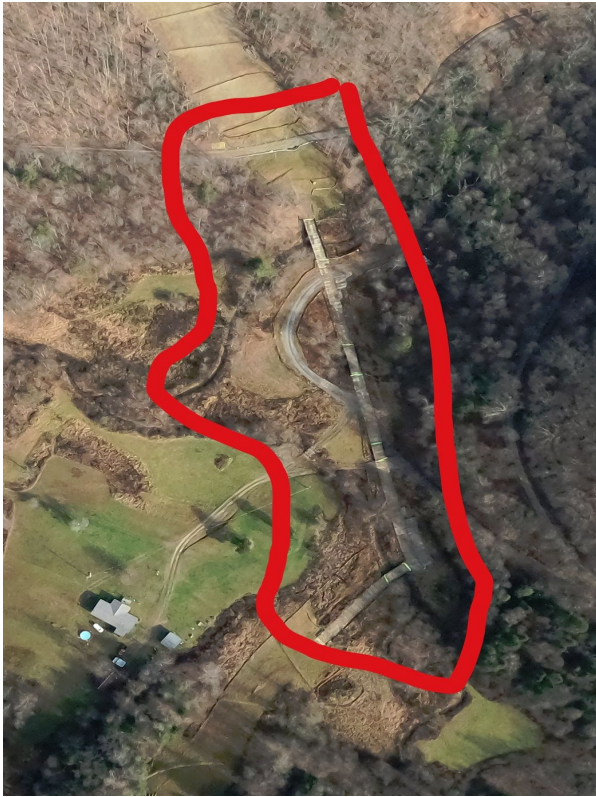
**Milepost 93.1** [G0024095.jpg](#)  
Stream crossings. The area at the bottom of slopes is not well protected. Erosion control devices are not visible. Too many unvegetated areas close to the stream. Pipeline has no stream buffer at the stream crossings.

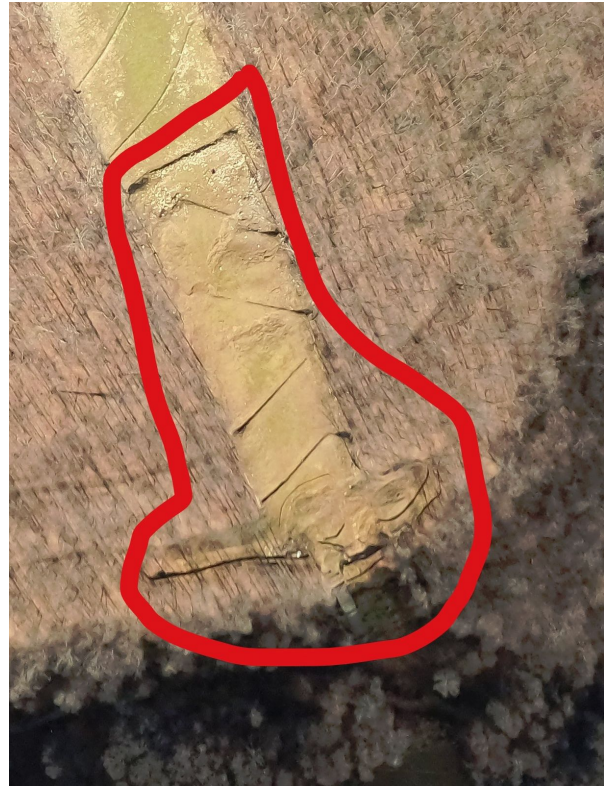
**Milepost 92.4** [G0024109.jpg](#)  
Large unvegetated areas adjacent to stream crossing on both sides. Rill erosion occurring on the slope above the stream. Possible slips forming on slope at this location. Inspection requested.

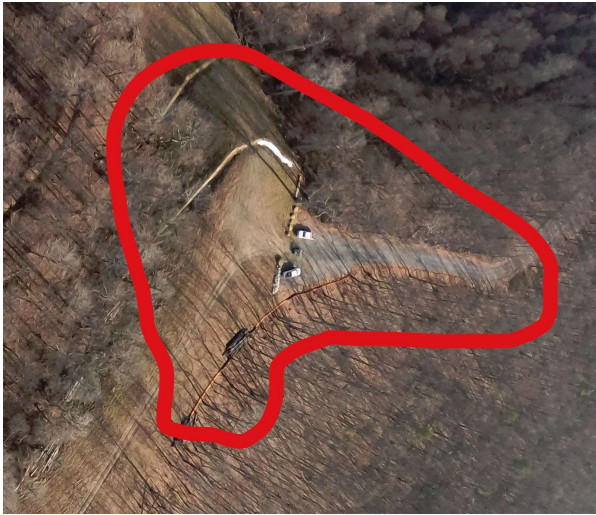
**Milepost 91.8** [G0024119.jpg](#)  
Areas along access road at the top of ridge need inspection for erosion along edges of access road.

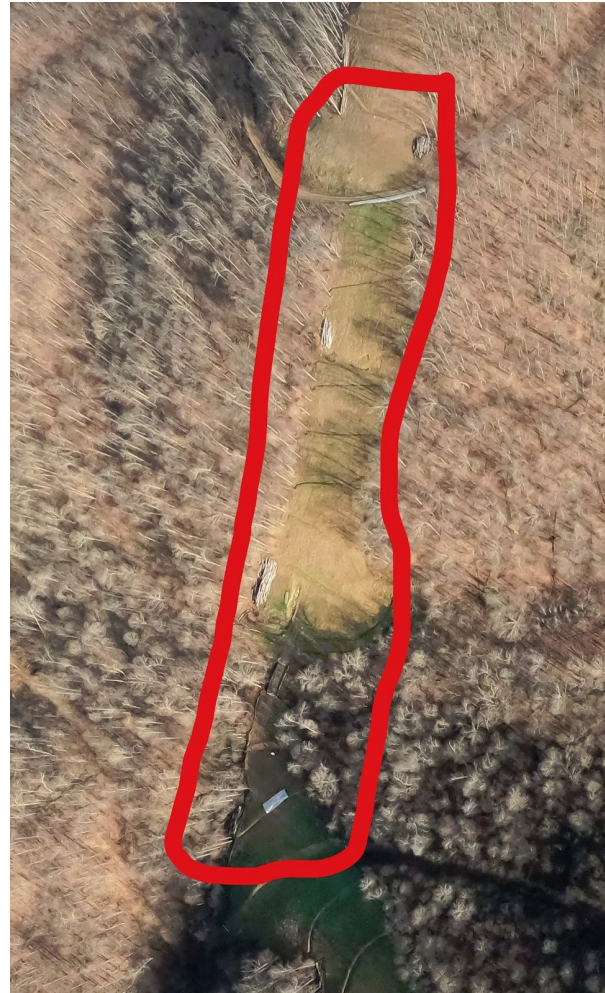
**Milepost 90.7** [G0024138.jpg](#)  
Unvegetated areas adjacent to stream crossing on both sides. Inspection requested.

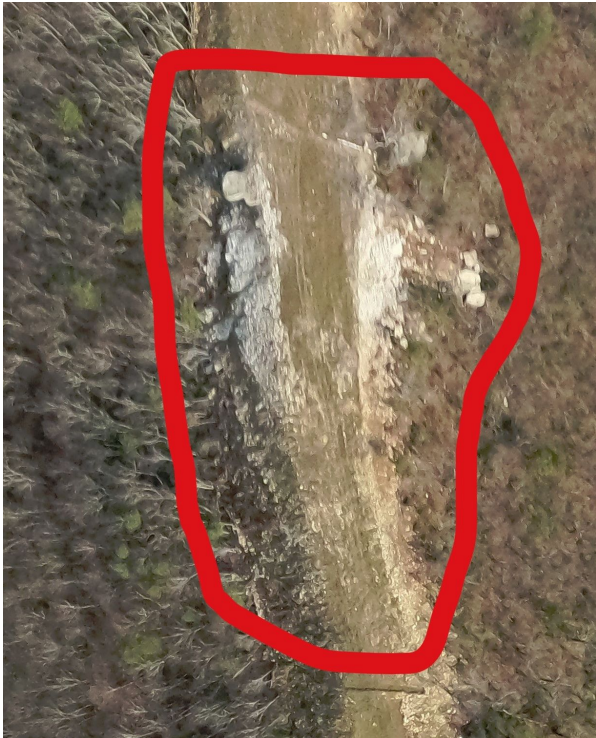
**Milepost 90.3** [G0024144.jpg](#)

A large amount of rock is strewn along the edge of ROW at the top of the ridge. Several large rocks have rolled out of ROW into the forest.

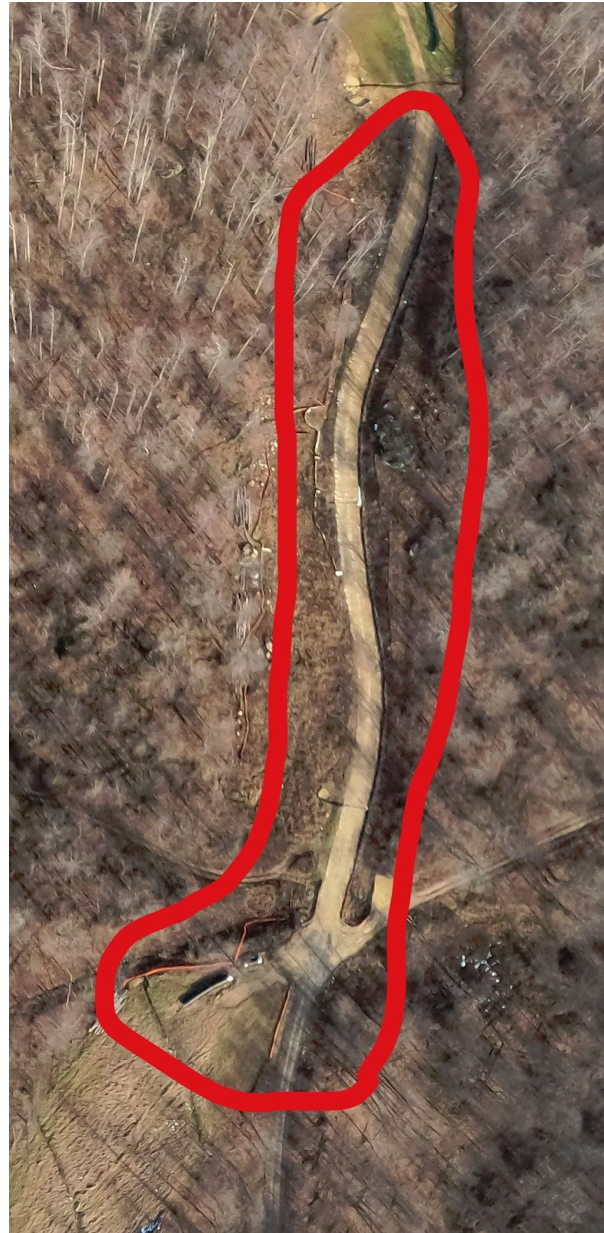
**Milepost 89.7** [G0024156.jpg](#)

Area at the intersection with the access road is bare and needs inspection. Wetlands crossing needs seeding. It has lain bare for more than 6 months.

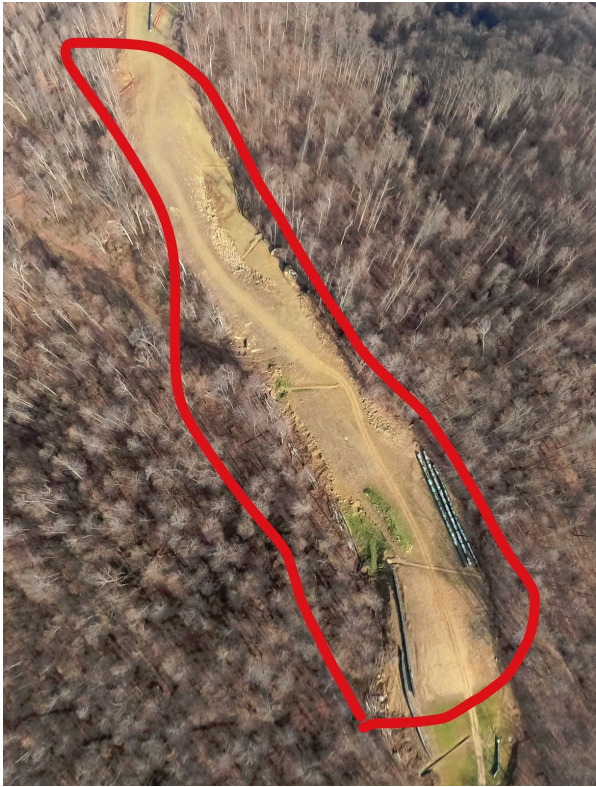
**Milepost 89.4** [G0024159.jpg](#)  
Large unvegetated area on the ridge line.  
Inspection and seeding requested.

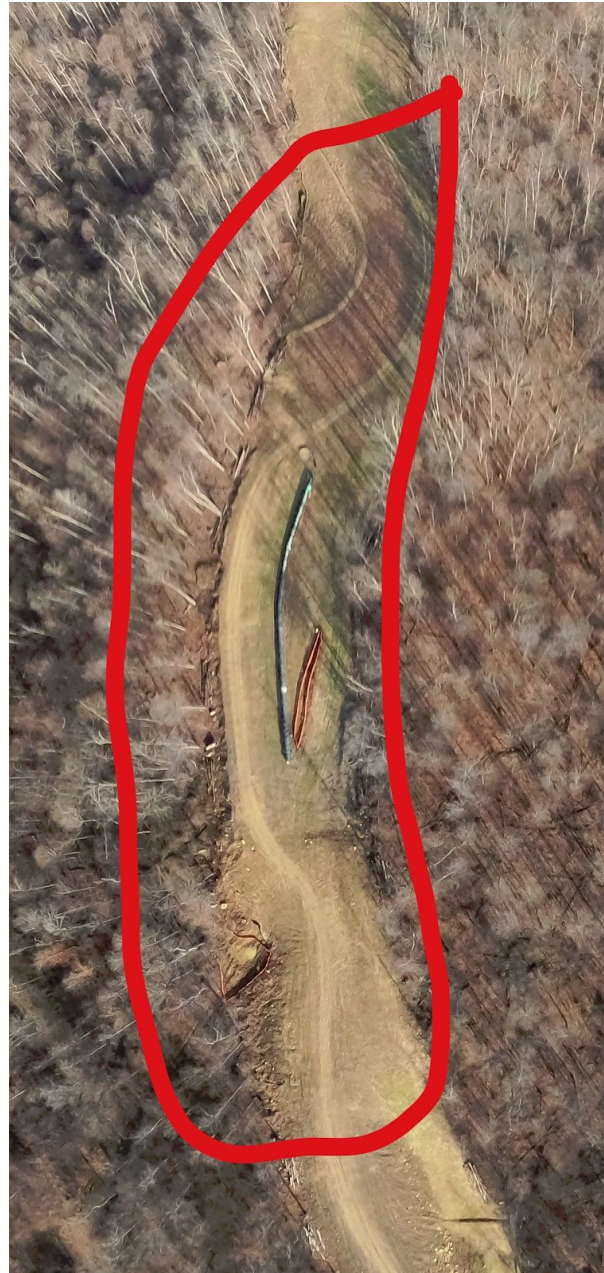
**Milepost 89.2** [G0024162.jpg](#)  
Bare unvegetated areas on the ridge line.  
Seeding maintenance needed at this  
location.

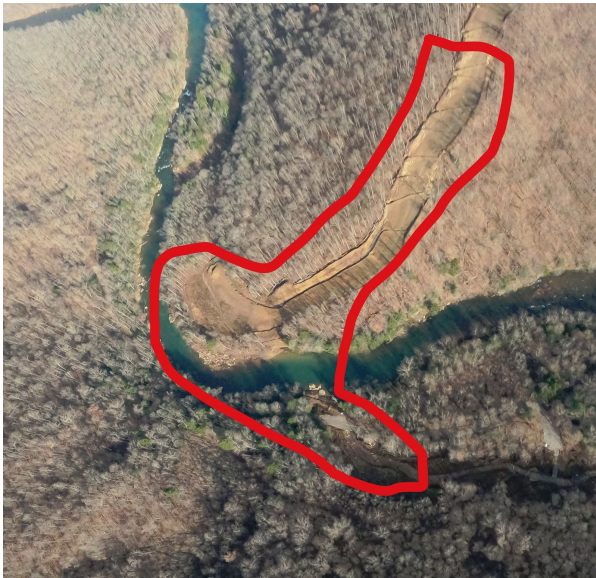
**Milepost 87.2 - 87.4** [G0024192.jpg](#)  
Large area with no vegetative cover next to river crossing. There is evidence of sediment flowing out of ROW, This area needs inspection.

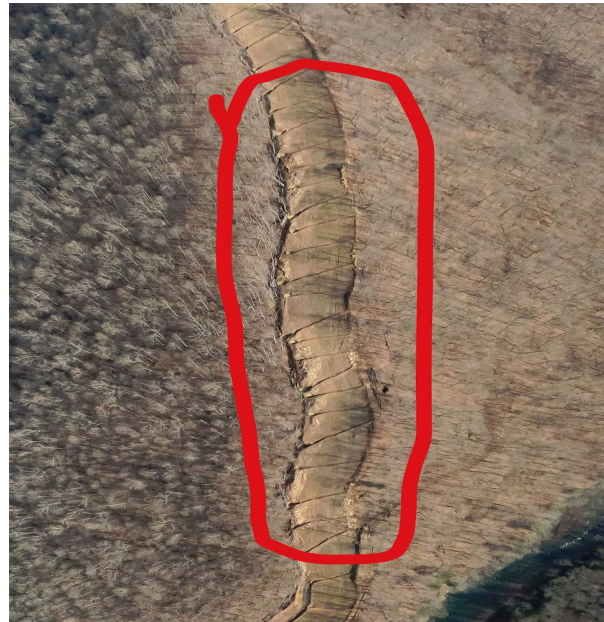
**Milepost 87.1** [G0024196.jpg](#)  
Remote area with long steep slope showing signs of erosion. This area needs inspection.

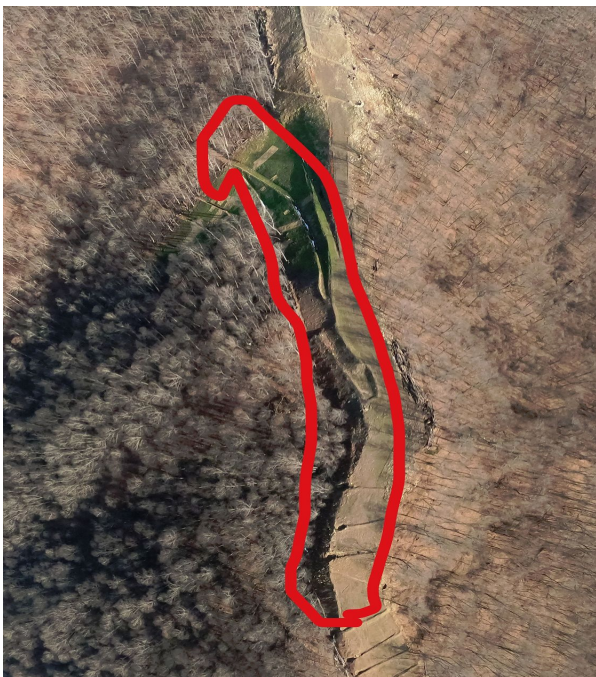
**Milepost 86.9** [G0024202.jpg](#)  
Steep drop off, clear erosion/brown dirt on side of dropoff. Drainage channels forming on edge of ROW. Needs inspection.

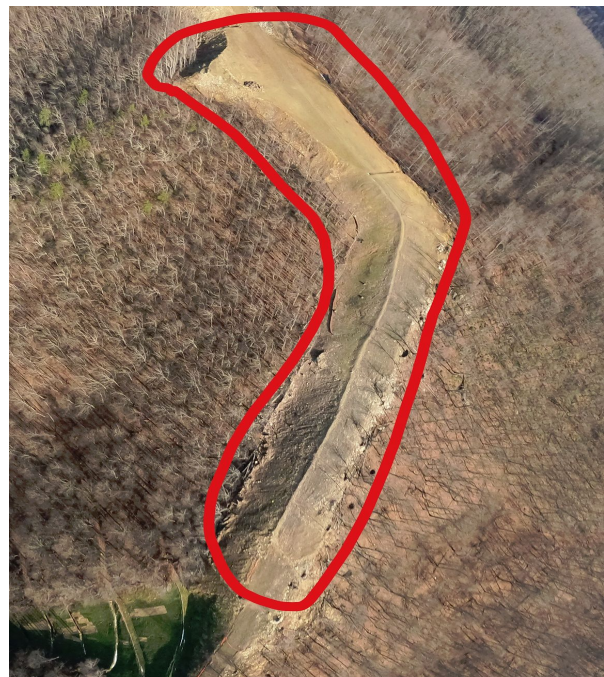
**Milepost 86.7 - 86.6** [G0024205.jpg](#)  
Large area with little vegetation on top of ridge. Remote location that needs inspection. It looks like the erosion control devices require maintenance.

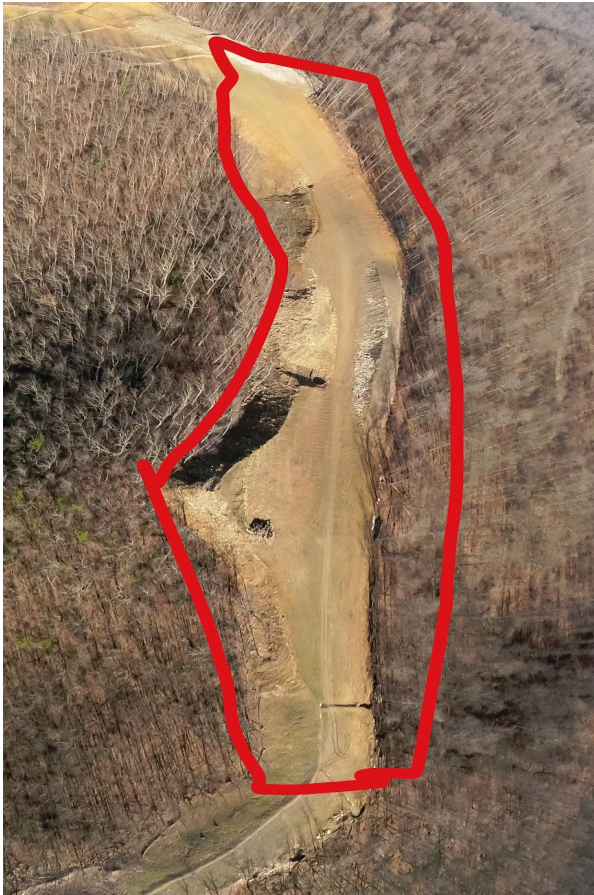
**Milepost 86.5** [G0024207.jpg](#)

Large area on ridge with little vegetation showing. Perimeter erosion control measures are not visible. Inspection needed.

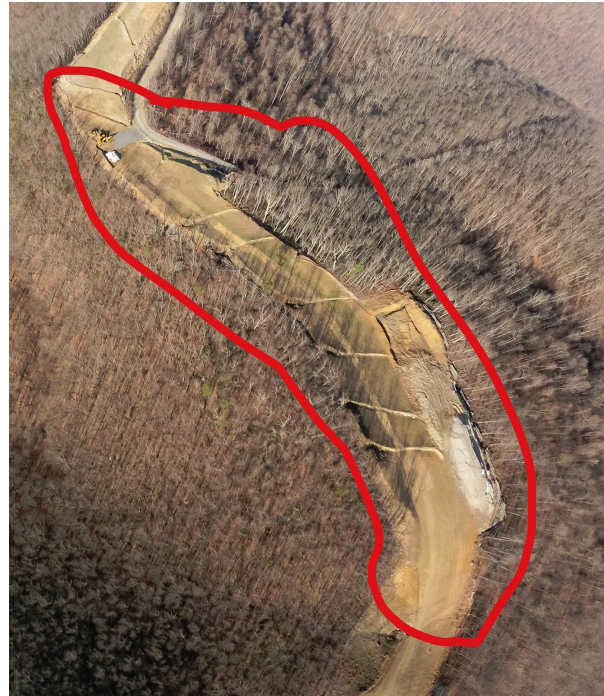
**Milepost 86.3** [G0024210.jpg](#)

Large bare area on slope. How long has this area remained bare? Perimeter controls are difficult to see. No E&S measures are visible at the bottom of the slope. This area needs ground inspection.

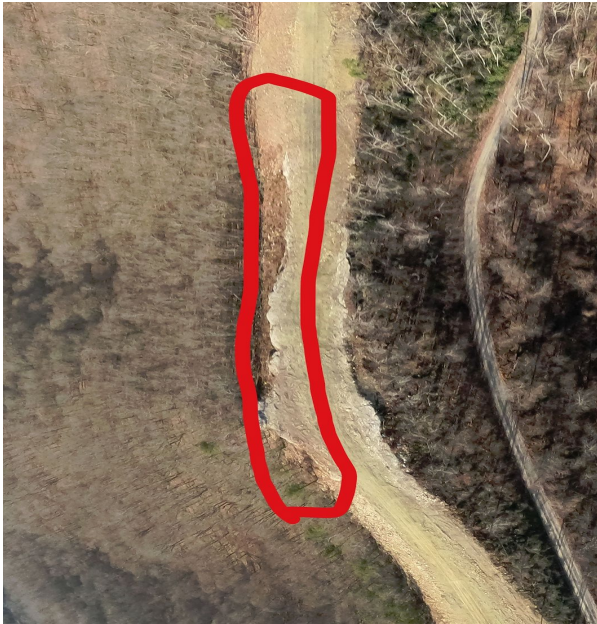
**Milepost 86.0** [G0024217.jpg](#)  
Large bare area forming. Soil collapse on slope. Need inspection for stabilization.

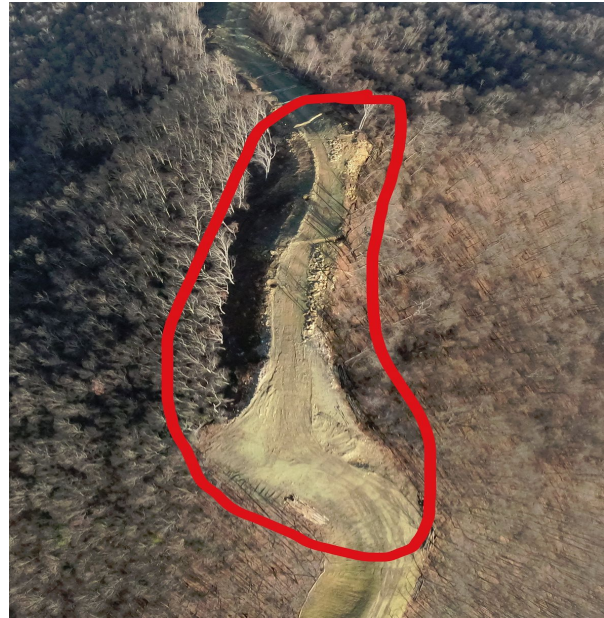
**Milepost 84.7** [G0024239.jpg](#)  
This area has sparse vegetation. It has lain bare for more than 6 months. Very remote location. Inspection requested.

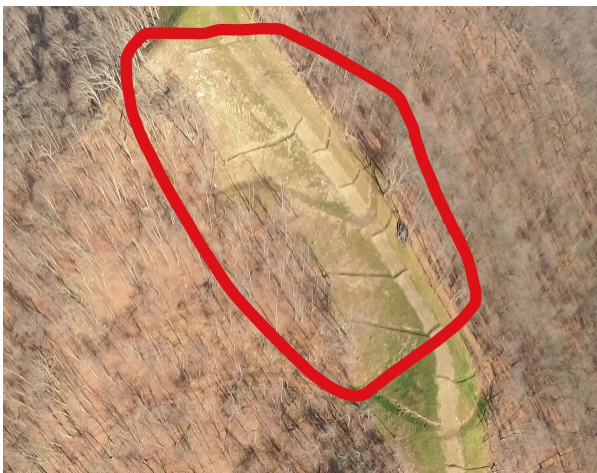
**Milepost 83.7** [G0024252.jpg](#)  
Bare areas on the upper slope need reseeding. Inspection requested.

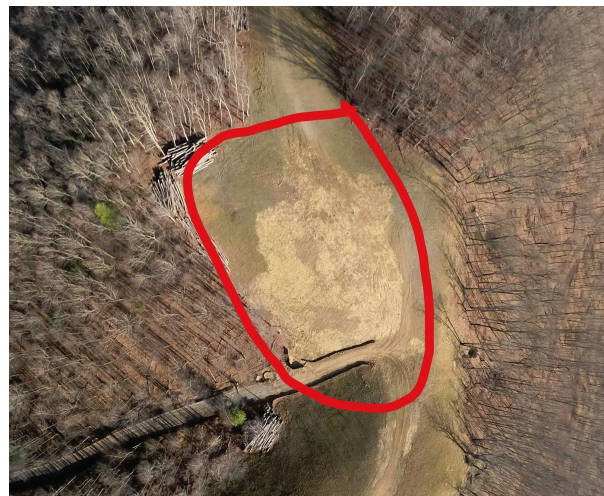
**Milepost 83** [G0024264.jpg](#)  
Bare area on top of ridge. Additional seeding needed to cover the area.

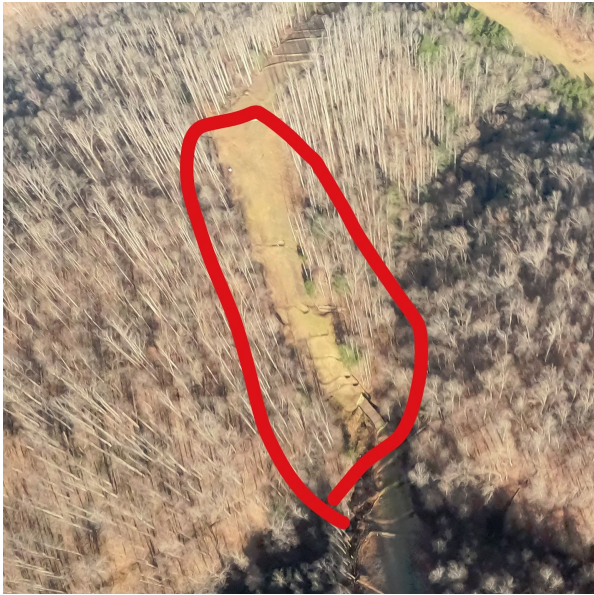
**Milepost 82.6** [G0024271.jpg](#)  
Steep slope with sparse vegetation in remote area. Additional stabilization measures needed. Inspection requested.

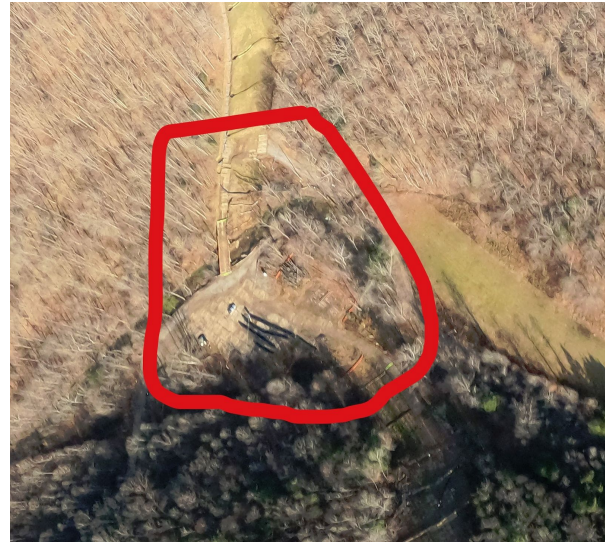
**Milepost 82.3** [G0024276.jpg](#)  
Perimeter controls for large bare area are at the edge of stream crossing, instead of setback from stream bank. This area needs stabilization measures installed. Inspection requested.

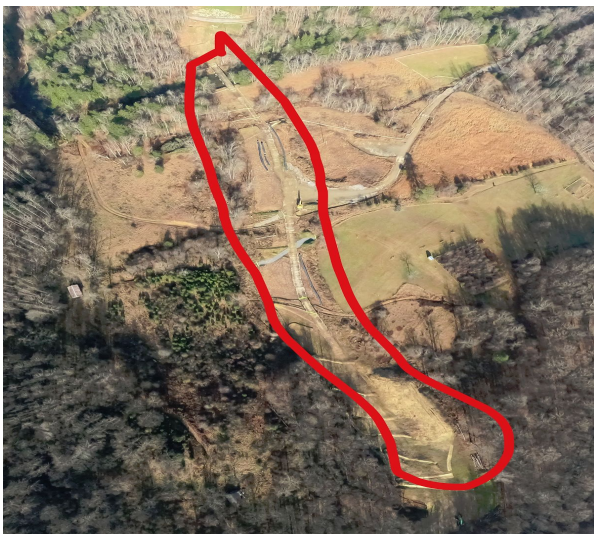
**Milepost 81.8** [G0024285.jpg](#)  
Several areas without vegetation cover next to stream crossings.

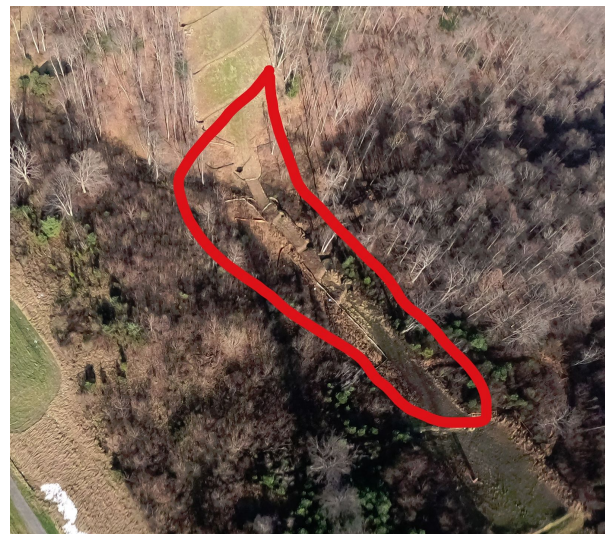
**Milepost 80.8** [G0024302.jpg](#)  
Bare areas on both sides of stream crossing. Inspection requested.

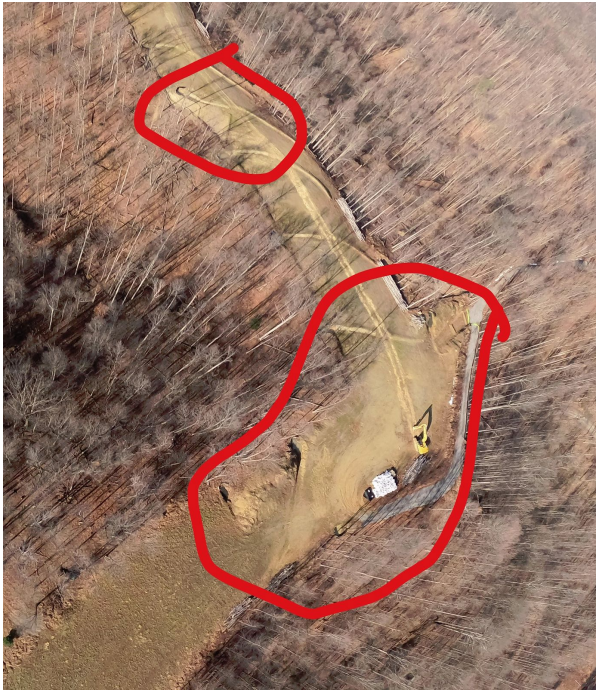
**Milepost 80.3** [G0024310.jpg](#)  
Stabilization measures for bare areas are needed. Inspection for cover requested.
