January 13, 2020

SUBJ: Mountain Valley Pipeline Stabilization
Braxton, Lewis and Doddridge Counties, WV

We are submitting documentation of slips and lack of stabilization in the right-of-way of the Mountain Valley Pipeline.

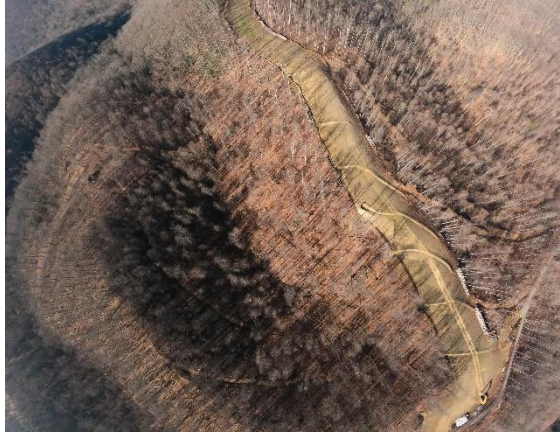
Milepost 80.2 [G0024312.jpg](#)
Possible washouts through woods,
sediment piles

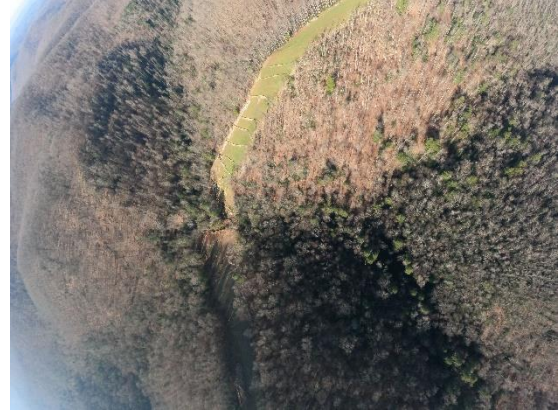
Milepost 79.7 [G0024321.jpg](#)
Bare areas, looks like sediment may
have washed out where they are
trying to contain

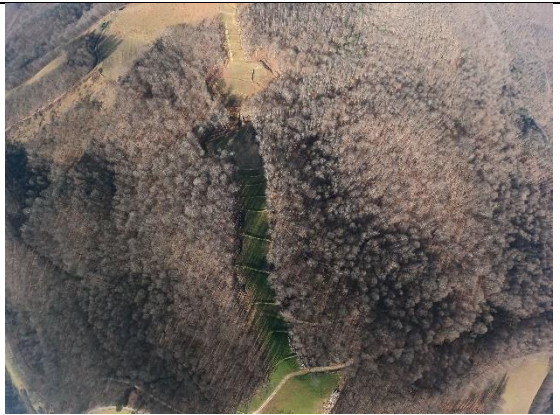
Milepost 78.2 [G0024346.jpg](#)
Bare areas, lot of loose dirt by a
stream crossing.

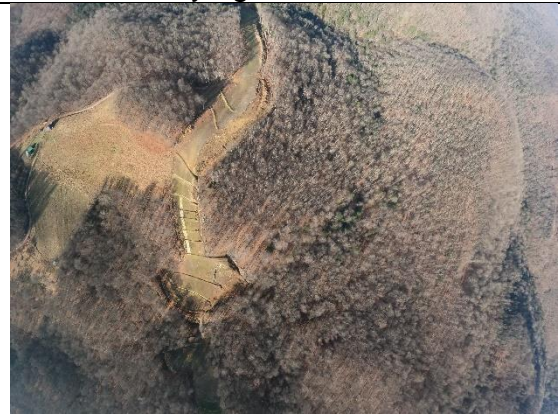
Milepost 77.9 [G0024350.jpg](#)
Bare areas by top water bars, piles of
dirt/sediment

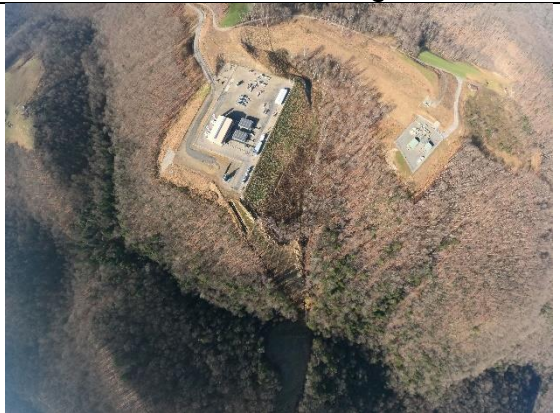
Milepost 77.5 [G0024358.jpg](#)
Rock/dirt piles/sediment coming off of
hillside and slope around
Compressor station

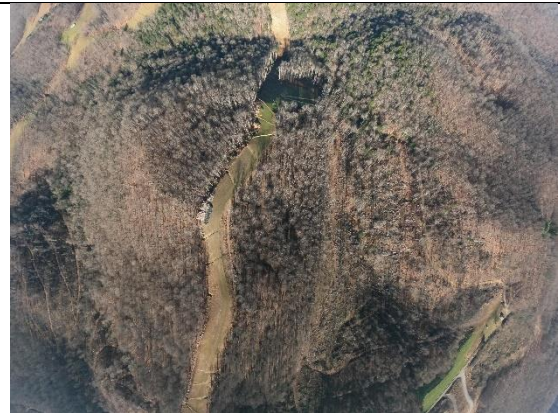
Milepost 76.9 [G0024367.jpg](#)
Bare patches, possible erosion.

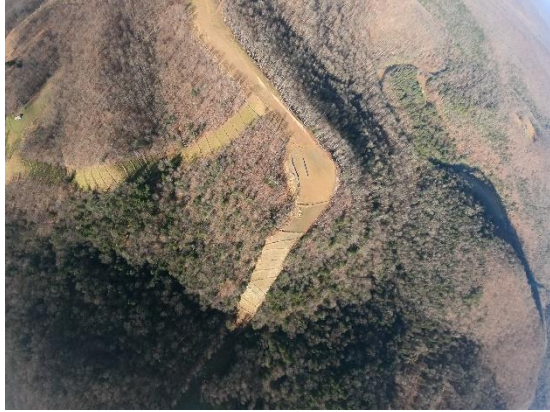
Milepost 76.5 [G0024373.jpg](#)
Bare ground. No cover in several areas.

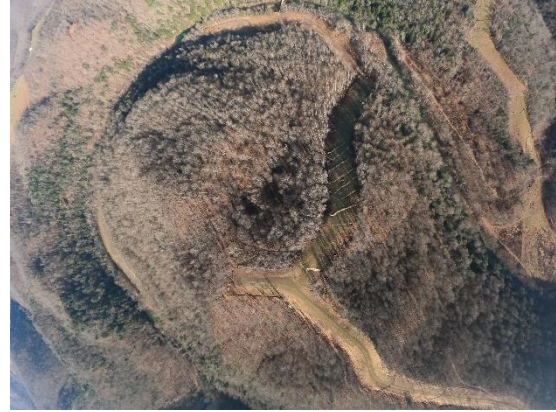
Milepost 75.1 [G0024401.jpg](#)
Bare areas next to stream crossing. Erosion devices appear to be missing.

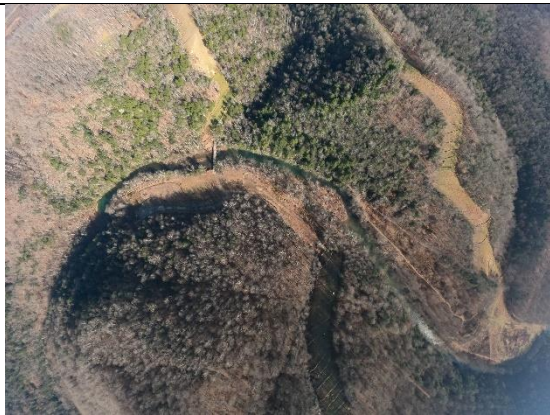
Milepost 74.9 [G0024404.jpg](#)
Major Stream crossing issues.

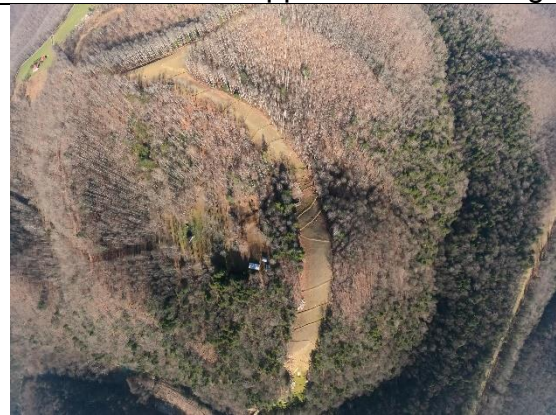
Milepost 74.6 [G0024410.jpg](#)
Bare dirt. No vegetative cover in areas.

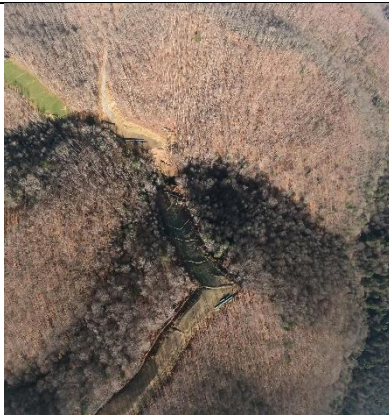
Milepost 74.1 [G0024418.jpg](#)
Bare ground, steep drop off, possible hole, pipe laying out exposed

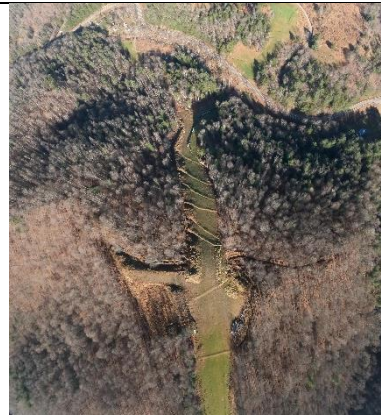
Milepost 72.6 [G0024449.jpg](#)
No vegetation on slopes above stream crossing.

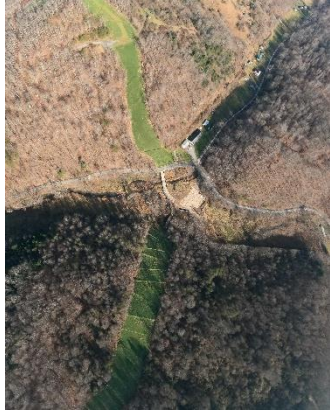
Milepost 68.7 [G0024524.jpg](#)
Muddy construction area/water crossing, timber mats

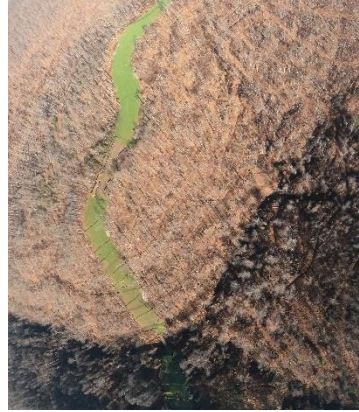
Milepost 69.9 [G0024501.jpg](#)
Disturbed ground, pipe out of the ground and lying on the ground on both sides

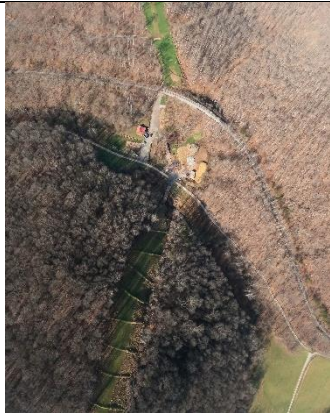
Milepost 65.5 [G0024584.jpg](#)
Construction area. Bare unvegetated areas next to stream.

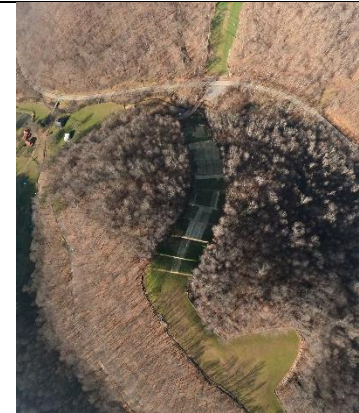
Milepost 62.2 [G0024643.jpg](#)
Extensive matting shown with slips at MP 62.3 on 10/15/20, 10/29/20 and 12/5/20.

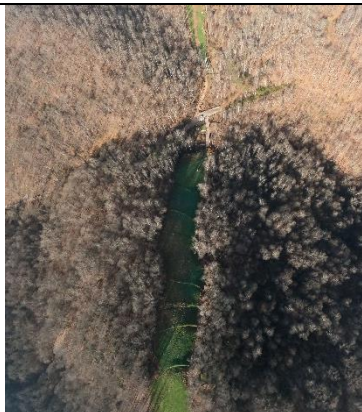
Milepost 61.3 [G0024660.jpg](#)
Lack of vegetation next to stream crossing.

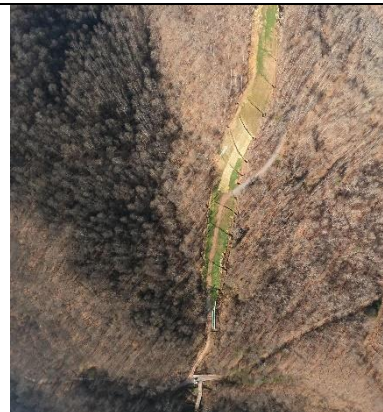
Milepost 61.1 [G0024664.jpg](#)
Large area of bare soil on slopes with matting.

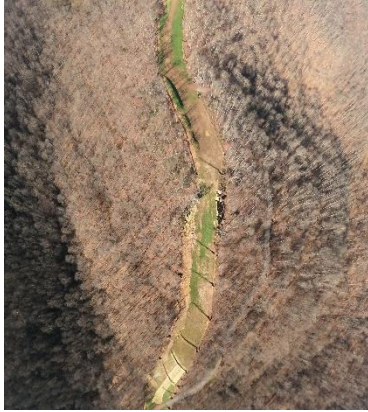
Milepost 61 [G0024667.jpg](#)
Several large unvegetated areas.

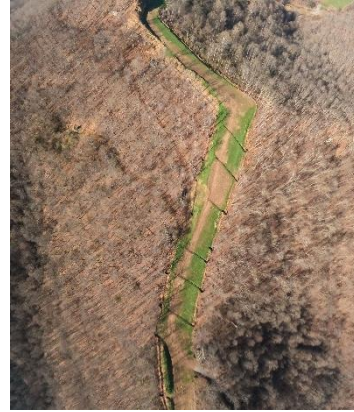
Milepost 60.8 [G0024671.jpg](#)
Several areas with lack of vegetation on steep slopes.

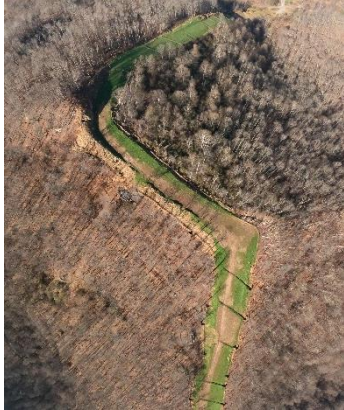
Milepost 60.6 [G0024673.jpg](#)
Unvegetated areas with signs of slip on slope.

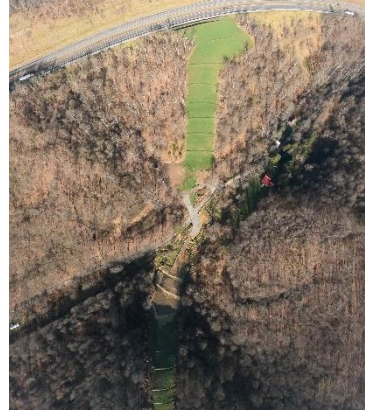
Milepost 60.3 [G0024680.jpg](#)
Bare dirt next to stream crossing.

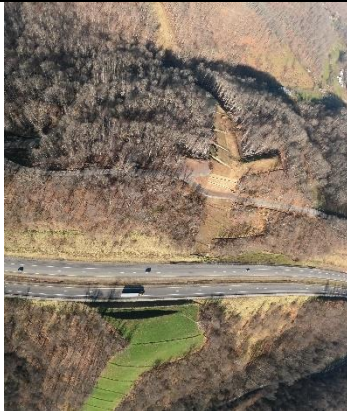
Milepost 60 [G0024684.jpg](#)
ROW v. brown, bare areas north of I-79, compared to ROW to immediate south.

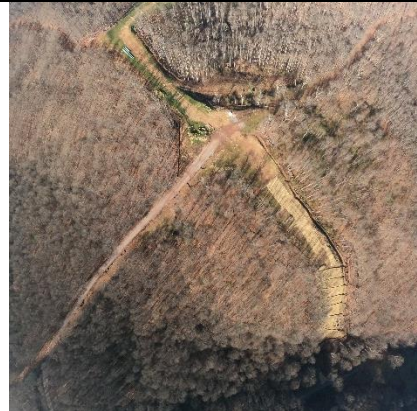
Milepost 59.7 [G0024690.jpg](#)
Bare areas at and near intersection with extremely steep access road.

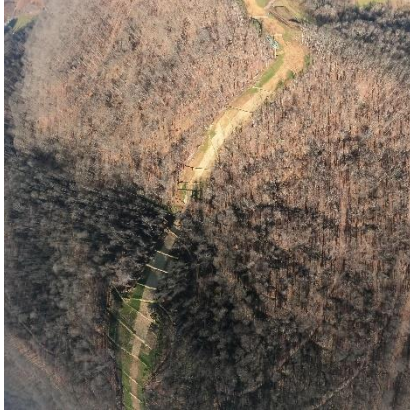
Milepost 59.4 [G0024695.jpg](#)
Large bare, unvegetated areas, E&S measures need maintenance.

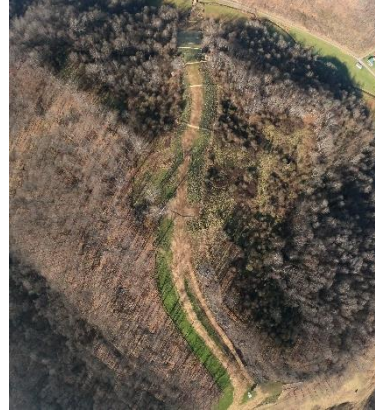
Milepost 58.7 [G0024705.jpg](#)
No vegetative in ROW next to wetlands crossing.

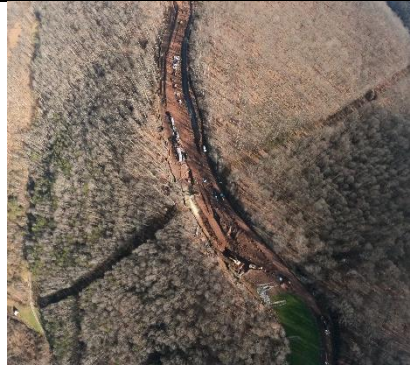
Milepost 57.3 [G0024732.jpg](#)
Construction underway at what appears to be an interconnect point.

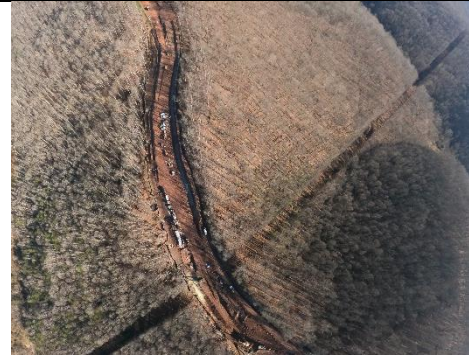
Milepost 57.2 [G0024733.jpg](#)
Large areas of bare dirt. There is no vegetation in ROW. Area under construction.

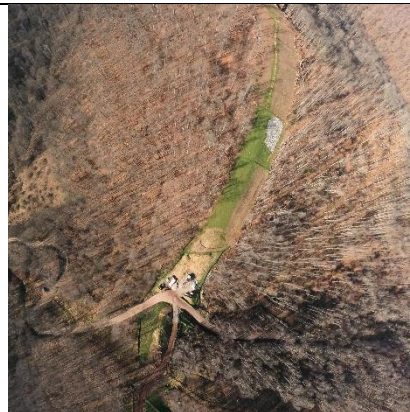
Milepost 56.5 [G0024748.jpg](#)
Bare, unvegetated areas north of Brush Run Rd and farther uphill. Slip area shown midway up slope.

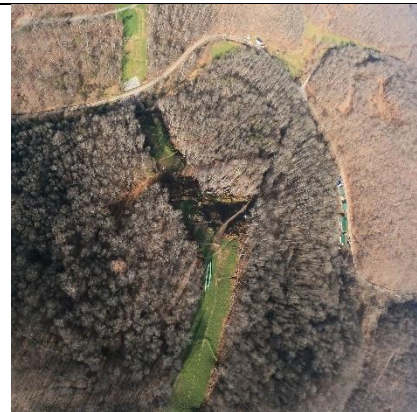
Milepost 55.2 [G0024770.jpg](#)
Problem area south of Copley Rd. ROW and triangular workspace area in shadow show collapsing slopes and sediment in stream crossing.

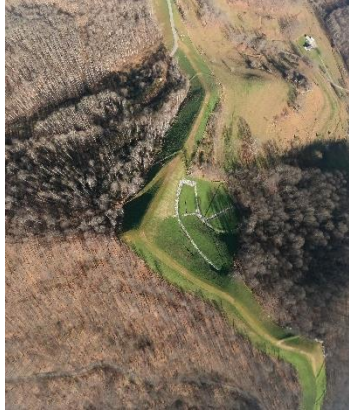
Milepost 53.5 [G0024800.jpg](#)
Large slip area re-vegetated. Upper slopes show signs of instability.

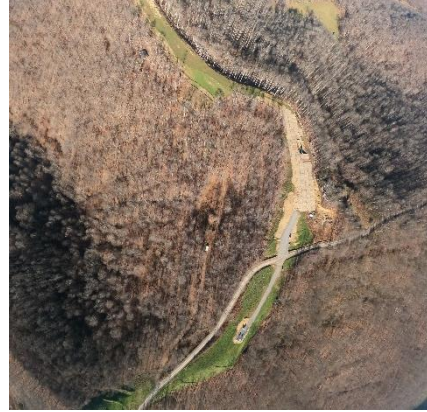
Milepost 52.8 [G0024810.jpg](#)
Large timber mat surface with slip and erosion control measure failure

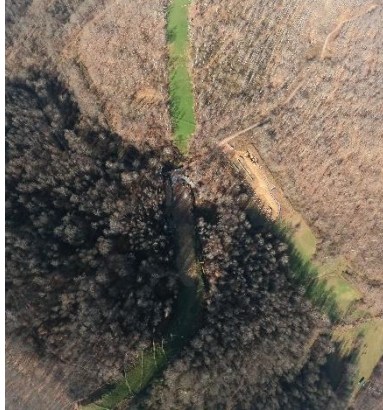
Milepost 52.3 [G0024817.jpg](#)
Bare, unvegetated area south of Cove Lick access road crossing.

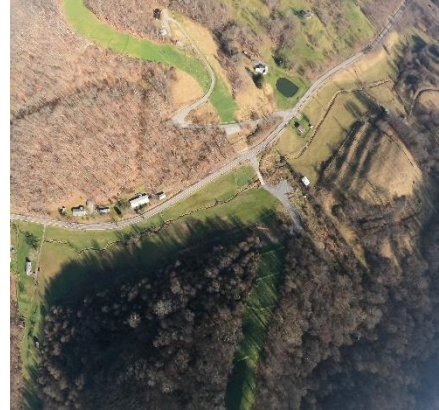
Milepost 47.9 [G0024901.jpg](#)
Bare areas south and north of road crossing US 119/33 near Camden

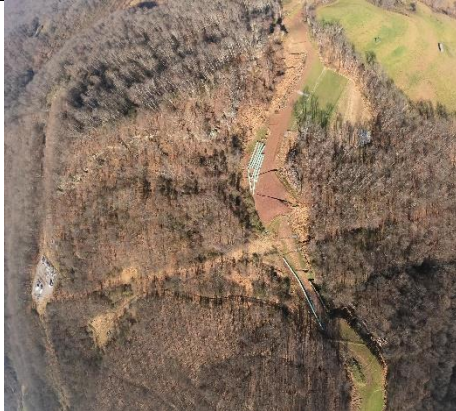
Milepost 47 [G0024921.jpg](#)
Bare, unvegetated area. Sediment overflowing E&S device near stream crossing. Large slip area that is still unvegetated.

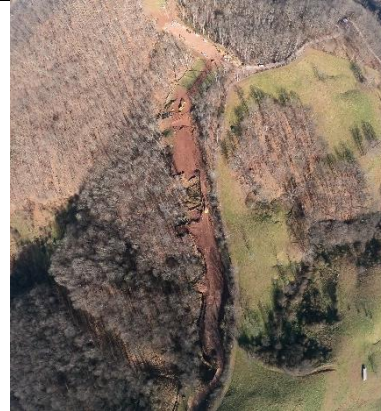
Milepost 46.6 [G0024928.jpg](#)
Construction underway. Large bare, unvegetated areas. Sediment flowing into stream crossings. Slip occurring on north side of photo.

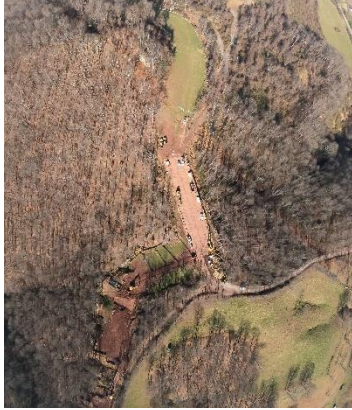
Milepost 46.5 [G0024931.jpg](#)
Unvegetated areas with sediment flowing off LOD.

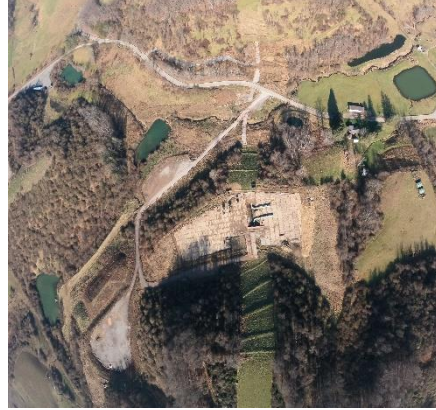
Milepost 45.9 [G0024942.jpg](#)
Large timber-matted work area south of Churchville Rd/CR-9 crossing. Sediment in stream below road crossing.

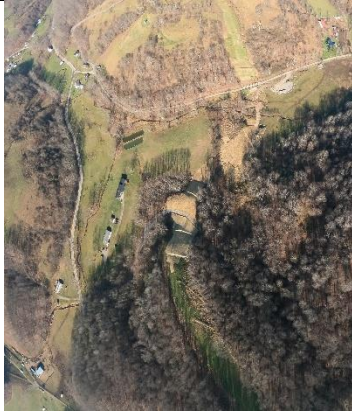
Milepost 44.8 [G0024963.jpg](#)
Unvegetated areas and extensive matting south of access road to crossing of Fink Ck. Sediment appears to be in stream.

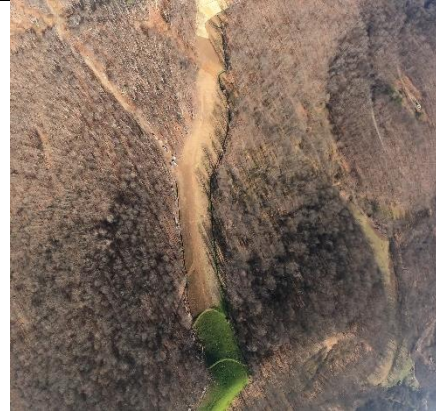
Milepost 43.5 [G0024988.jpg](#)
Large unvegetated area, Needs grass and cover.

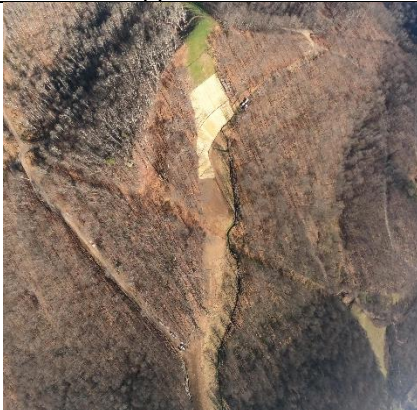
Milepost 44.3 [G0024990.jpg](#)
Large unvegetated area, Needs grass and cover.

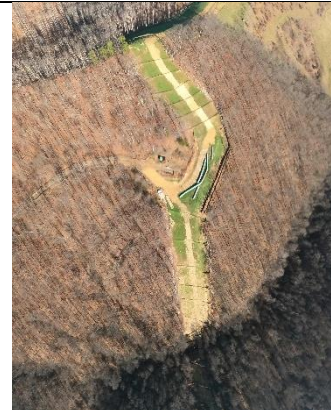
Milepost 43.0 [G0024996.jpg](#)
Unvegetated area at bottom slope is eroding into stream.

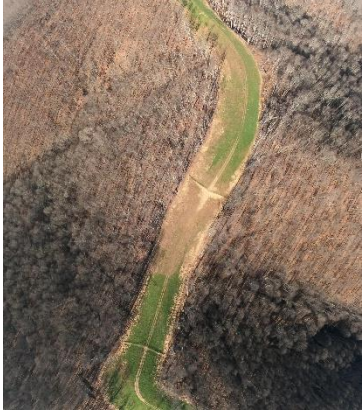
<p>Milepost 40.2 G0025044.jpg Unvegetated area needs re-seeding.</p>

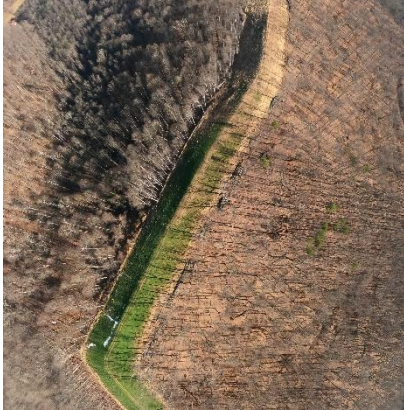
<p>Milepost 38.6 G0025075.jpg Large area of dead grass. Needs re-seeding.</p>

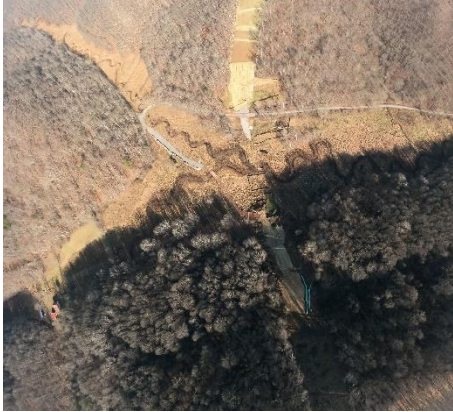
<p>Milepost 38.1 G0025085.jpg Needs detailed inspection. Slips forming above roadway. Bare areas above slips need vegetative cover or additional matting.</p>
