Cave Report

July 2019

A significant portion of the Mountain Valley Pipeline route through Giles, Craig, & Montgomery county crosses karst terrain. In May, 2019, an underground cavity or small cave was opened due to blasting in the MVP Right of Way near the Craig / Giles county line. The exposed rock shown in Figures 3 and 4 is limestone of high calcium carbonate content, and effervesces violently with contact to 10% HCl. Air temperatures (that day) in the ROW were in the mid to upper 80s as shown in Table 1, yet temperature readings at two cave openings were measured in the low to mid 50s. It is clear that an underground cavity exists in this area.

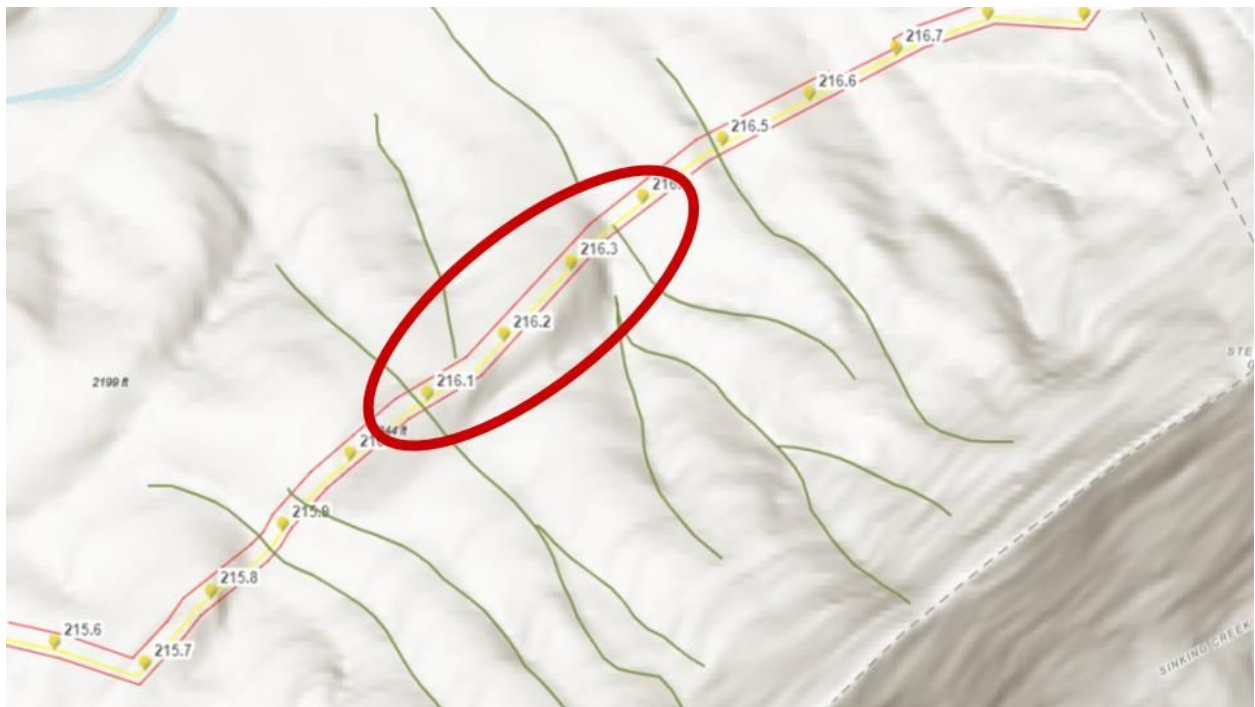
Figure 2: Drainage flow paths from ridge to valley and area of exposed cavern.

Figure 1 shows the location of the area in question, which falls between mile markers 216 - 216.5. This is in southeastern Giles county near the Craig county line. Blue dots in Figure 1 show the locations of photos taken in the field. Figure 2 examines terrain model flow paths from the ridge to the valley floor and Sinking creek. Area of exposed cavern is shown below in the red oval.

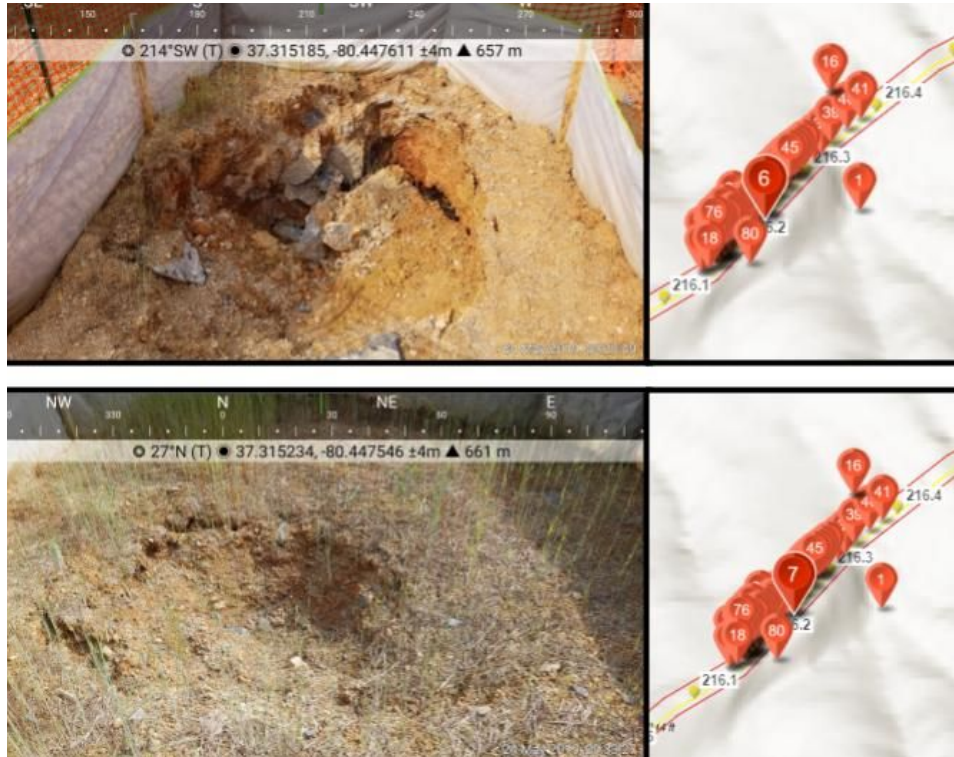
Figure 3: Two images showing areas of subsidence, the top is encircled in silt fence.

Field images show areas of subsidence along row, some of which were significant enough to encircle in silt fence. Blasting exposed cavities that were not visible before construction began. Examples are available in figures 3 and 4.

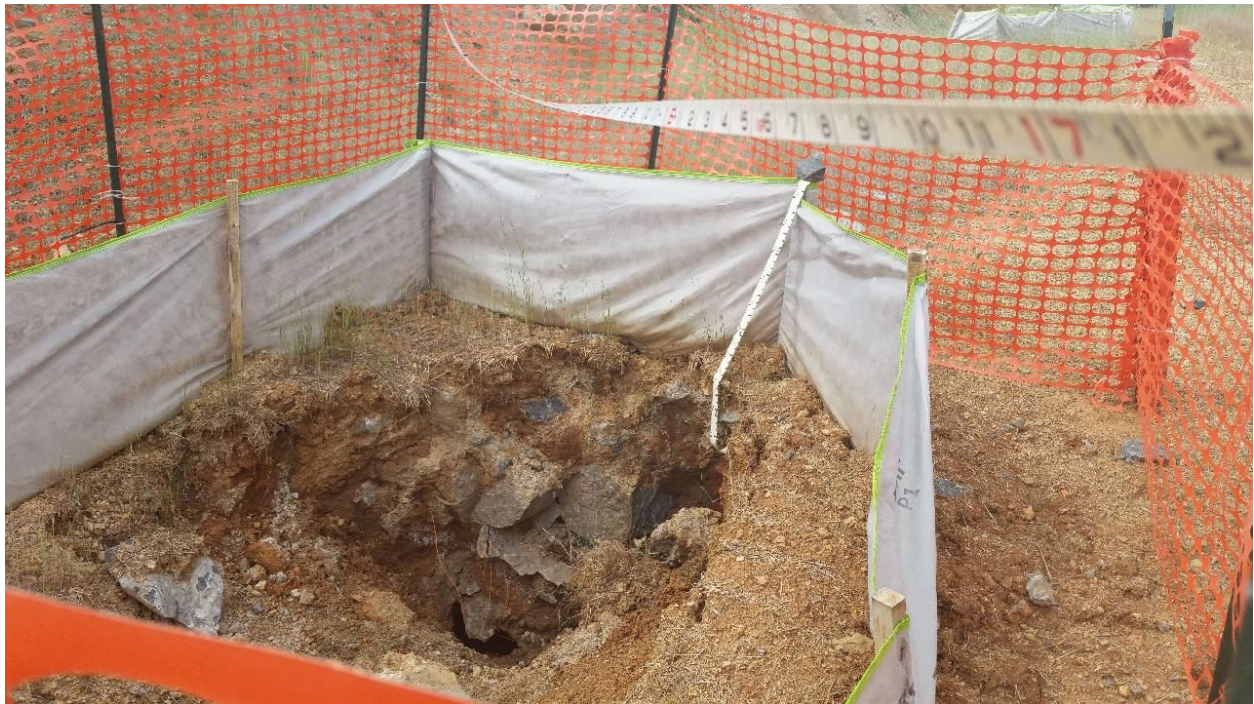
Figure 9: June site visit shows expanding subsidence.

Additional visits to the site show expanding areas of subsidence. Figures 9-

The extent of the underground caverns, potential impacts to underground aquifers and potential structural impacts to the pipeline needs further evaluation.
