September Report

June Virginia Water Control Board Meeting

Recent Problem Areas

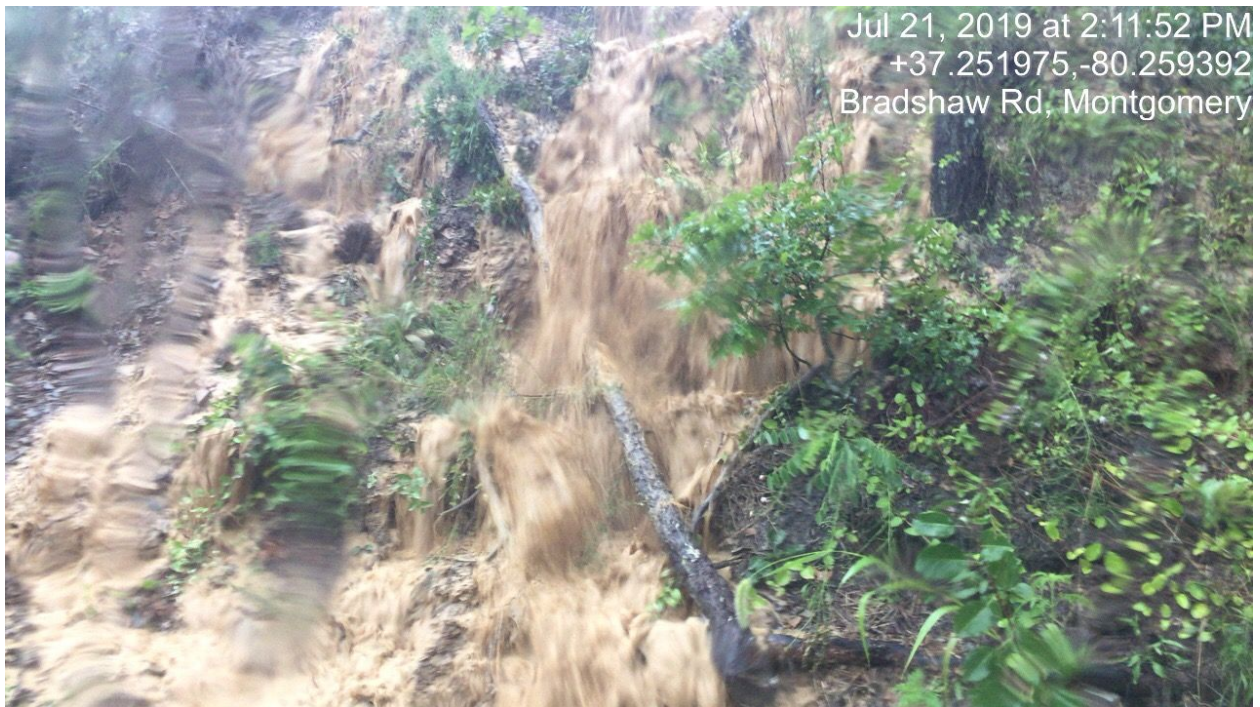
Figure 1. Sediment laden runoff flowing down slopes at bottom of Fort Lewis Mountain.

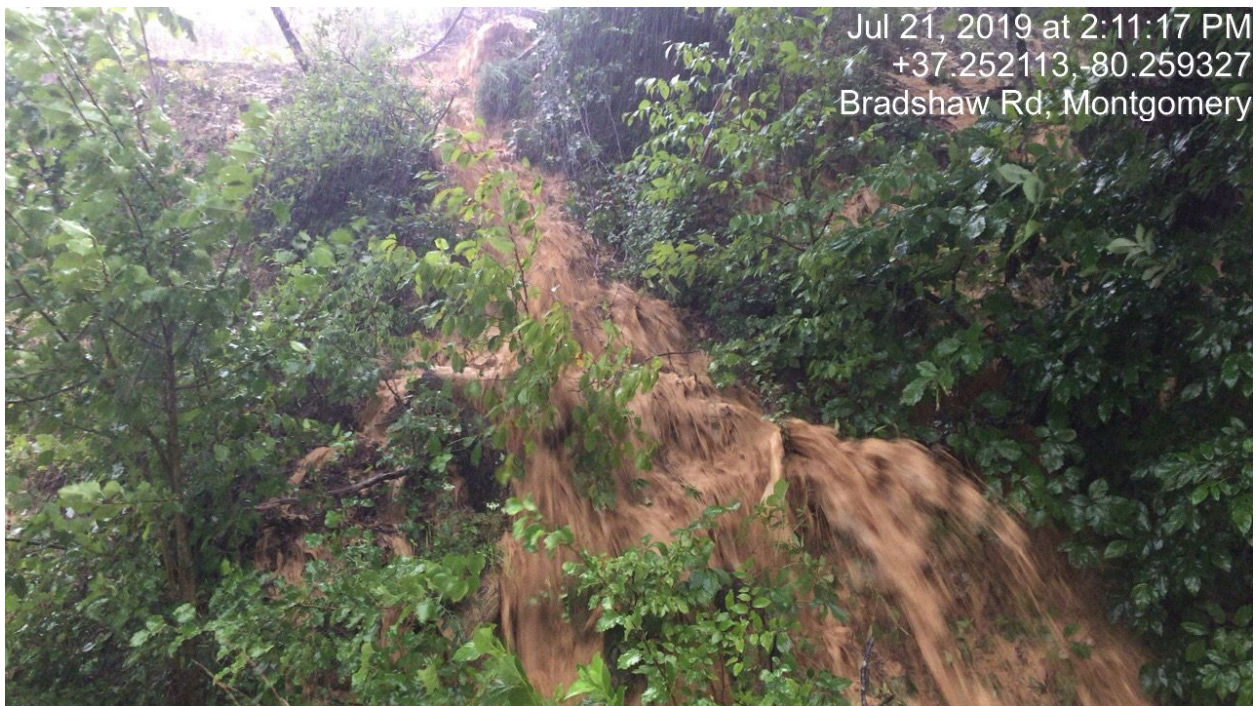
Figure 2. Sediment flowing down Fort Lewis Mountain with no controls.

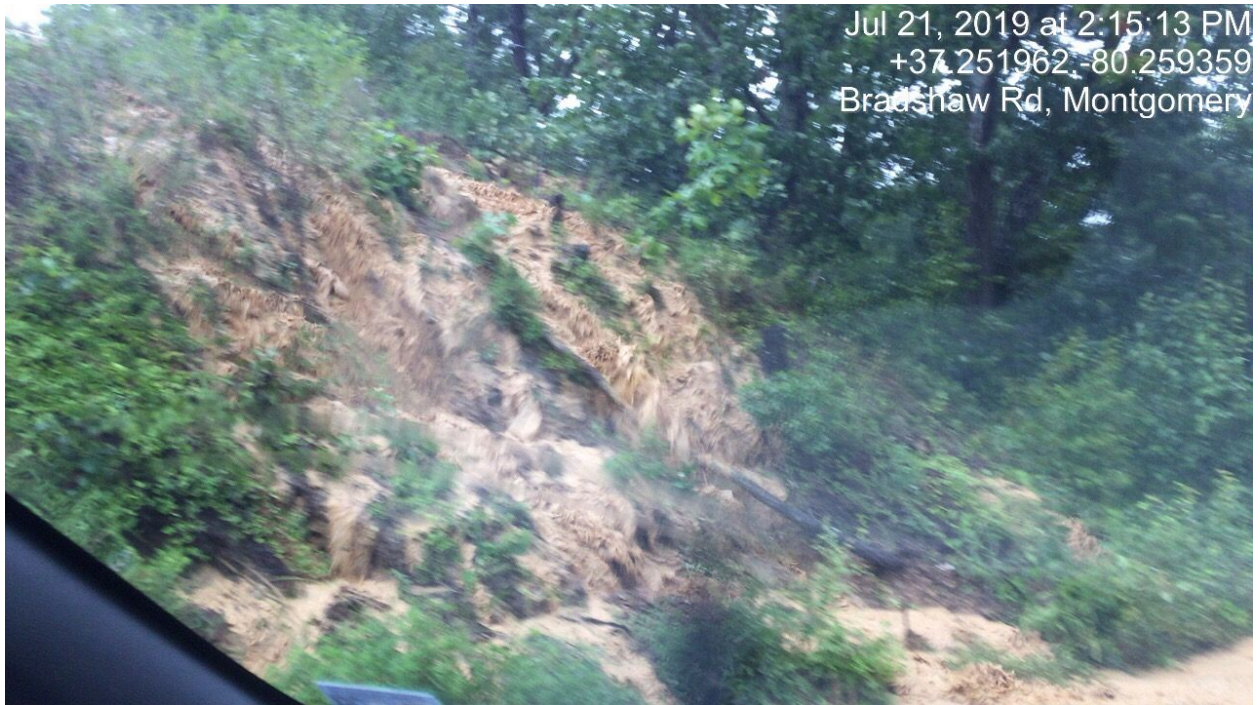
Figure 3. Runoff gouging gullies in steep slopes.

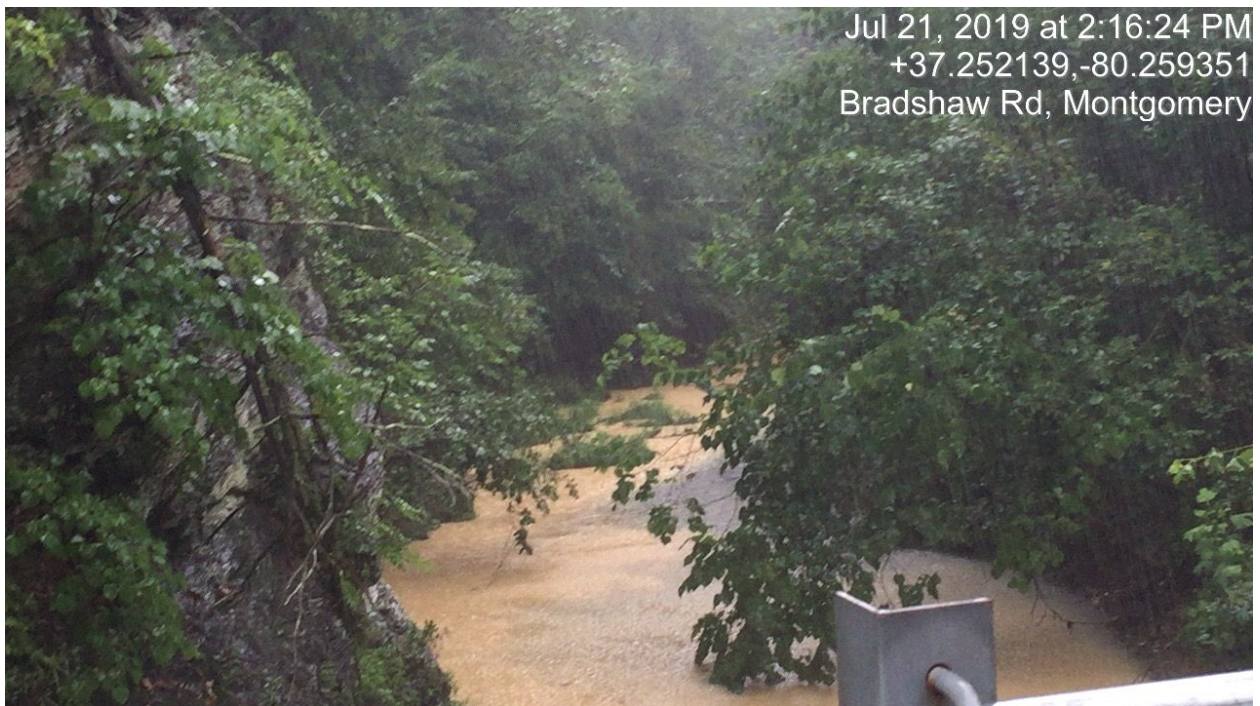
Figure 4. Sediment visible in Bradshaw Creek below MVP right-of-way.

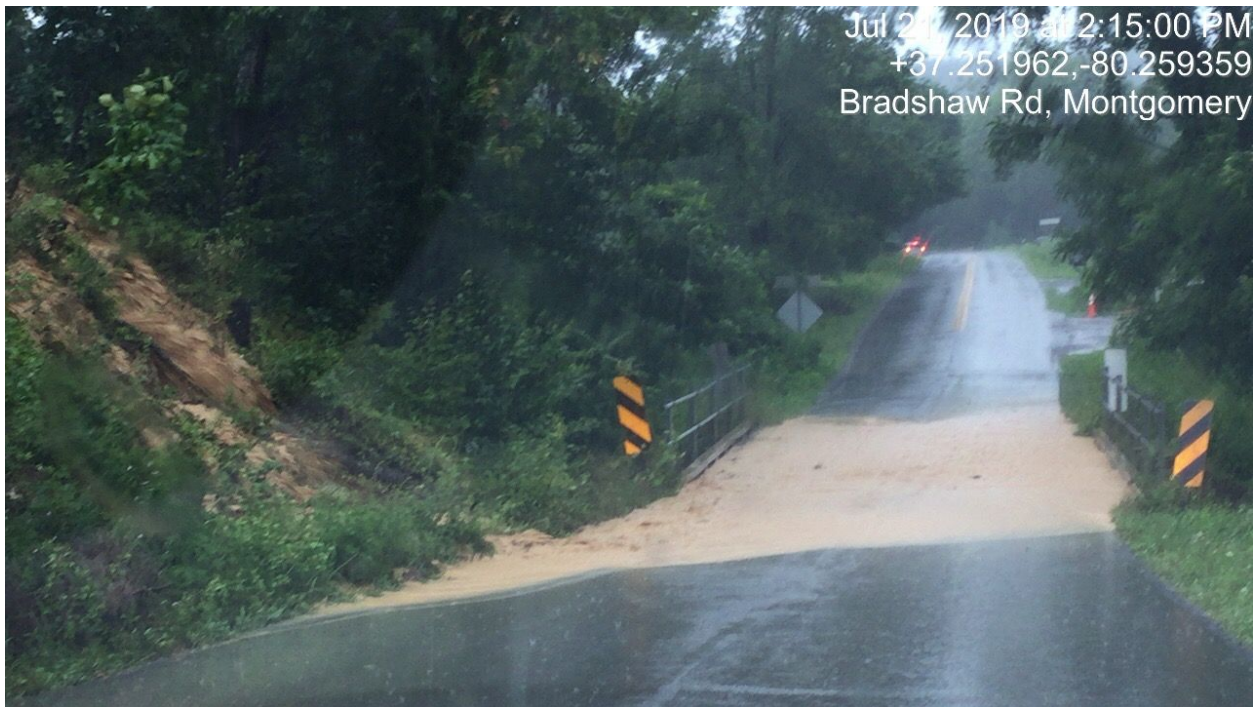
Figure 5. Sediment laden runoff flowing across Bradshaw Road into Bradshaw Creek.

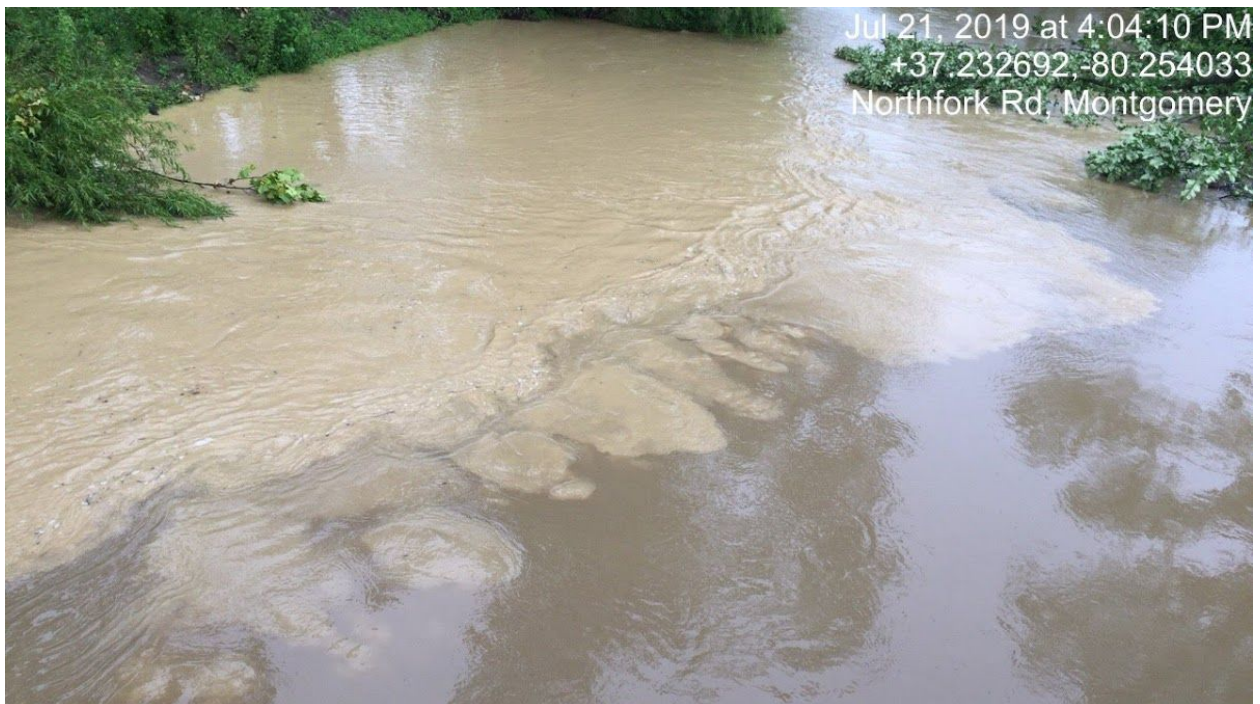
Figure 6. Confluence of Bradshaw Creek and North Fork Roanoke River. Sediment laden water from Bradshaw Creek shown at left of photo.

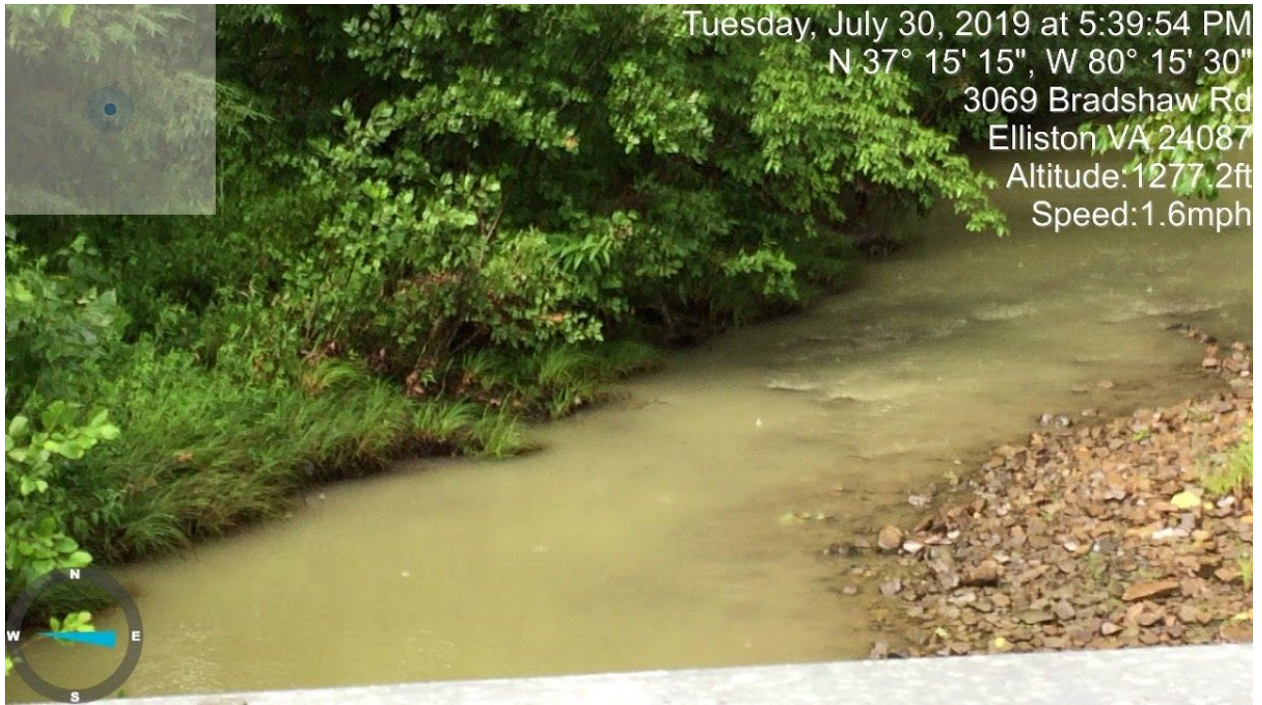
Figure 7. Sediment flowing in Bradshaw Creek after rainfall event on July 30, 2019.

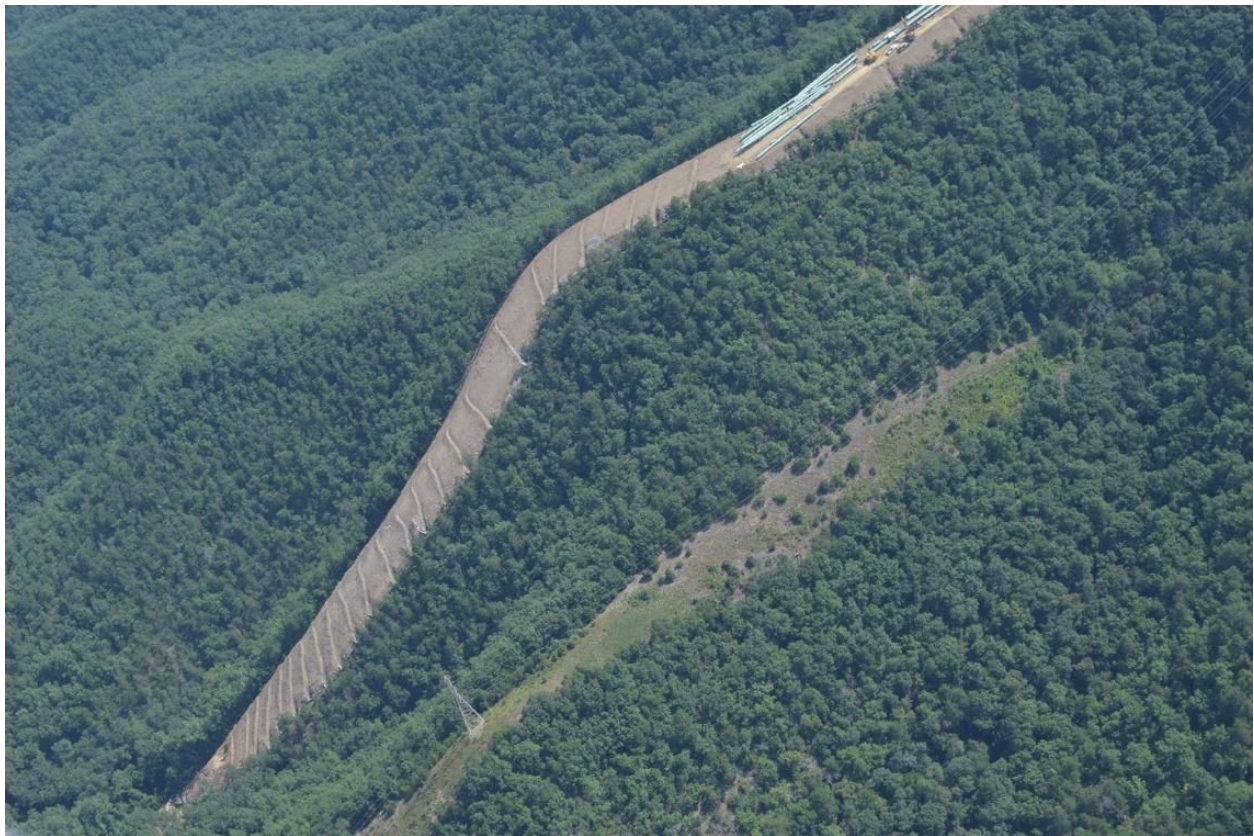
Figure 8. A July 27, 2017 flyover of the MVP ROW showed the magnitude of disturbance on steep slopes above Bradshaw Creek and other Roanoke River tributaries.

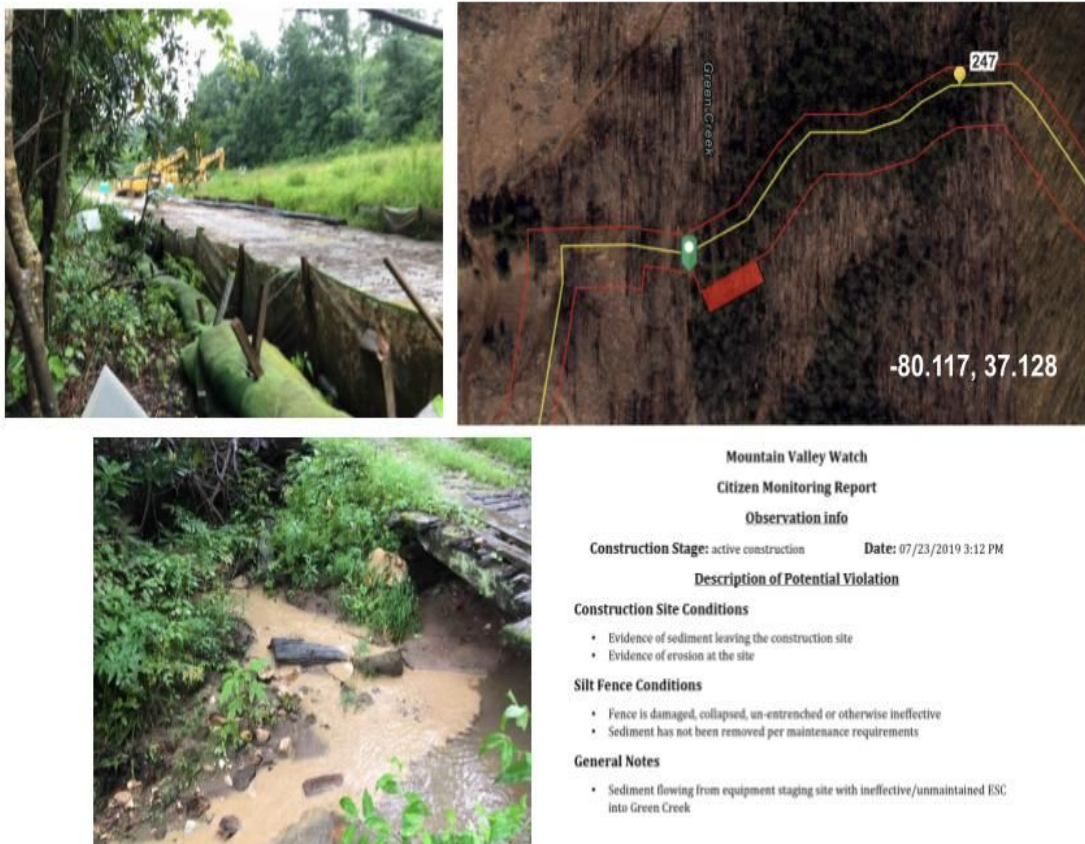
A severe sedimentation incident at this site was observed in the field on July 23, 2019 around 10:15 am and reported by Mountain Valley Watch to DEQ's PReP database on July 23, 2019 at 3:26 pm (reference number 291600), with additional information and photos submitted in a formal report at 3:28 pm. The formal report was sent to DEQ's automated email associated with the PReP database, as well as directly to Jerome Brooks and John McCutcheon.

Figure 9. Images of sedimentation to Green Creek July 23, 2019, with an excerpt from the report submitted to DEQ.

Status Reason: Appropriate compliance actions completed and verified by DEQ, Closure Comment: DEQ/MBP inspectors returned to the area on 8/3/19 and observed the specified repairs to the timber bridge geotextile liner had been completed. Sediment that had been deposited in the stream was reported removed on 7/27/18 [sic] and on the 8/3/19 inspection, DEQ/MBP inspectors verified that sediment in the stream bed had been retrieved.

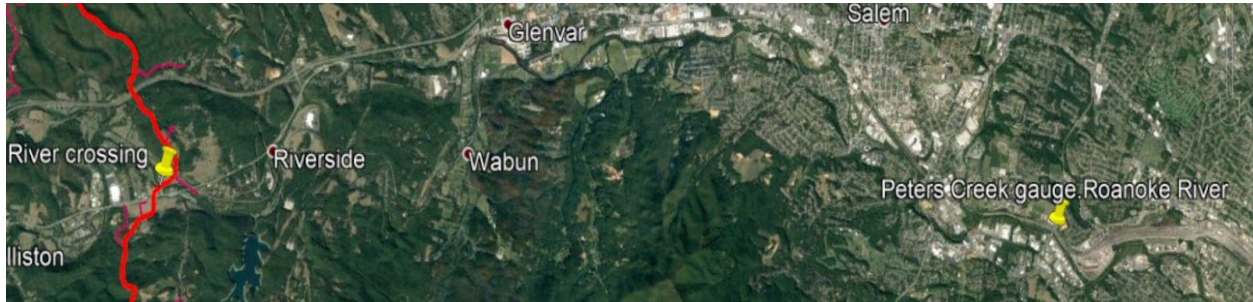
There are 3 USGS water monitoring gauges on the upper Roanoke River, all on the main stem. Two are located immediately upstream and downstream of the proposed open cut crossing of the Roanoke River by Mountain Valley Pipeline. The third is at the Peters Creek Road bridge where the Roanoke River enters the City of Roanoke.

See map below with approximate gauge locations marked with two yellow pins. RED = MVP ROW.

All three gauges on the Roanoke River experienced very high levels of turbidity through Salem and Roanoke following rainfall in the North Fork Roanoke River watershed and its tributaries (including Bradshaw Creek) on the evening of July 15, 2019. These readings are unprecedented for these gauges, even during the exceptionally high rainfall during 2018.

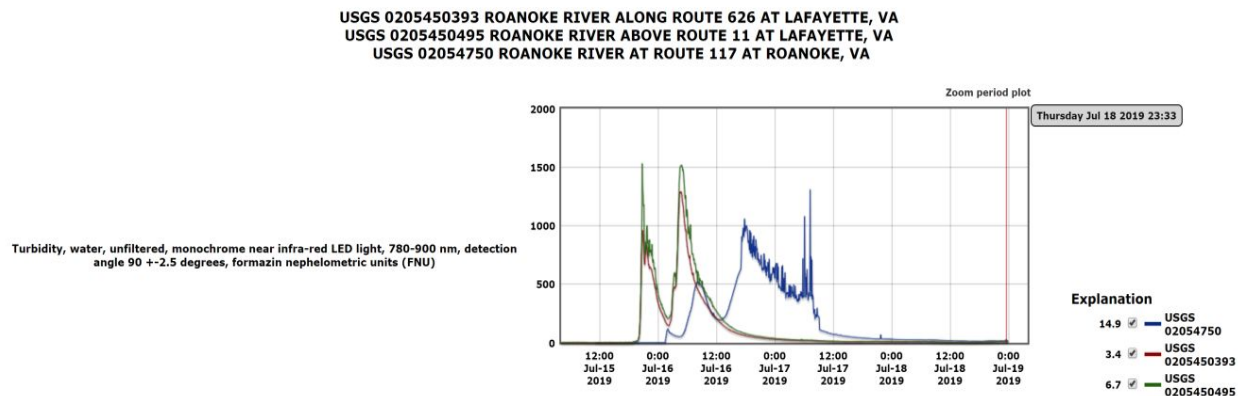
Turbidity measurements for the Roanoke River are shown on the graph below in formazin nephelometric units (FNU). According to USGS documentation, **readings >1,000 FNU are considered “very high.”**

Why did turbidity rise? It appears likely that a localized storm on the North Fork of the Roanoke River and its tributary, Bradshaw Creek, along the MVP right-of-way (ROW) was a major contributor to the problem.

Additional problems occurred and were reported when it rained during the week of July 21, and all three gauges showed a second, smaller spike and ongoing impairment that would impact the endangered species Roanoke Logperch. Note that even though there was less rainfall than on July 15, the river sustained a higher than normal level of turbidity for days. This indicates that the soils in this area have a high clay content with small soil particles that remain suspended in water for long periods of time. The endangered Roanoke logperch and other aquatic life are directly impacted by days of muddy water.

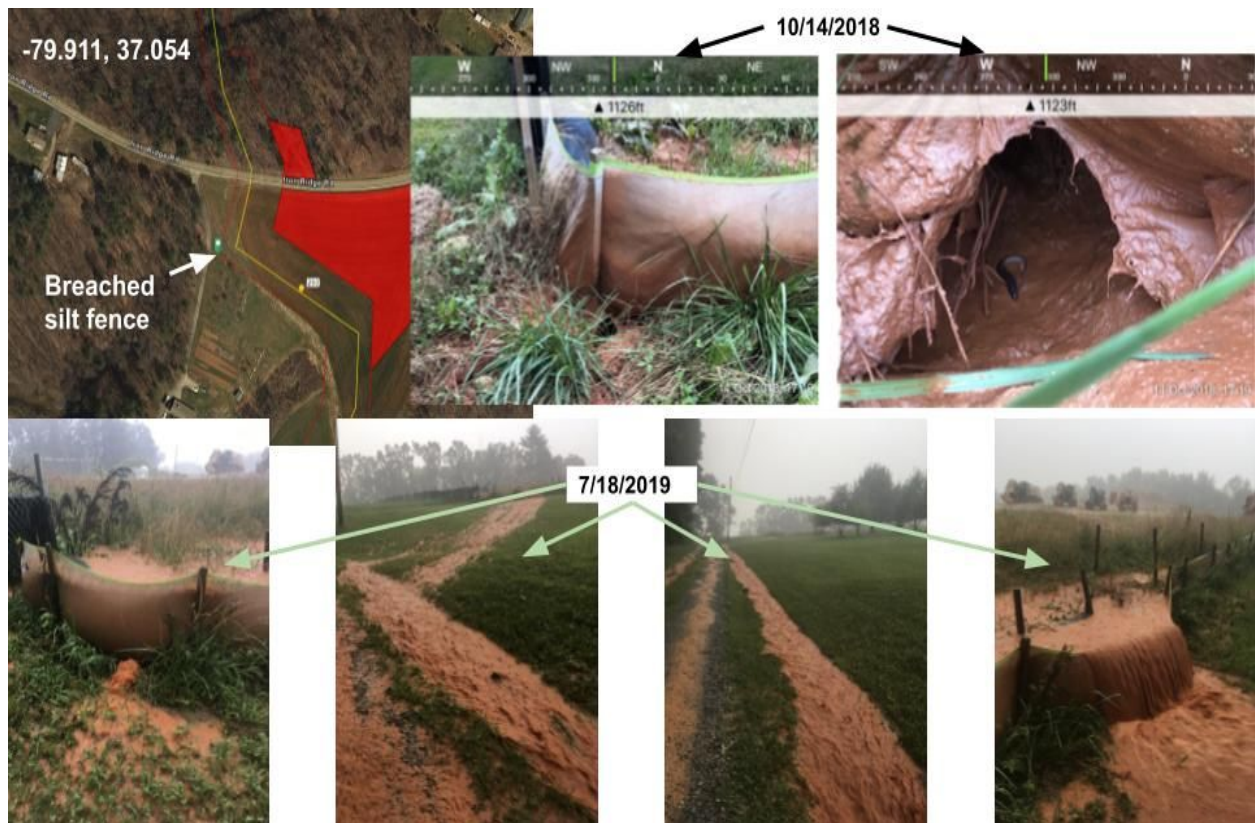
The Angle Farm has seen recurrent issues since construction began on the Mountain Valley Pipeline. Below is a set of images showing a breached silt fence on October 14, 2018. Moving ahead to July 2019 observations show the same hole, in the same silt fence, in the same location, continuing to fail and provide an increased sediment loads to the Blackwater River.

Figure 10. History of sedimentation at the Angle Farm, with images from October 2018 and recent sedimentation event of July 2019.

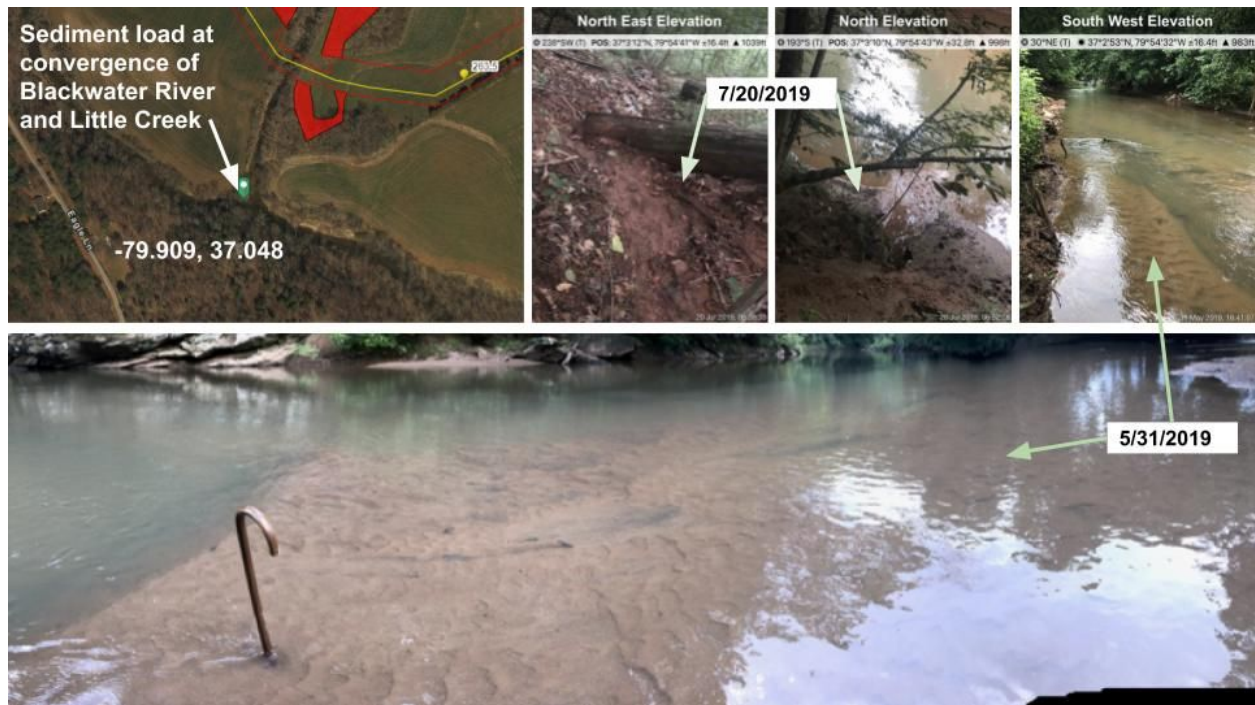
Figure 11. Images of sedimentation from May 31 are at the confluence of Little Creek and the North Fork of the Blackwater River, just downstream from the crossing of Little Creek on the Angle Farm. Images of sedimentation from July 20 are from the banks of the Blackwater River, following the path of sediment from MVP's workspace shown in Figure 10.

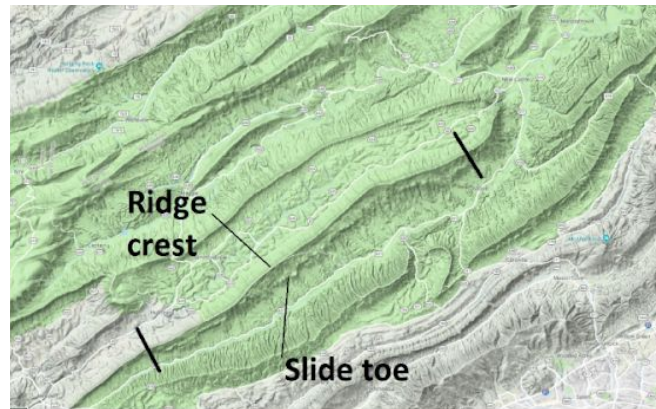
Philip S. Prince, with the Virginia Division of Geology and Mineral Resources, recently published an article titled “The landslide that is too big to notice.”¹ The figure below shows the location of the landslide study on Sinking Creek mountain in Montgomery County, VA. The western most black line is the MVP crossing at Sinking Creek Mountain. It is imperative that geologic field surveys are conducted to explore slope stability at the ridge and down the southeast slope of Sinking Creek Mountain (Montgomery County side) to ensure slope is stable enough to construct and restore without triggering a landslide.

There are currently springs (more than one) that traverse across the MVP ROW on this slope. After a storm, Sinking Creek Mountain has some very impressive hydraulic pressure impacting that environment. A long linear infrastructure project, like MVP, has the potential to block underground water from flowing to springs, causing increased hydraulic pressure on the natural spring path and potential failure of the slope along the same slip surface formation. This is a note of concern regarding this location and should be further evaluated with an extensive geologic field study and slope stability analysis.
