SUBJ: Mountain Valley Pipeline Stabilization
Greenbrier County, WV

We are submitting documentation of slips and lack of stabilization in the right-of-way of the Mountain Valley Pipeline.

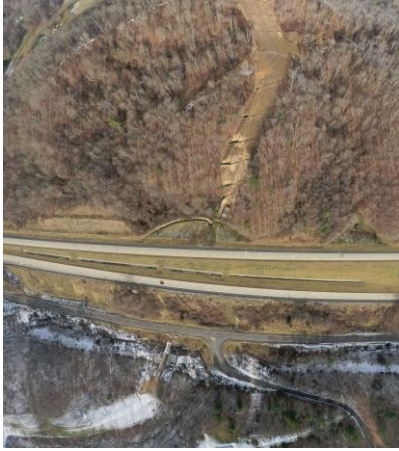
Milepost 156.6 - 156.7 [G0022979.jpg](#)
Large area with no vegetative cover on steep slope with slips and gullies forming on slope.

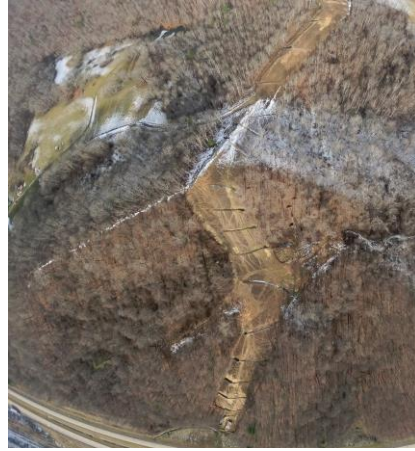
Milepost 156.6 - 156.7 [G0022982.jpg](#)
Continuation of areas with sparse vegetation with slips and gullies forming.

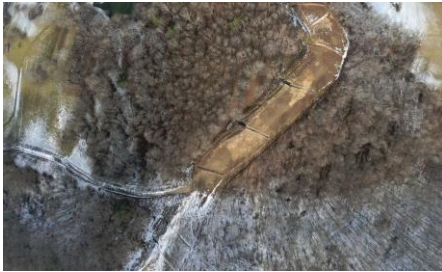
Milepost 156.4 - 156.5 [G0022985.jpg](#)
Large area on slope at end of access road with sparse or dead vegetation. Slips and rill gullies forming on bare areas of slope.

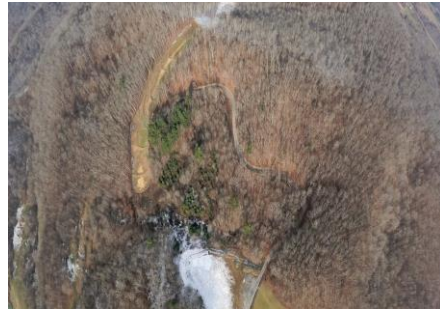
Milepost 155.5 [G0022998.jpg](#)
Sparse vegetation or dead grass with bare areas and rill erosion at toe of slope.

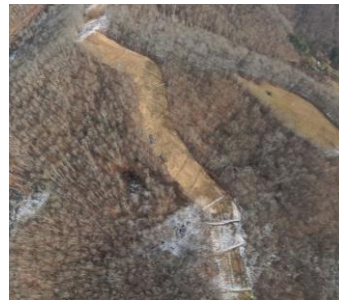
Milepost 153.75 - 153.9 [G0023025.jpg](#)
Bare or sparse vegetation. Re-seeding is needed.

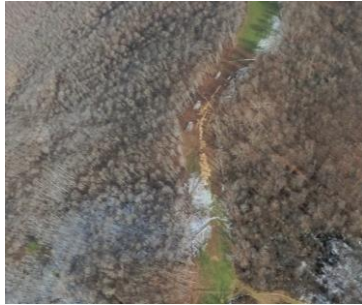
Milepost 150.9 [G0023076.jpg](#)
Bare/sparsely vegetated area at bend of ROW. Re-seeding required.

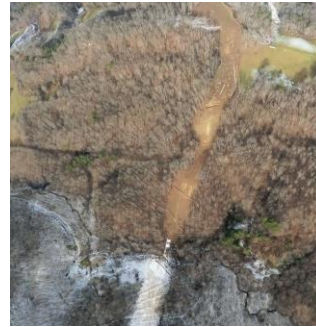
Milepost 149.8 [G0023098.jpg](#)
Bare/sparsely vegetated areas with rill erosion creating possible slips. Re-seeding required to stabilize slopes.

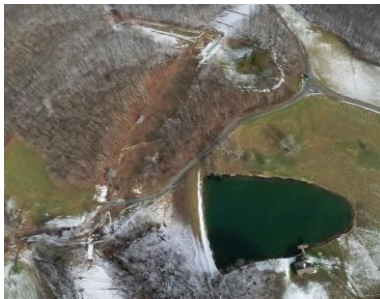
Milepost 148.2 [G0023130.jpg](#)
Bare/sparsely vegetated areas with rill erosion at toe of slope. Re-seeding required to stabilize slopes.

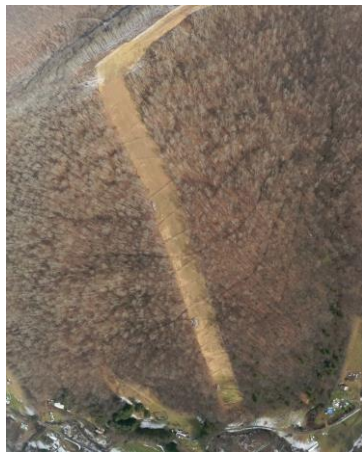
Milepost 146.6 - 146.9 [G0023156.jpg](#)
Long steep slope with bare/sparsely vegetated areas and rill erosion. Re-seeding required to stabilize slopes.

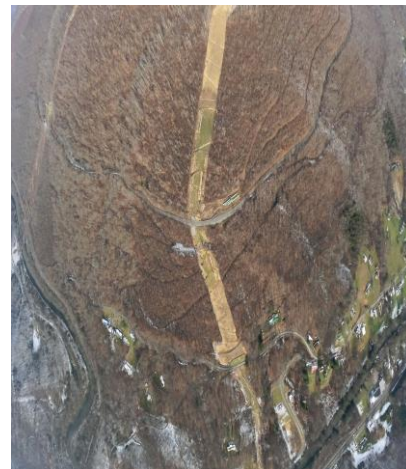
Milepost 143.5 - 143.8 [G0023210.jpg](#)
Long steep slope with bare/sparsely vegetated areas and rill erosion. Re-seeding and erosion control matting required to stabilize slopes.

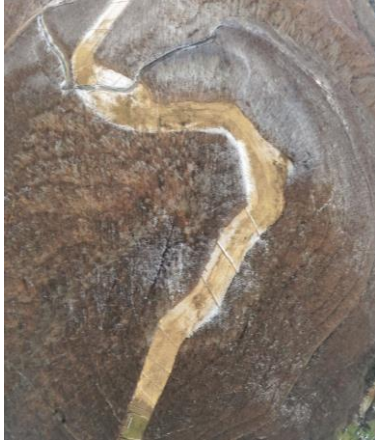
Milepost 143.2 - 143.5 [G0023215.jpg](#)
Long slope with bare/sparsely vegetated areas and rill erosion. Re-seeding and erosion control matting required to stabilize slopes.

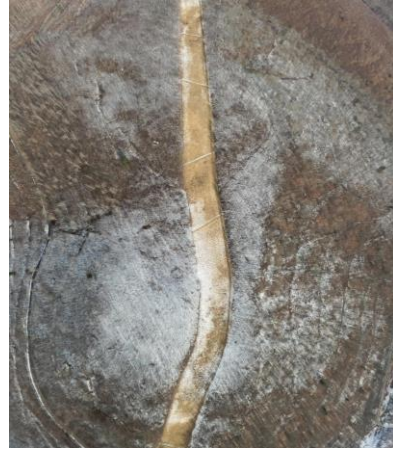
Milepost 142.2 [G0023234.jpg](#)
Long slope with bare/sparsely vegetated areas. Re-seeding required to stabilize slope.

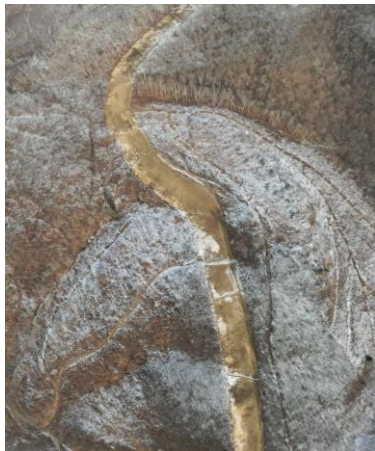
Milepost 141.6 [G0023245.jpg](#)
Long slope with bare/sparsely vegetated areas. Re-seeding required.

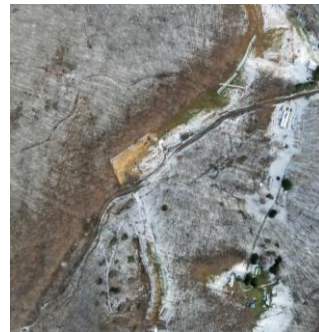
Milepost 140.8 [G0023259.jpg](#)
Area next to the road crossing has no vegetative cover in place. Inspection needed to determine the condition of this area.

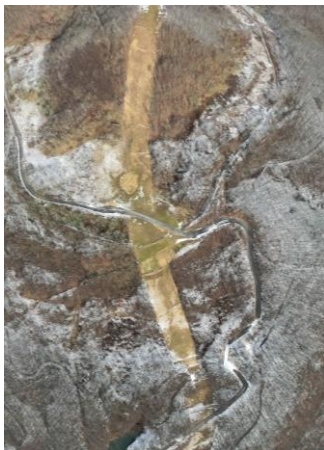
<p>Milepost 139.7 - 139.9 G0023274.jpg Sparsely vegetated areas with rill erosion in places on slope. Re-seeding needed.</p>	
---	--
