April Report 2019

Introduction

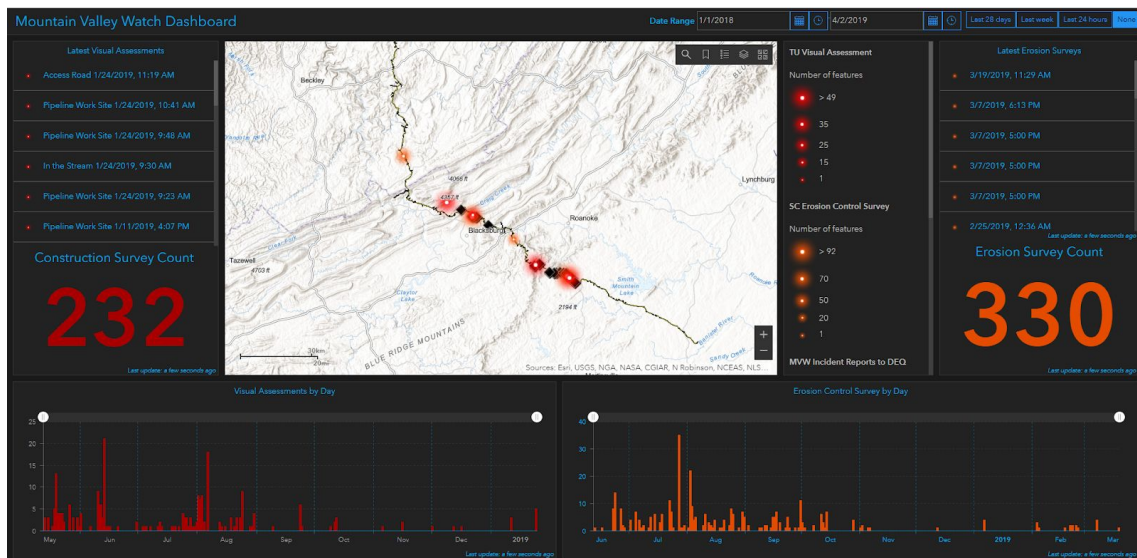
Figure 1: Citizen survey submissions from start of project through 4/2/2019.

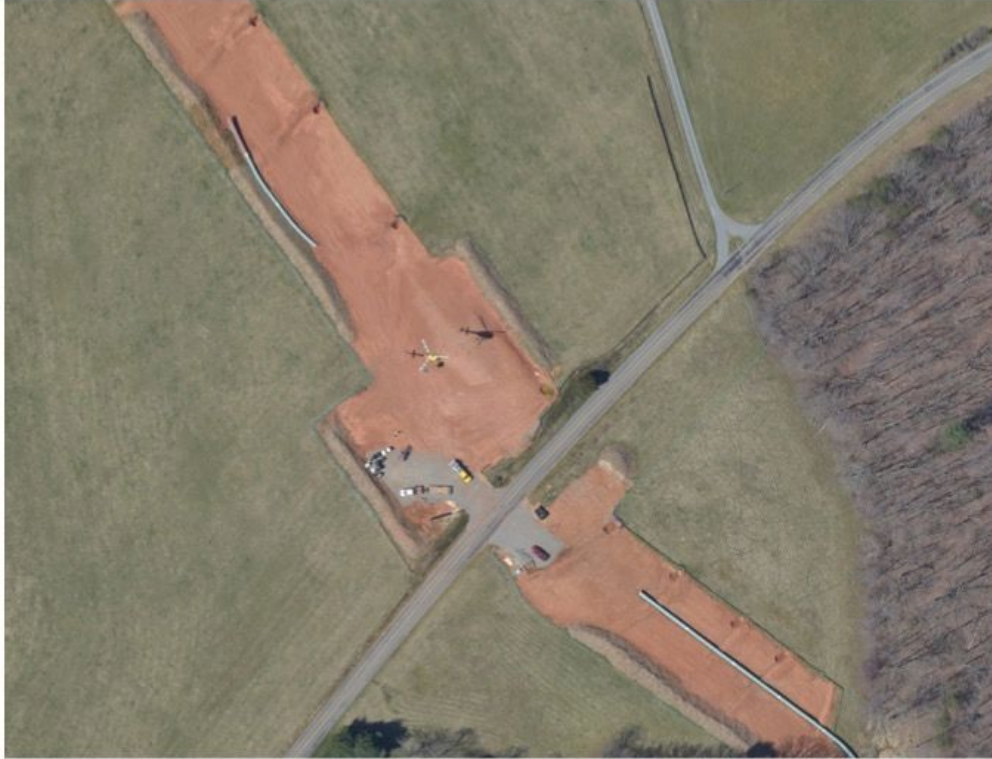
Figure 11: Aerial image of a helicopter taking off from the MVP right-of-way in Franklin County, Virginia.

These helicopters are used to spread erosion control pellets called EarthGuard on the right of way. However, reports from both West Virginia and Virginia indicate that this method of spreading pellets is imprecise and results in pellets being dropped into streams and waterways. A lawsuit was filed in West Virginia against MVP alleging that the pellets landed off the right-of-way on the property of an organic farm and violated conditions for organic certification. The GHS Safety Data Sheet for EarthGuard pellets indicates they contain acrylamide, which is known to cause cancer, birth defects, and other reproductive harm.
