Comments to State Water Control Board

August 10, 2018 (REVISED - August 13, 2018)

The following report was created by Mountain Valley Watch, a collaboration of public, private, and non-profit interests, and documents repeated failures of Mountain Valley Pipeline, LLC (Mountain Valley) and its contractors to protect water quality while constructing the Mountain Valley Pipeline (MVP). This information is relevant to the Board's consideration of the sufficiency of NWP 12 because it (1) documents harm to streams directly caused by crossings authorized by NWP 12 despite that permit's conditions and (2) documents harm to streams from sedimentation from upland areas. The information contained in this report further demonstrates that the Board must exercise its authority to require individual review of all waters crossed by the Mountain Valley Pipeline to determine if additional safeguards are necessary to protect Virginia water quality.

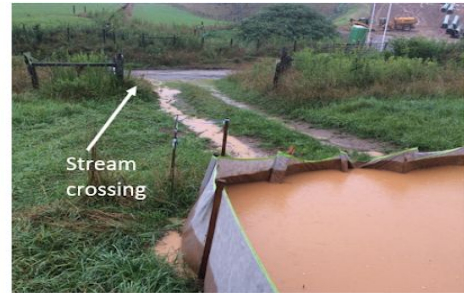
Figure 5: Work site pictures described previously in section B.

C. Another significant failure across the road. This one is pouring sediment off the LOD, into the stream and into SR 642 – SGT.

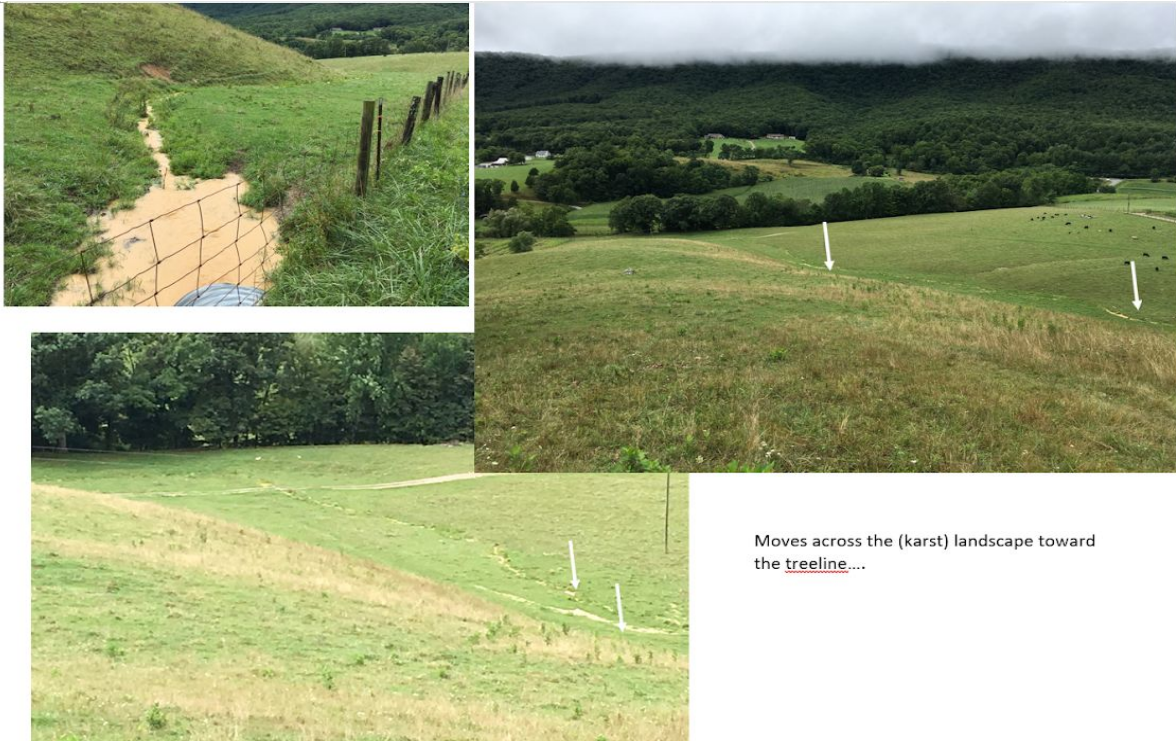
Figure 7: Work site pictures described previously in section B.

This is 05 Aug at 13:15 hr Friday. After crew departure, a gravel truck arrives and delivers a last load of gravel to the worksite. Note that the road is still receiving copious amounts of sediment and they enter the stream at the damaged streambank.

This is 05 Aug at 15:08 hr. Sediment is still still entering stream at damaged bank.

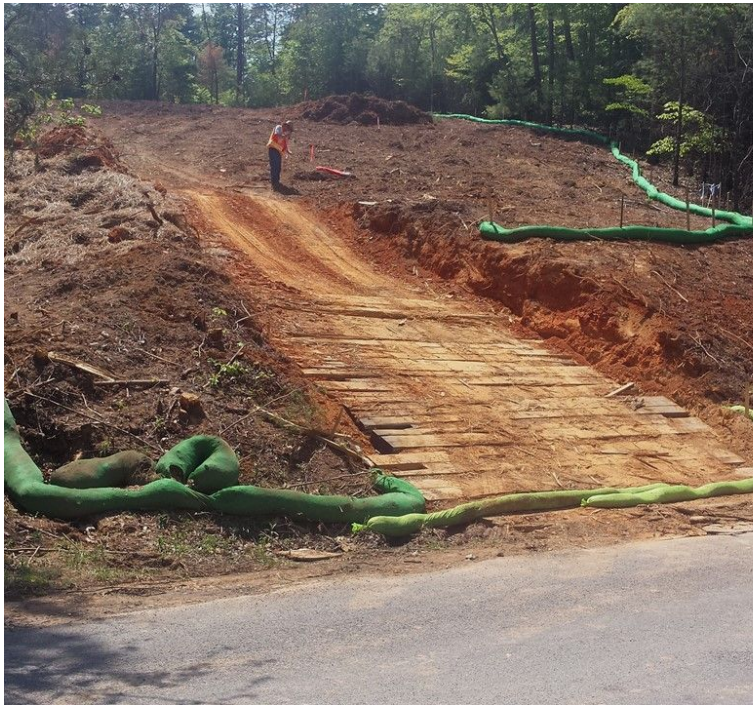
Figure 10: Potential violation reported - May 13, 2018

Mountain Valley Watch
Citizen Monitoring Report
Observation Info
Construction Stage: active construction **Date:** 05/13/2018 2:54 PM
Incident Data
Assessment Type: Pipeline worksite
Description of potential violation

Lack of gravel; inadequate E&SC; mudslide; sediment leaving construction site; failed BMPs.

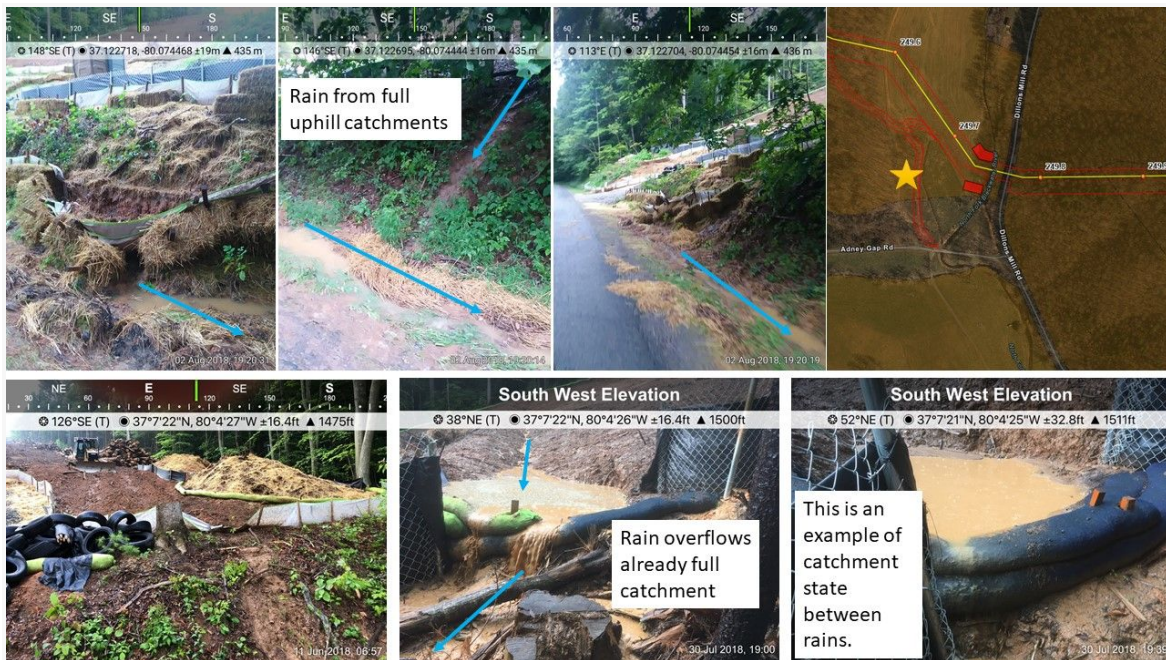
Figure 19: Violations reported - June 10, 2018 and August 3, 2018

Temporary right-of-way diversions (RWD) were not properly installed. Per Std & Spec 3.11 of the Virginia Erosion Control Handbook. Violation reported - June 10, 2018

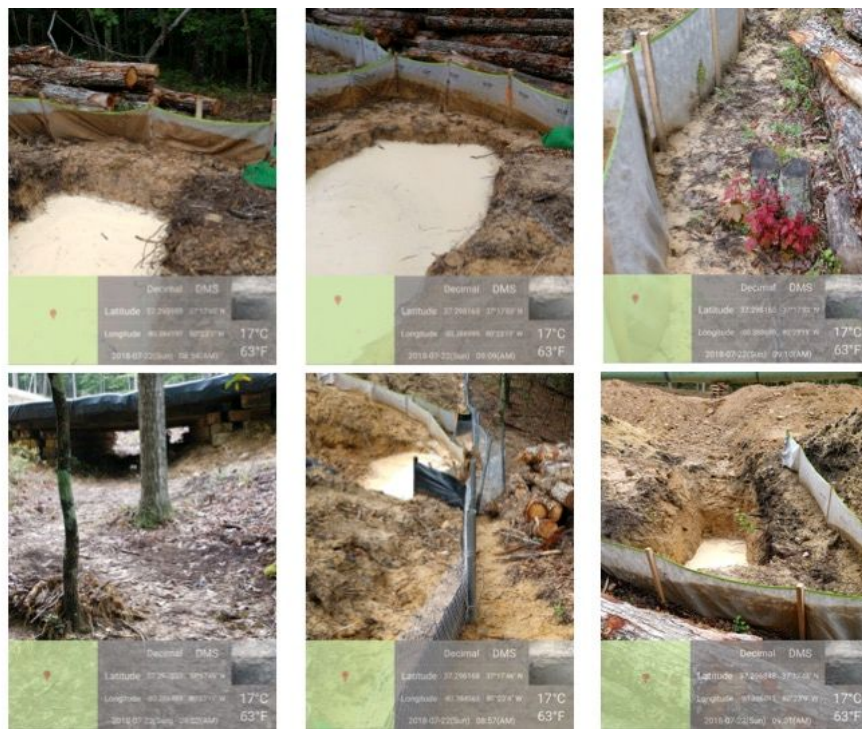
Figure 31: Photos from July 22, 2018 reported incident on Slayton property

Despite DEQ's issuance of a Notice of Violation July 9, 2018 and MVP's subsequent voluntary stop work to repair ESC measures, the Slusser's Chapel Conservation area continued to see erosion and sediment control incidents, with additional ESC failures reported on the Dyer property July 17 and July 22, and on the Slayton property July 22, 2018. The images shown below are from those reports. One image in figure 31 from the reported incident on the Slayton property shows the stream bed clogged with mud as a result of repeated failures.

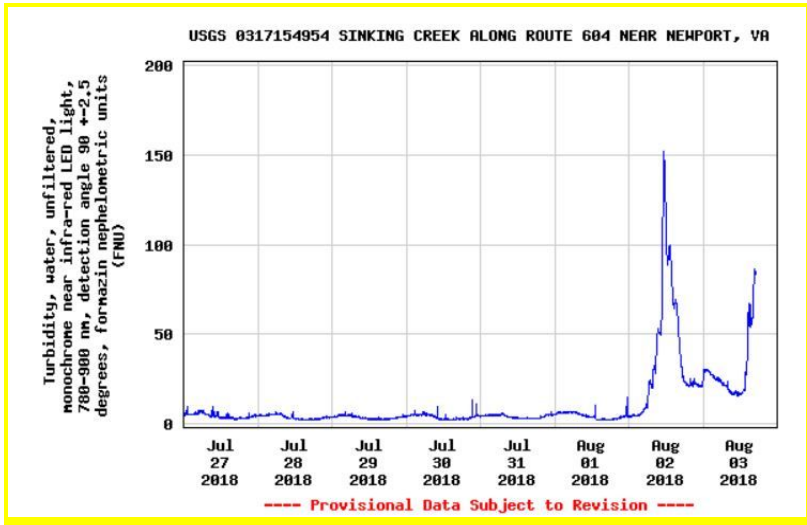
Figure 33: USGS water quality gauge located 1.71 miles downstream in Sinking Creek

This is the first major failure observed in Historic Newport Virginia. This is the pattern for future rain events and impacts to Sinking Creek. See images of potential violation below. The drainage area for stormwater runoff includes a portion of an access road and a large area from the MVP right of way. Overwhelmed outlet structures at the discharge point of diversion bars cause rain water to create new runoff gullies adjacent to the ROW. Runoff from the access road combines with ROW runoff and result in the sedimentation shown in figure 32. A snapshot of the USGS water quality gauge, figure 33, located 1.71 miles downstream in Sinking Creek indicates a large spike in sediment loading on August 2, 2018.

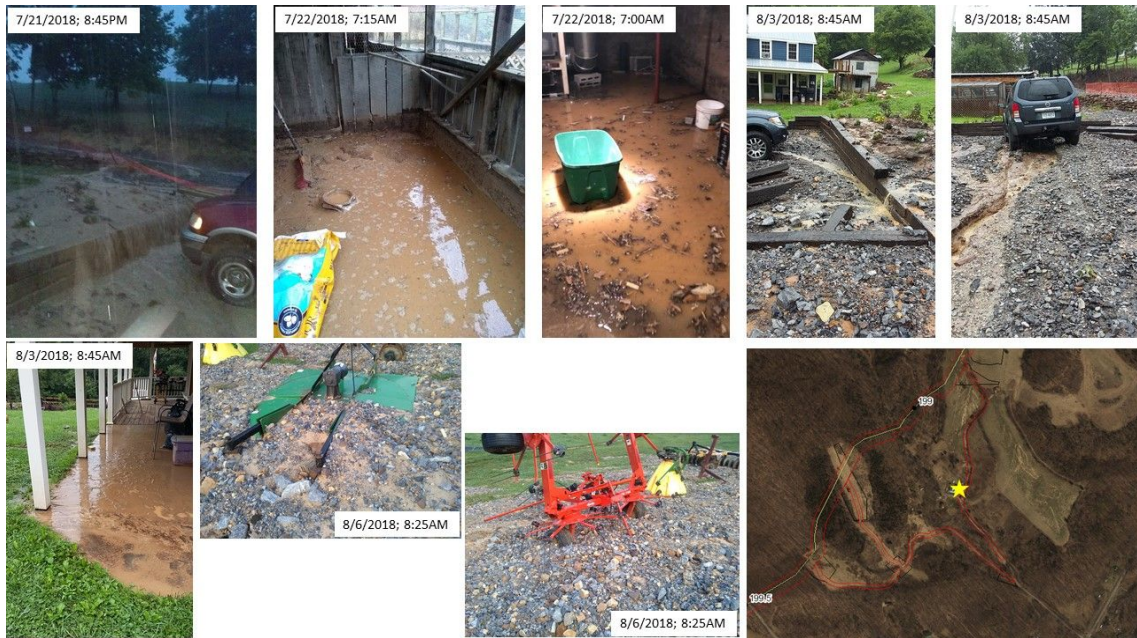
Figure 34: Location and time series of rain events on Gallagher property.

As of the writing of this report, three major failures (on 7/21, 7/31 and 8/2) had occurred at the Gallagher property. Grading for an access road redirected runoff toward the house and chicken coop. Both the chicken coop and basement of the house were flooded. Figures 34-36 illustrate the resulting damage. As part of the continued updating of this report a fourth and the most significant failure to date occurred today 8/13/2018. We are collecting images and will update report.
