December Report

2018

Monthly Citizen Reports

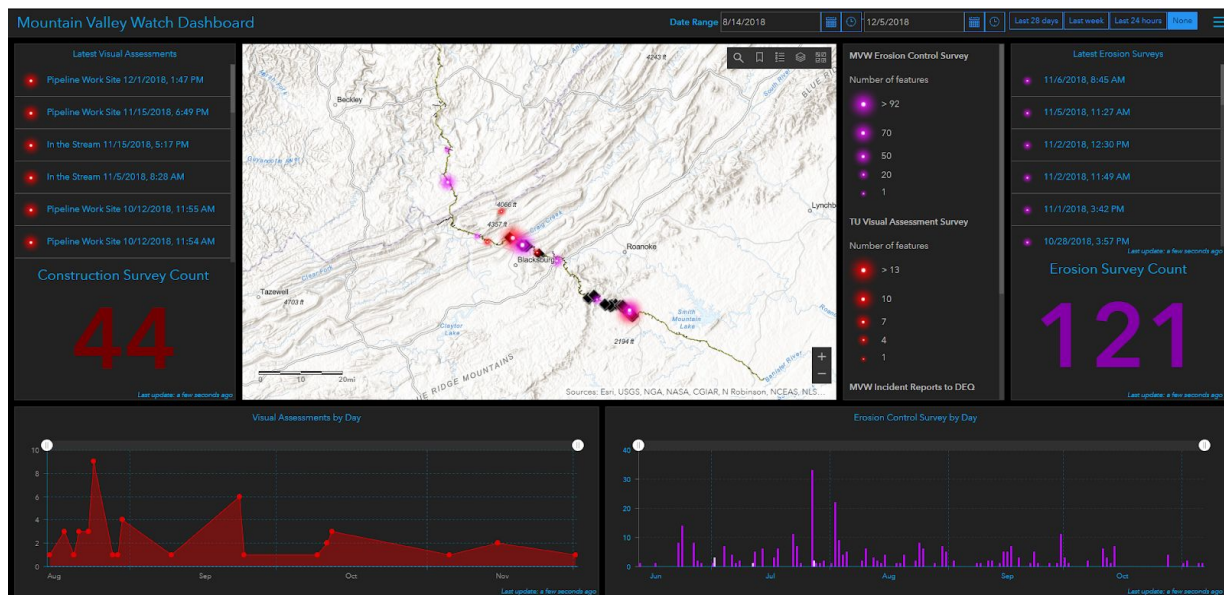
Since our previous report to the Water Control Board, a total of 165 citizen submissions have been compiled in our database as of 12/5/2018. Volunteers have consistently documented overwhelmed erosion and sediment control devices throughout every county in Virginia. Figure 1 shows incidents reported in the Mountain Valley Watch Dashboard from 8/14/2018 - 12/5/2018.

Figure 1: Data dashboard showing citizen survey submissions from 8/14 - 12/05/2018.
