Cave Report

May 2020

This report is intended to demonstrate the consequences of blasting in known karst areas in Giles County, Virginia and Monroe County, West Virginia. Mountain Valley Pipeline did not fully implement the measures in its Karst Mitigation Plan or General Blasting Plan outlined in Section 4 of the Final Environmental Impact Statement (FEIS). There are serious issues that require further evaluation to avoid potential pipeline rupture and contamination of groundwater. This is a highly unstable area in karst terrain.

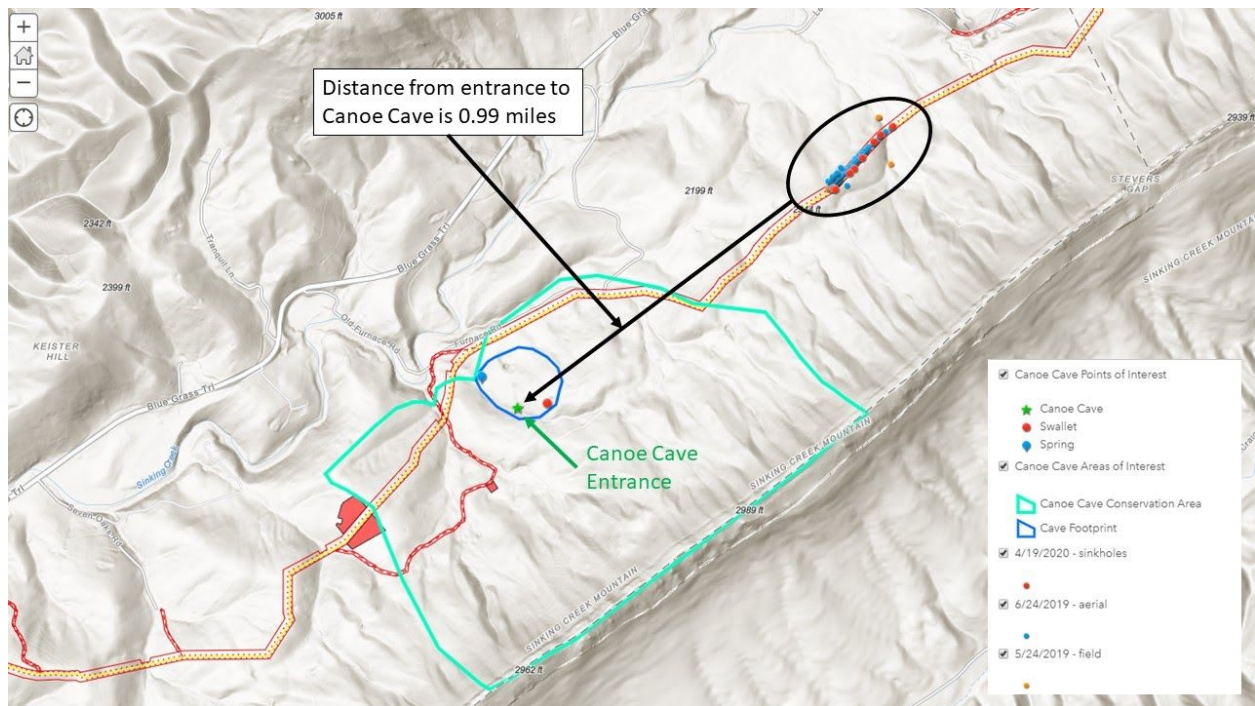
Figure 3: Canoe Cave entrance location in relation to sinkhole photos from site visits on June 24, 2019 and April 15, 2020.

Figure 3 shows the location of Canoe Cave in relation to the blasted area with sinkholes and caverns formed in the MVP right-of-way between mile markers 216.1 and 216.5. The **blue** dots in Figure 3 show the locations of drone and ground photos taken in the field on June 24, 2019. The **orange** dots in Figure 3 show the locations of photos of new sinkholes forming in the MVP right-of-way on April 19, 2020.

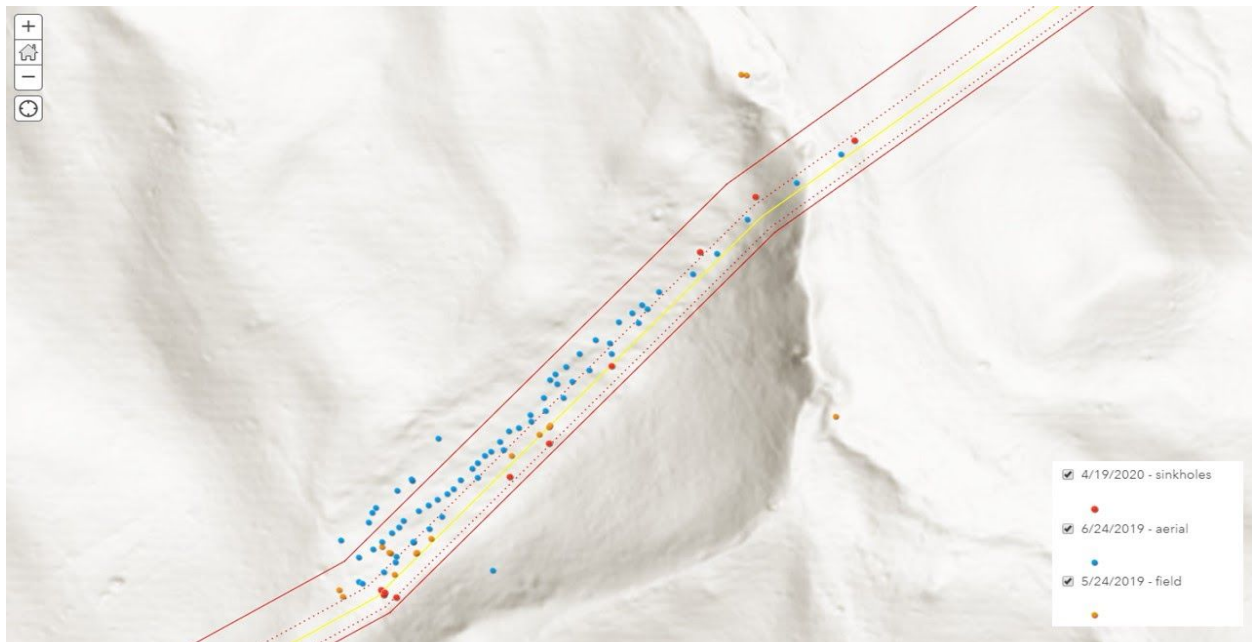
Figure 4: Location map of field photos with dates.

Field photos show areas of subsidence and sinkholes beginning to form within right-of-way after rock blasting between mile markers 216.1 and 216.4. Several areas of significant subsidence are encircled in silt fences. Blasting of rock in July 2018 during pipeline construction exposed cavities that were not visible before construction began. During site visits, drilled blast holes were found and measured for depth. Several blast holes measured between eight to eleven feet in depth. During observation of measurements, the measuring device could be heard passing through underground cavities and hitting underground water at the bottom of blast holes.
