FROM: Kirk A Bowers, PE
Mountain Valley Watch

DATE: February 16, 2021

SUBJ: Mountain Valley Pipeline Slip report analysis, milepost 57.2-57.3

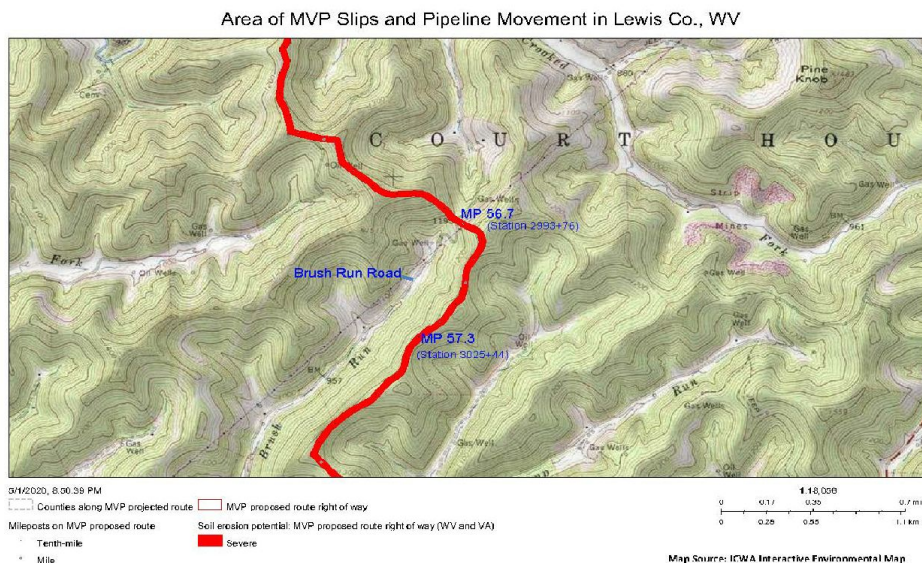
The map below shows the location of the MVP in the area of continued land subsidence. The map shows that south of Brush Run Road (MP 56.7) the pipeline route makes a steep ascent, then runs southwest along or near the top of the ridge. MP 57.3, where the 200 ft-long slip occurred, appears to be about midway along the ridge. Exact locations of where the crew identified pipeline shifts was not reported.

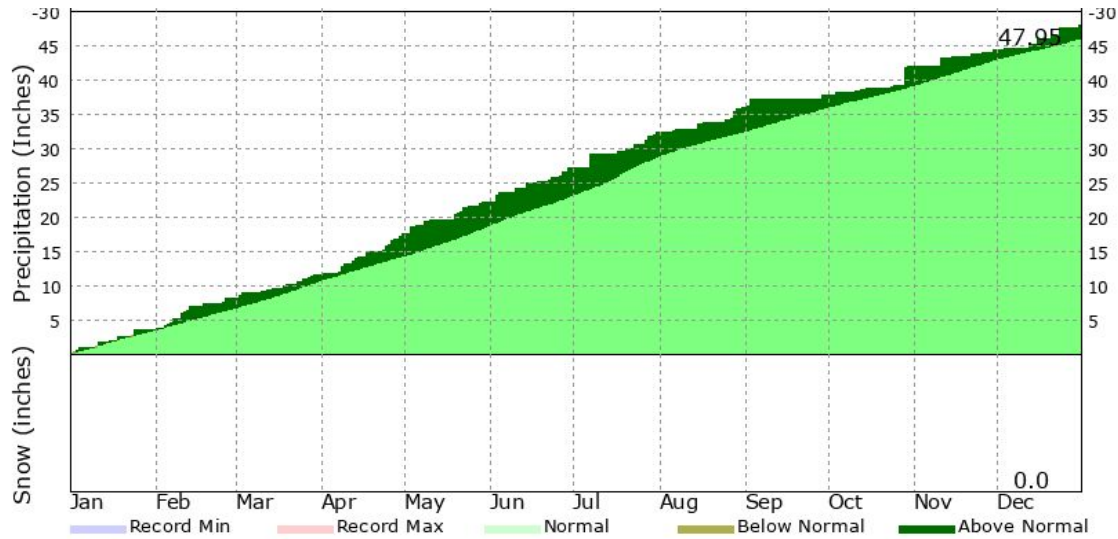
Year 2020: Total Monthly Precipitation for Clarksburg, WV

Mountain areas tend to receive more precipitation overall because they force air to be lifted and cooled. The totals shown in the graphs below indicate above average rainfall for this area of West Virginia during the year 2020.

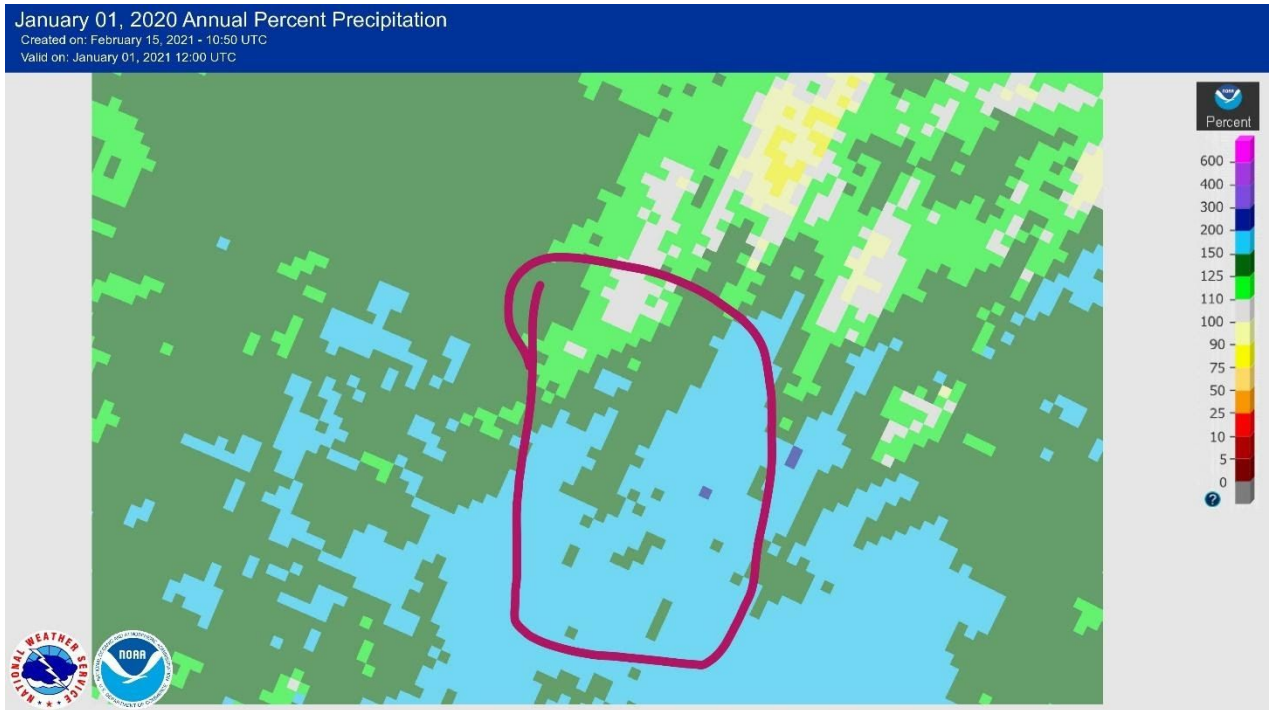
The MVP runs through the area circled in Red above which shows 125% to 150% increase in rainfall during 2020.
